**REPORT FINDINGS**

PRJ # BRO 8006 (46)		PCN: 6778		Date: 6/10/14		Year Constructed: 2009							
County: Brookings				Structure Location: 06-290-177									
Assessed By: Maier/Boone				Stream Name: Medary Creek									
Structure Type			Structure Shape Comments										
	Number of Barrels X Width (ft) X Height (ft)		Inlet Type					Outlet Type*					
Box	4x12'x8'		Projecting					At Stream Grade					x
Arch			Wing wall					Cascade over Riprap					
Pipe Diameter			Headwall					Free Fall into Pool					
<sup>1</sup> Bridge			Apron					Free Fall Onto Rip Rap					
<sup>1</sup> Bridge Deck Length X Width			Riprap					Apron					
			Other:					Other:					
Rapid Visual Assessment:													
Observation												Y / N N.A.

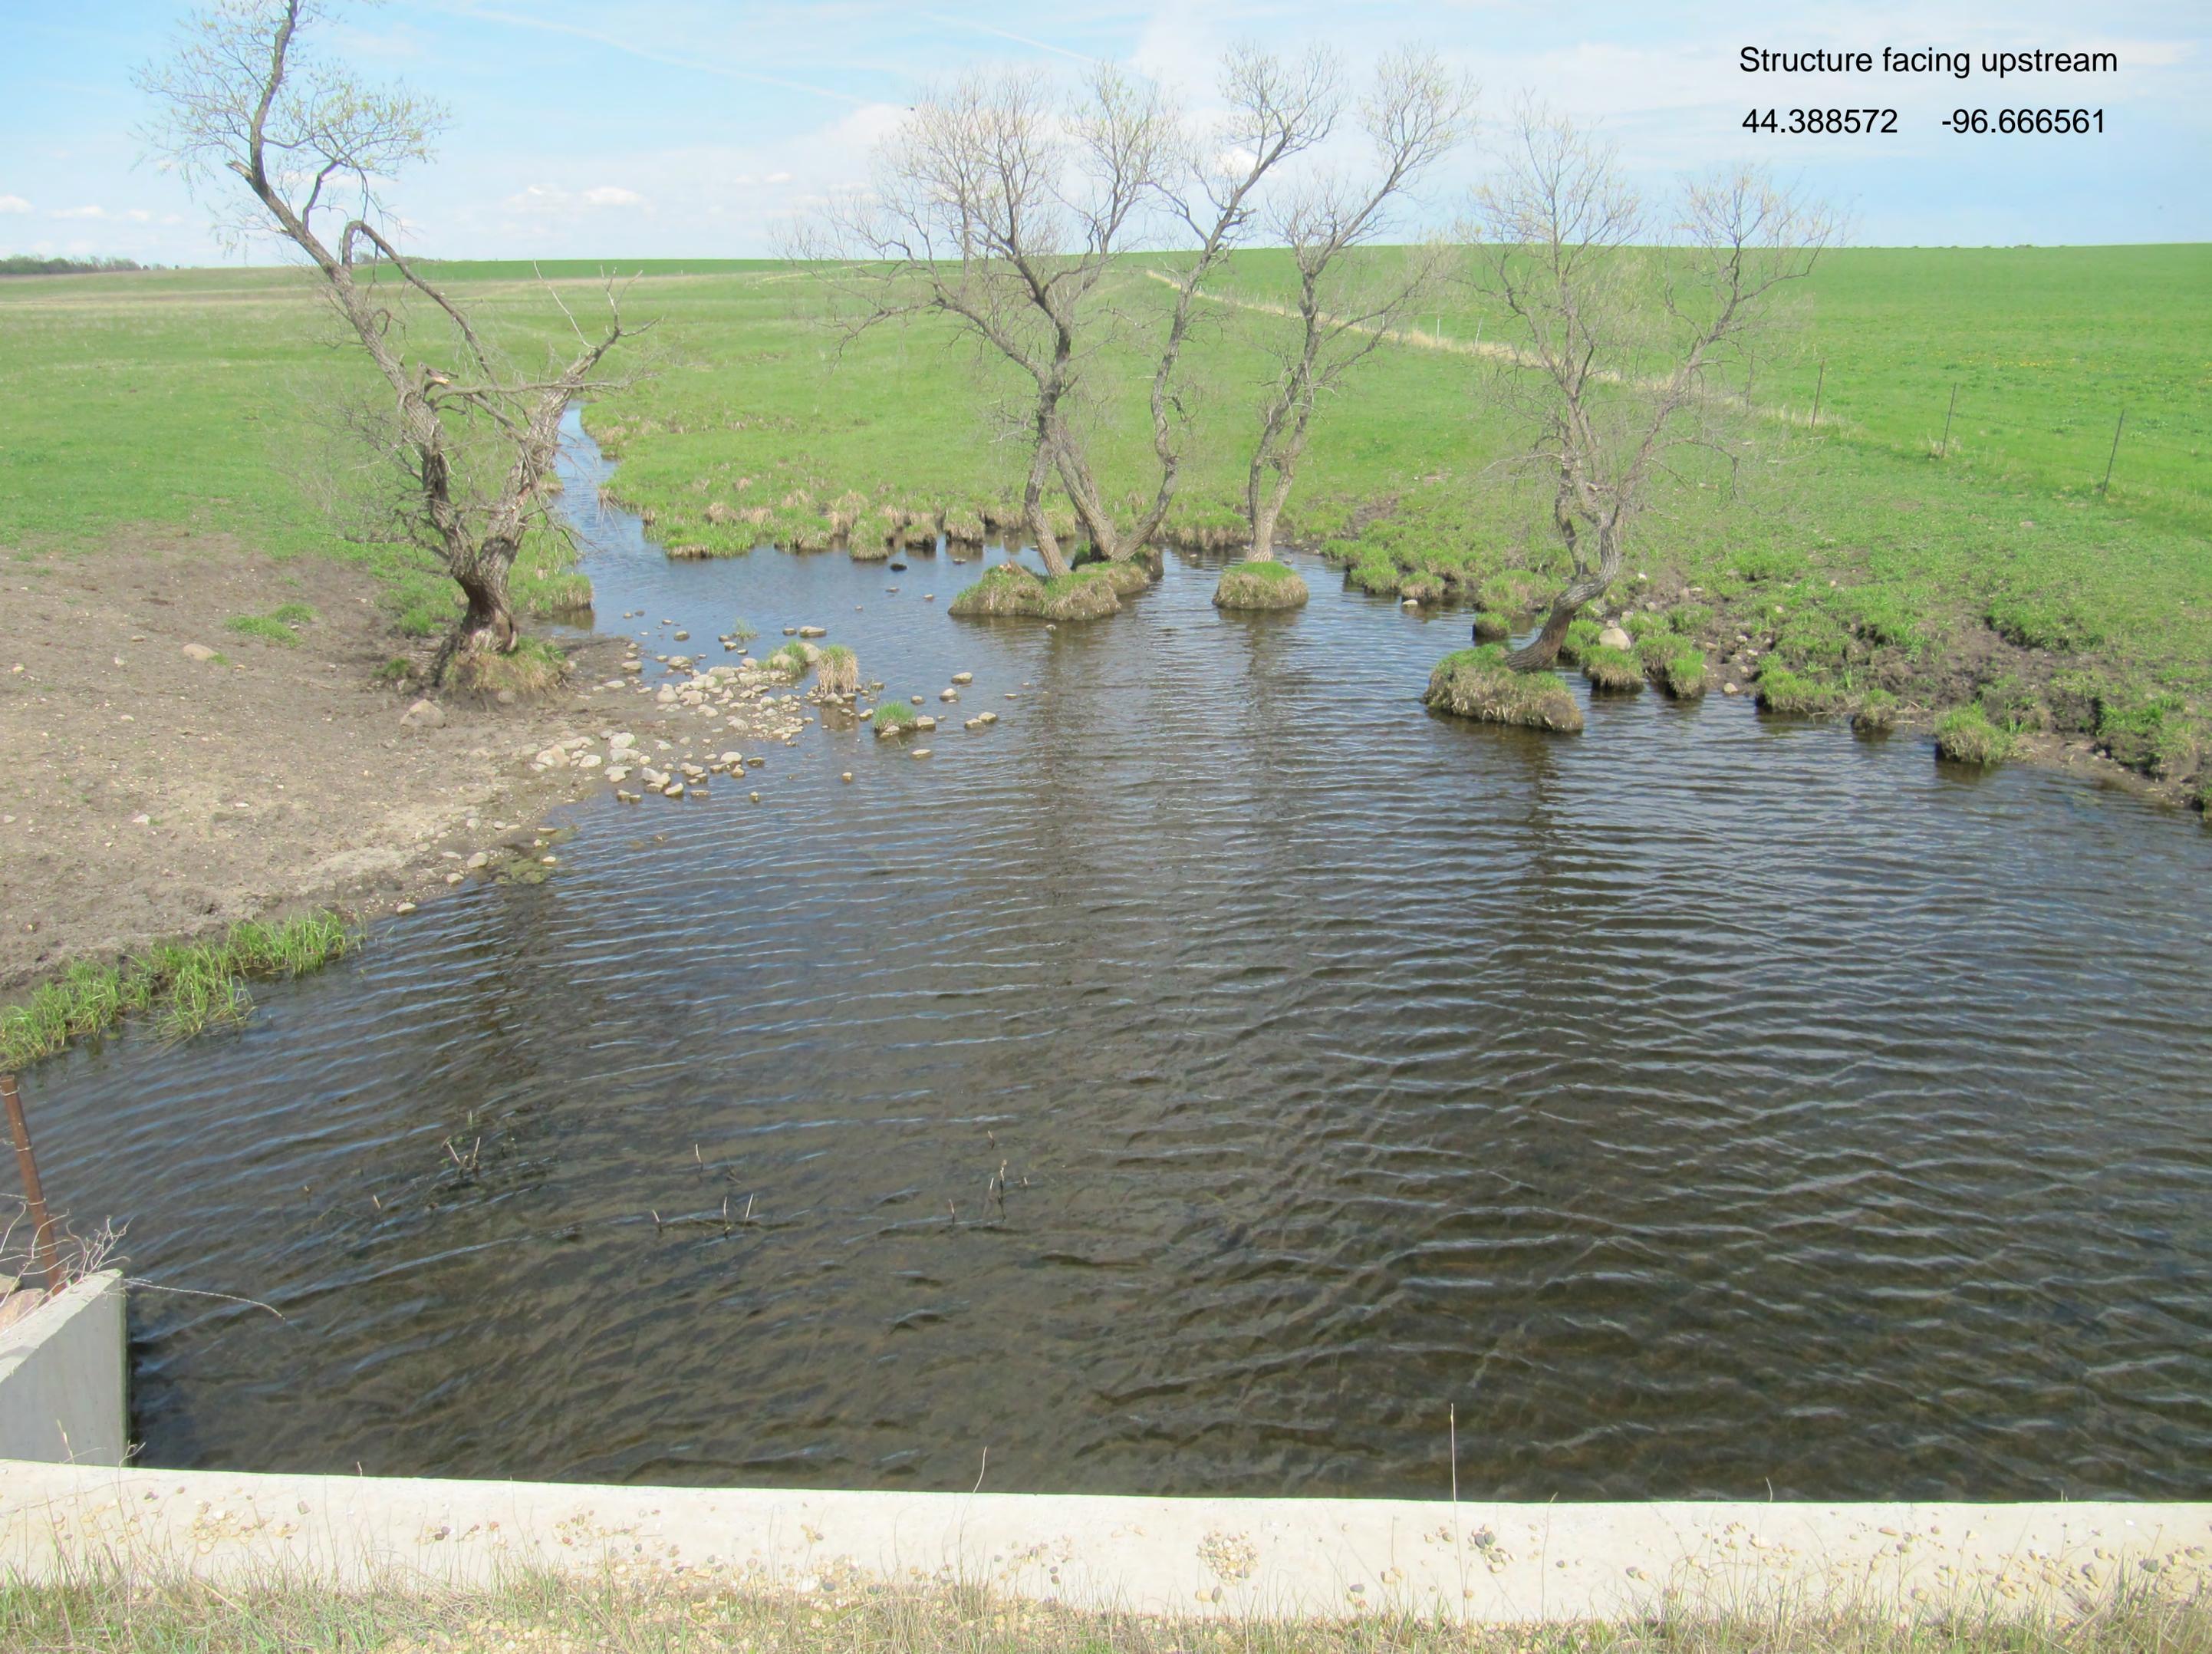
44.388572 -96.666561

Structure facing upstream

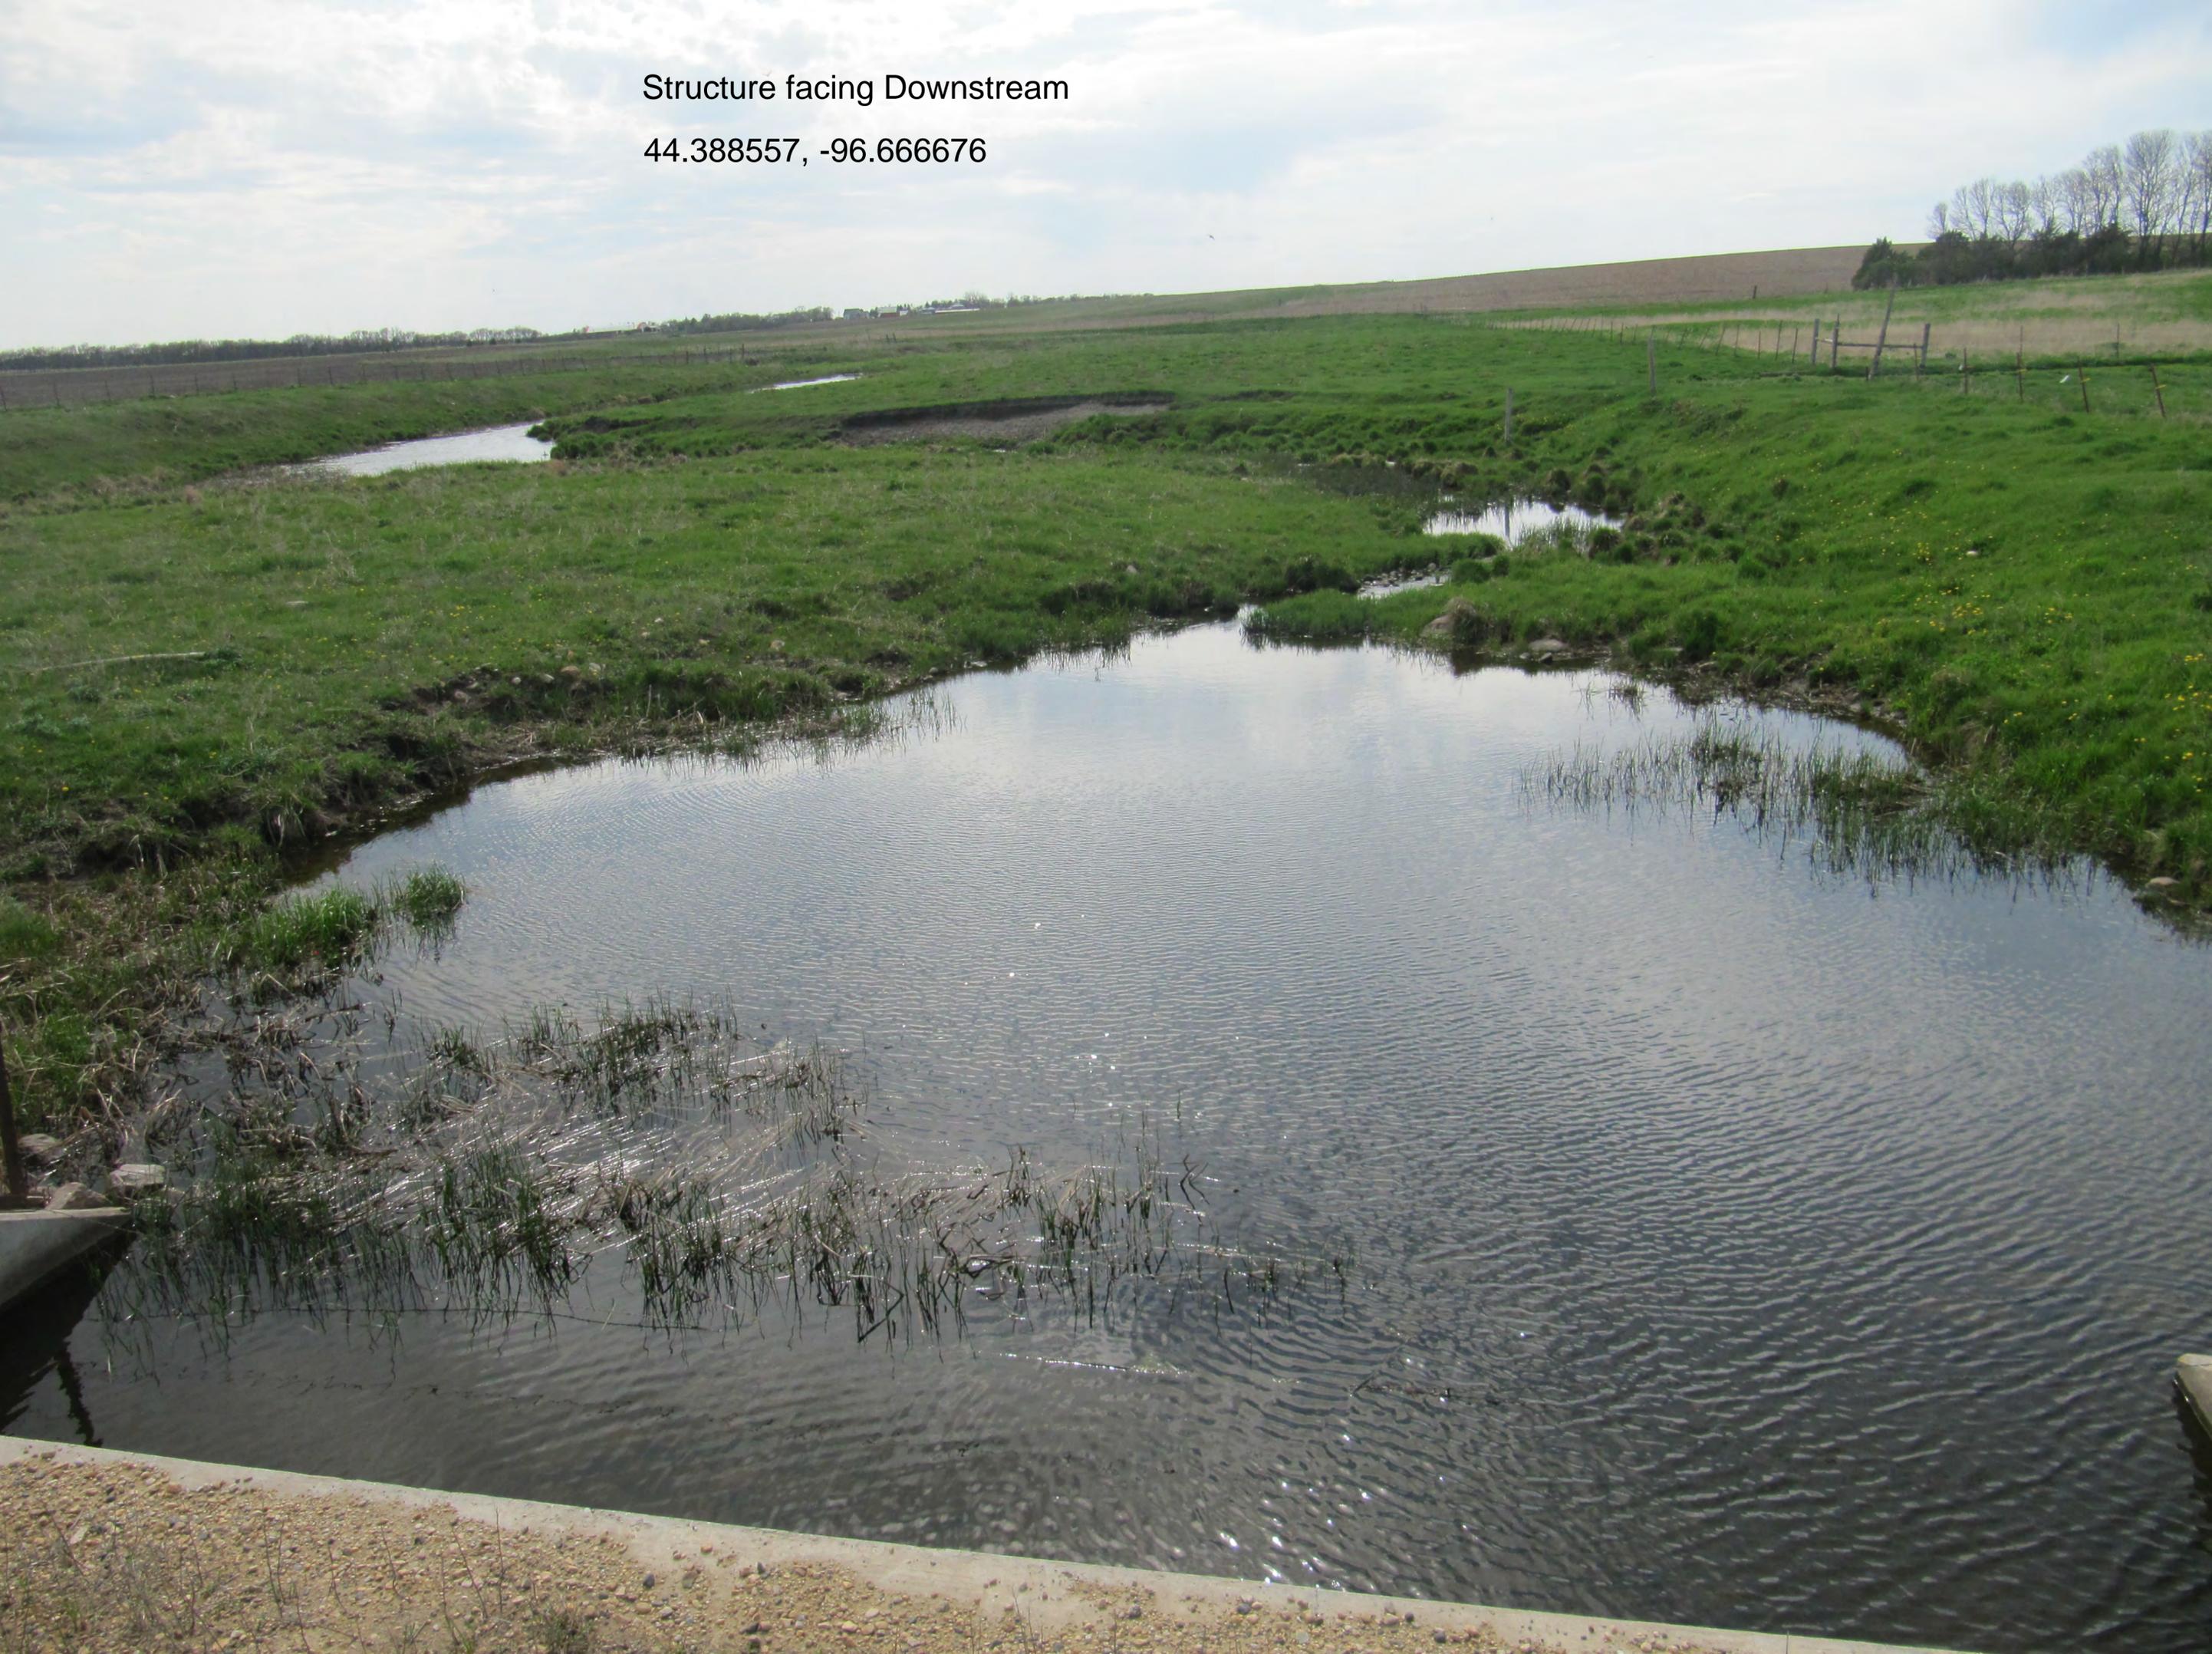
44.388557, -96.666676

Structure facing Downstream

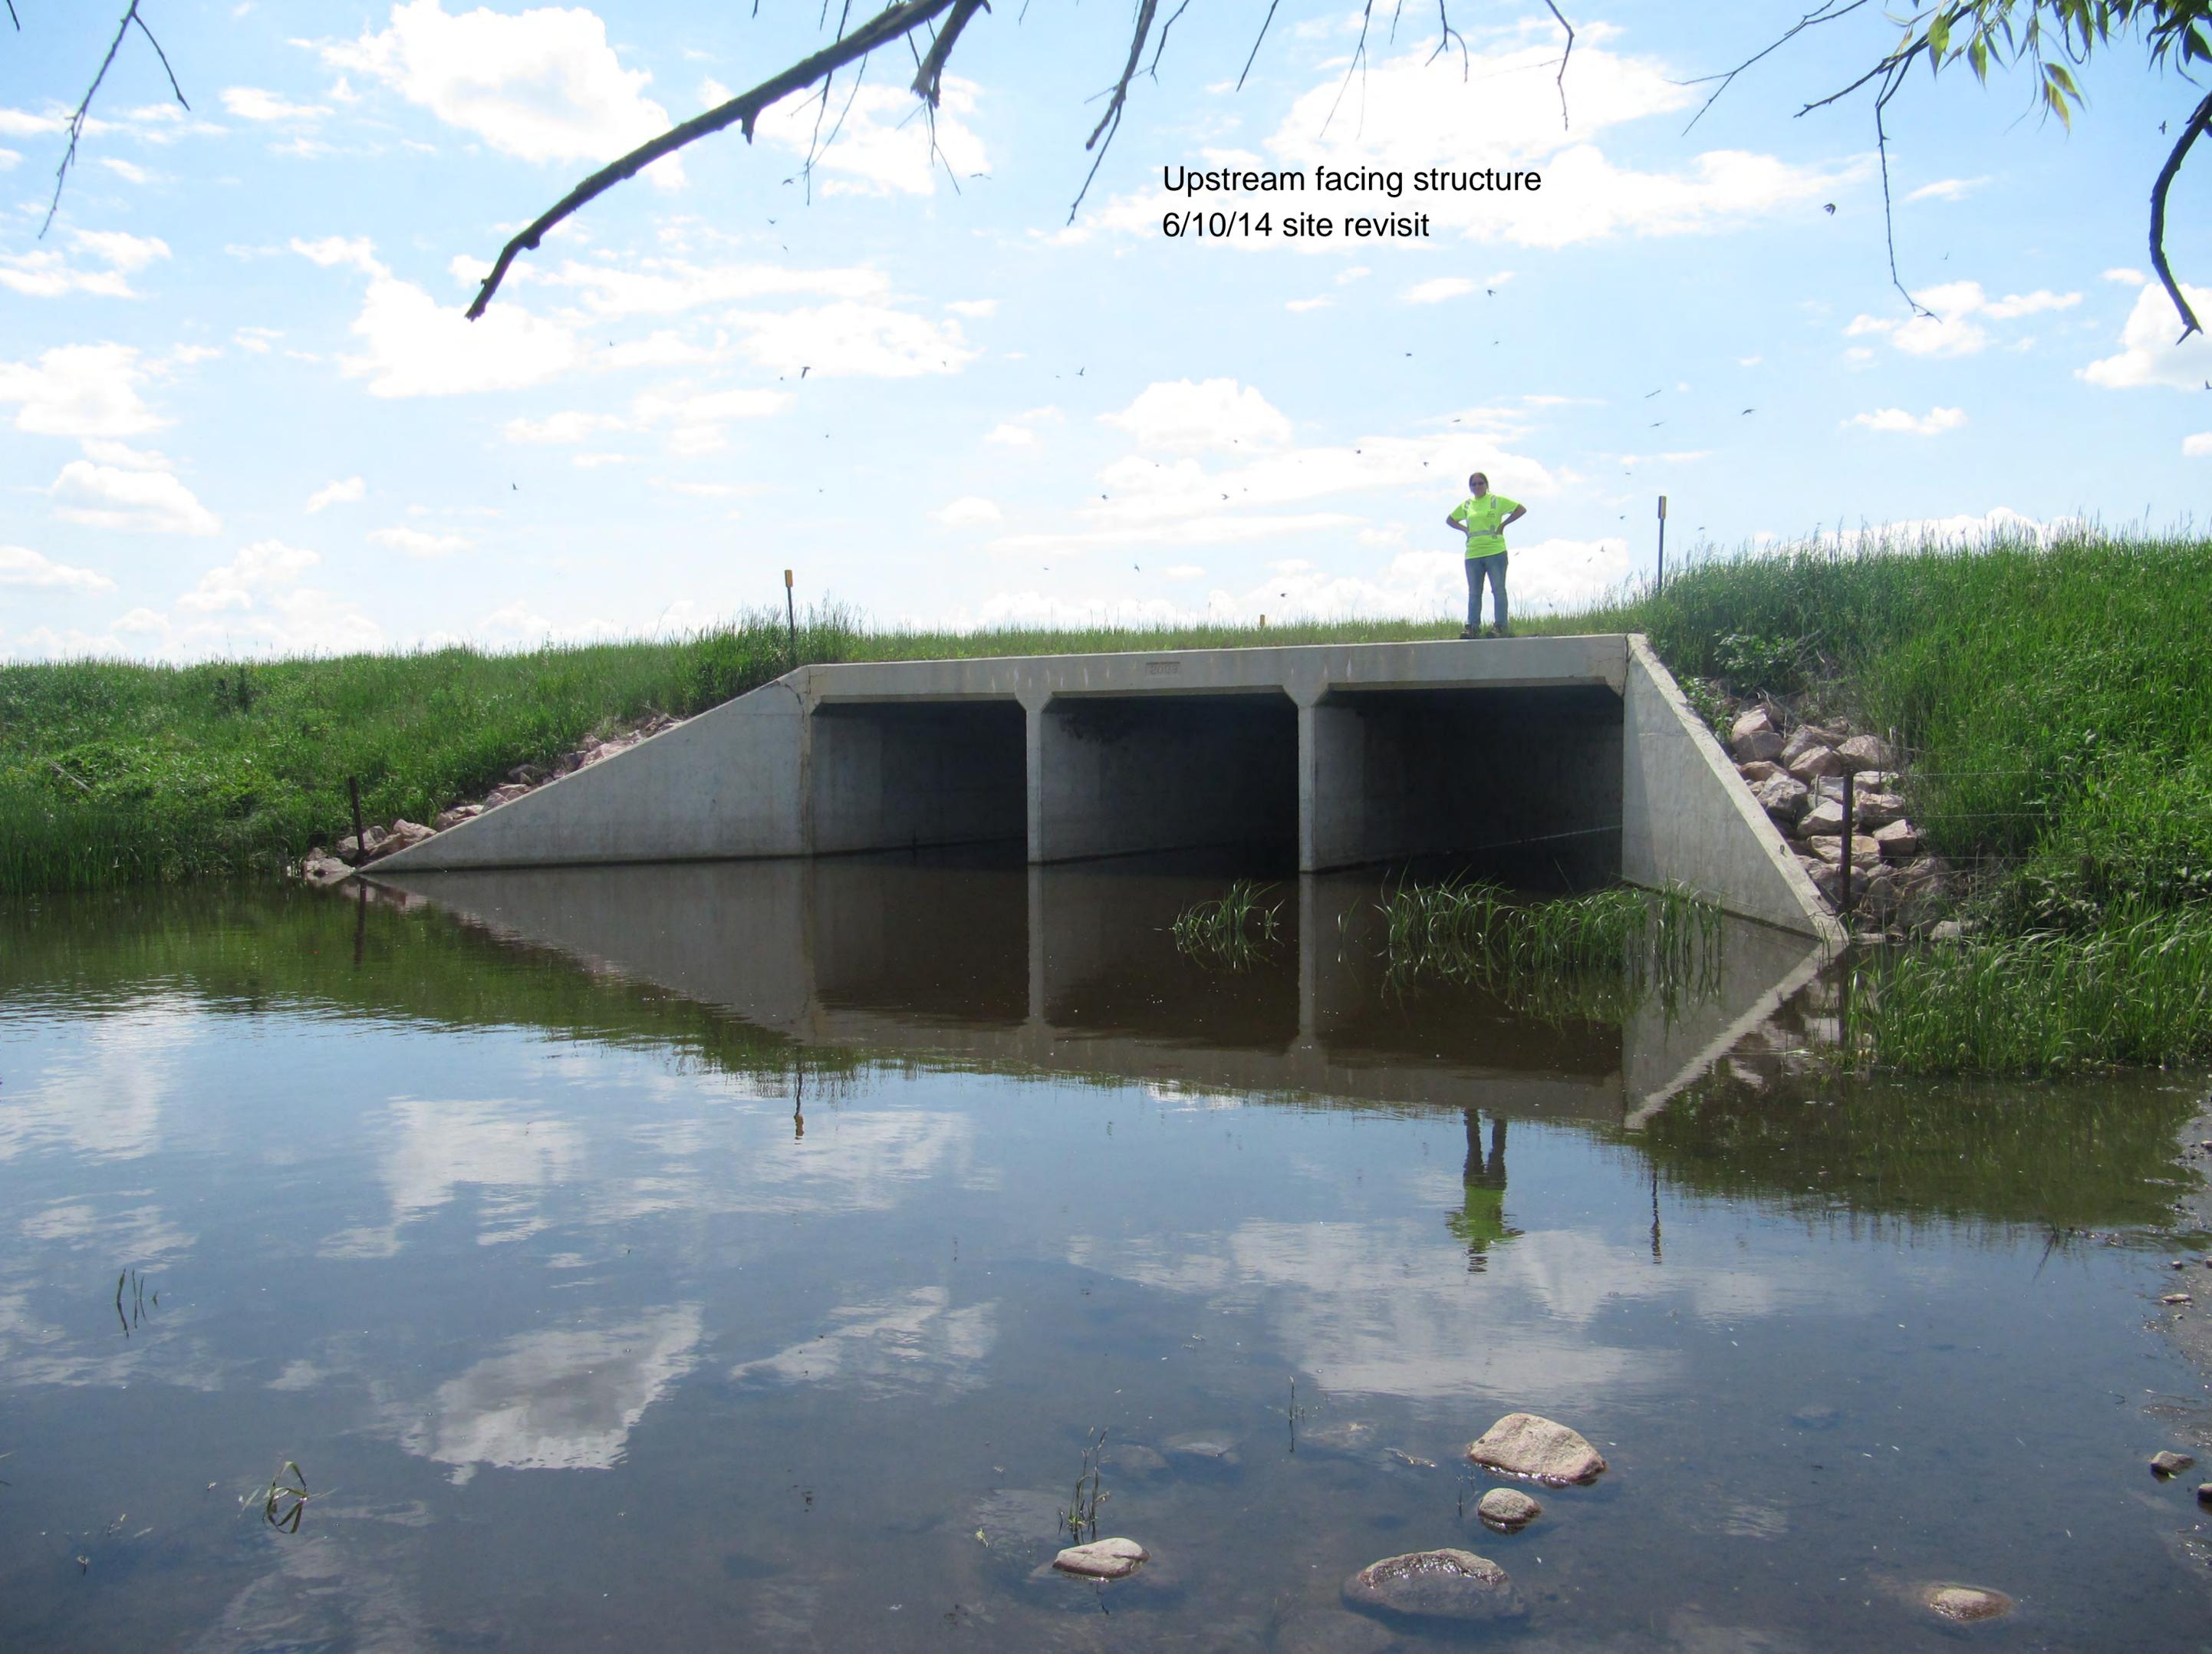
Upstream facing structure  
6/10/14 site revisit

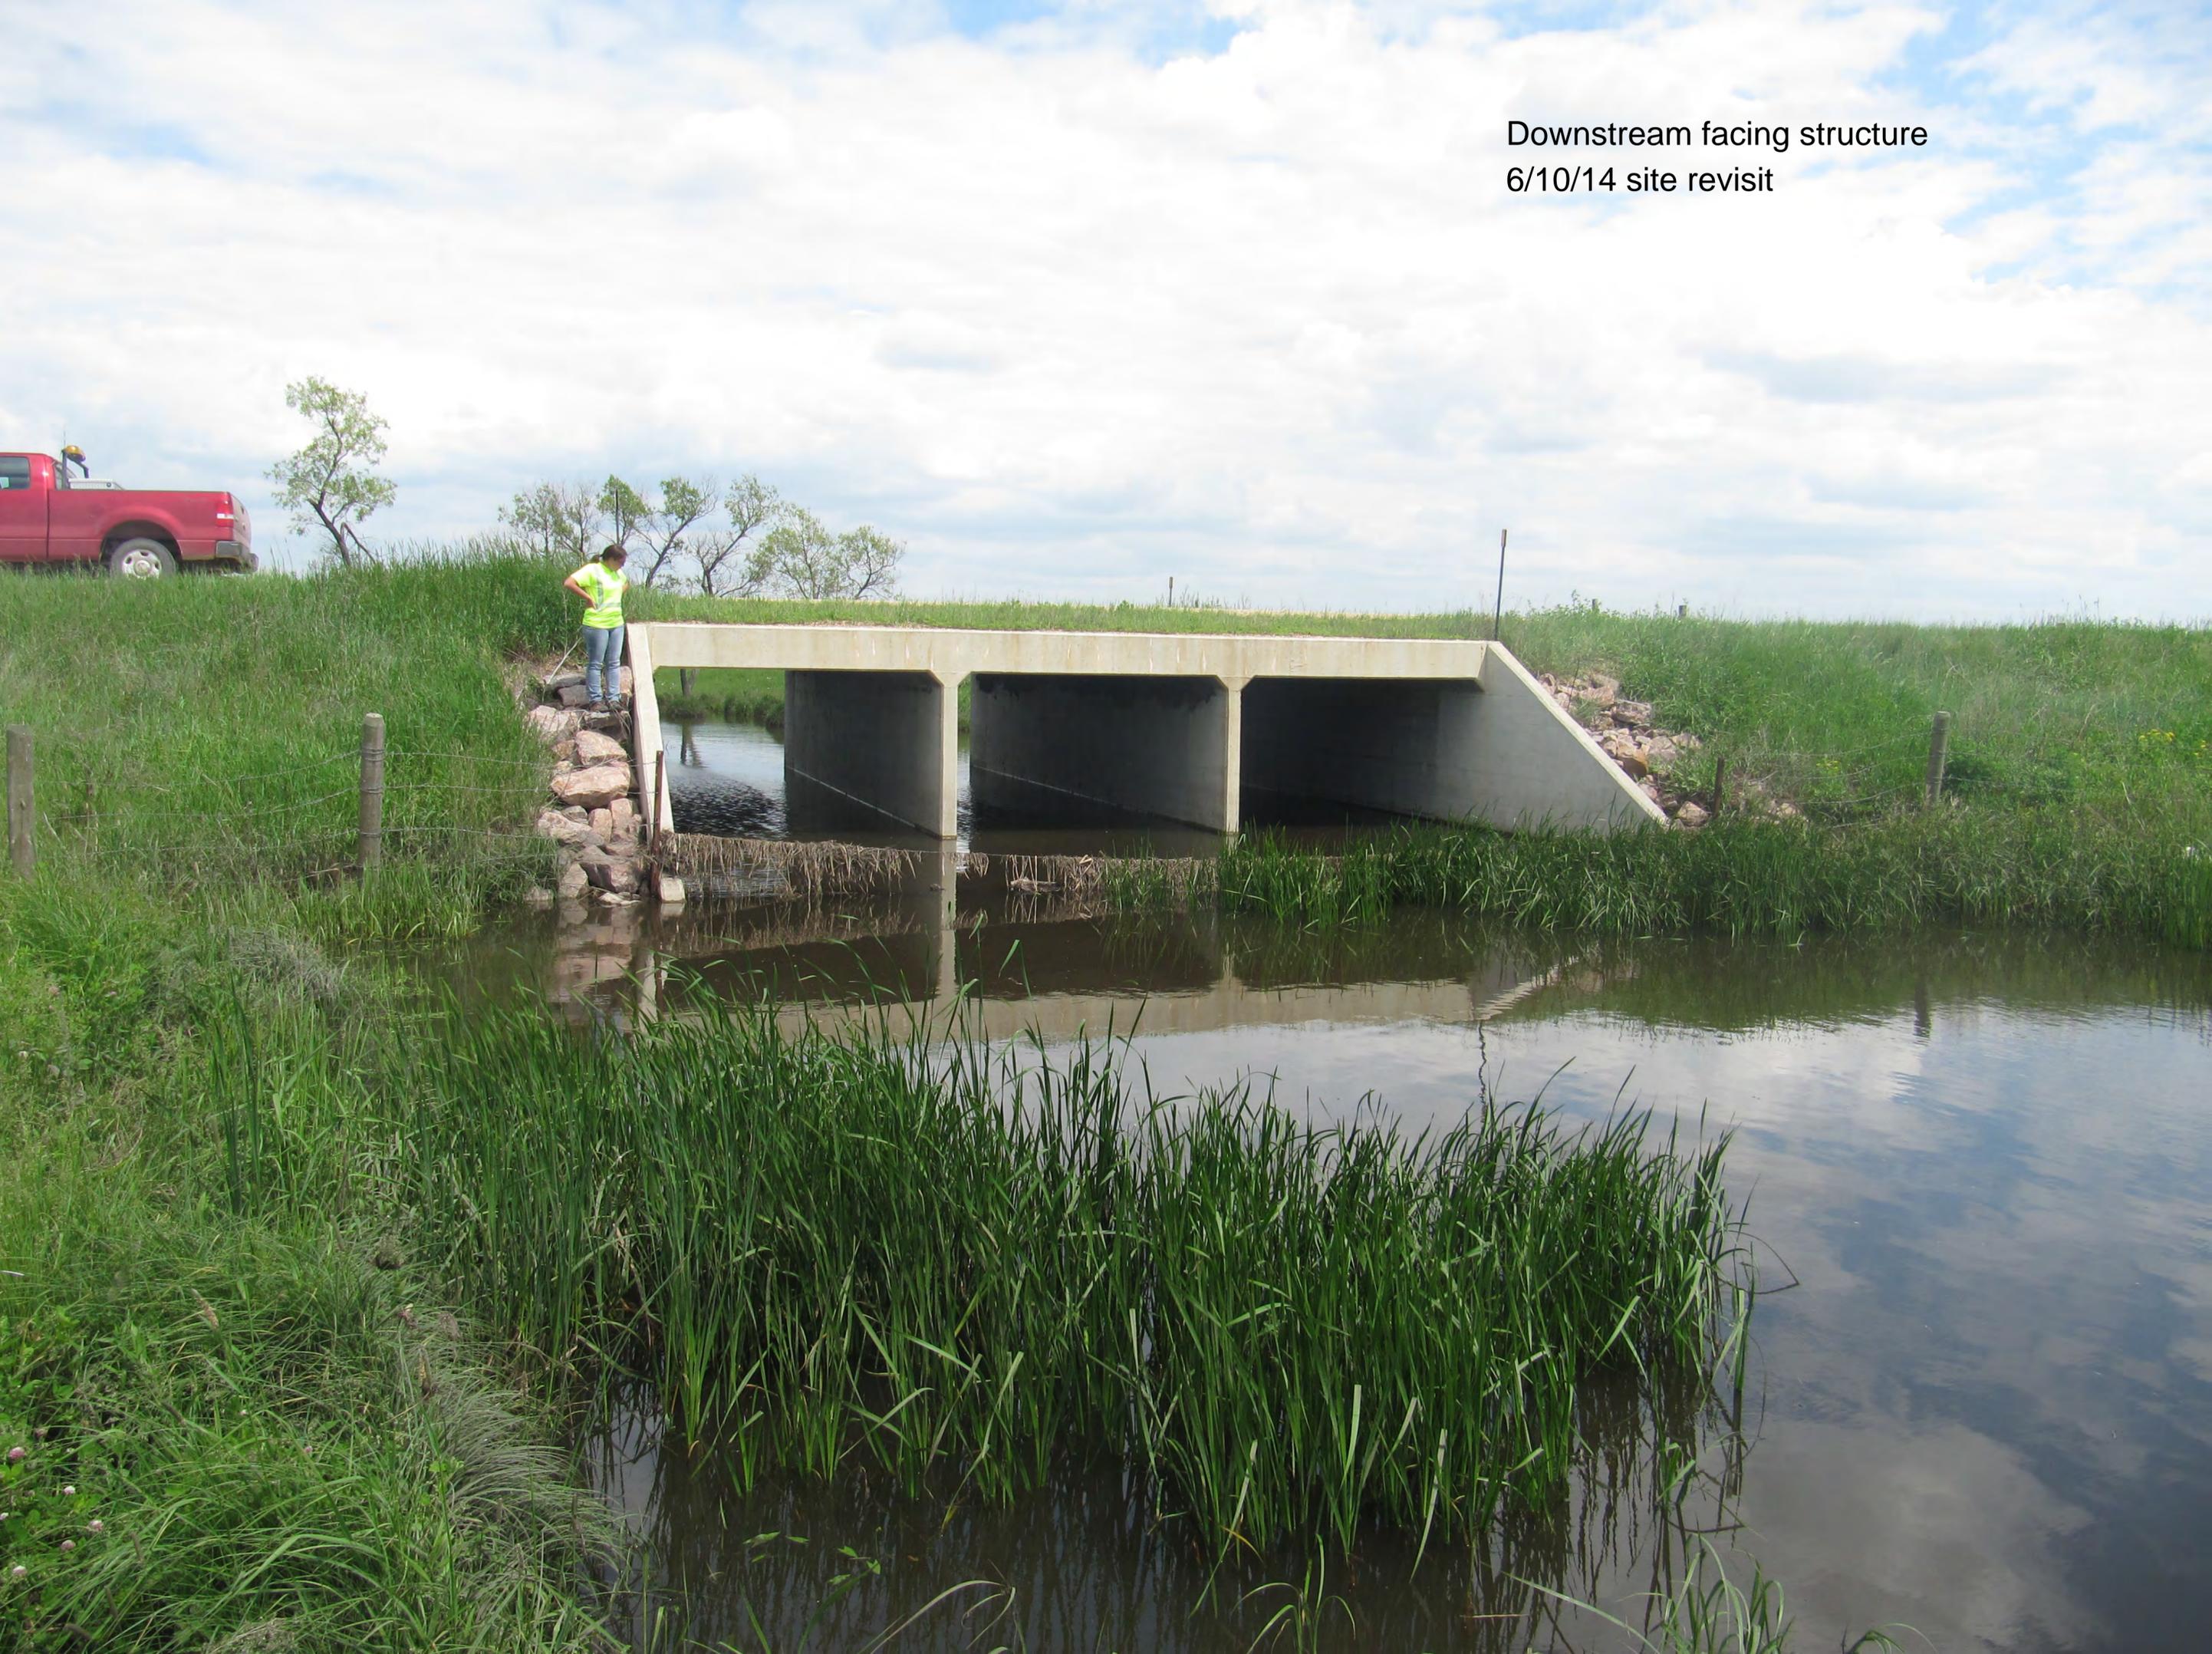
Downstream facing structure  
6/10/14 site revisit

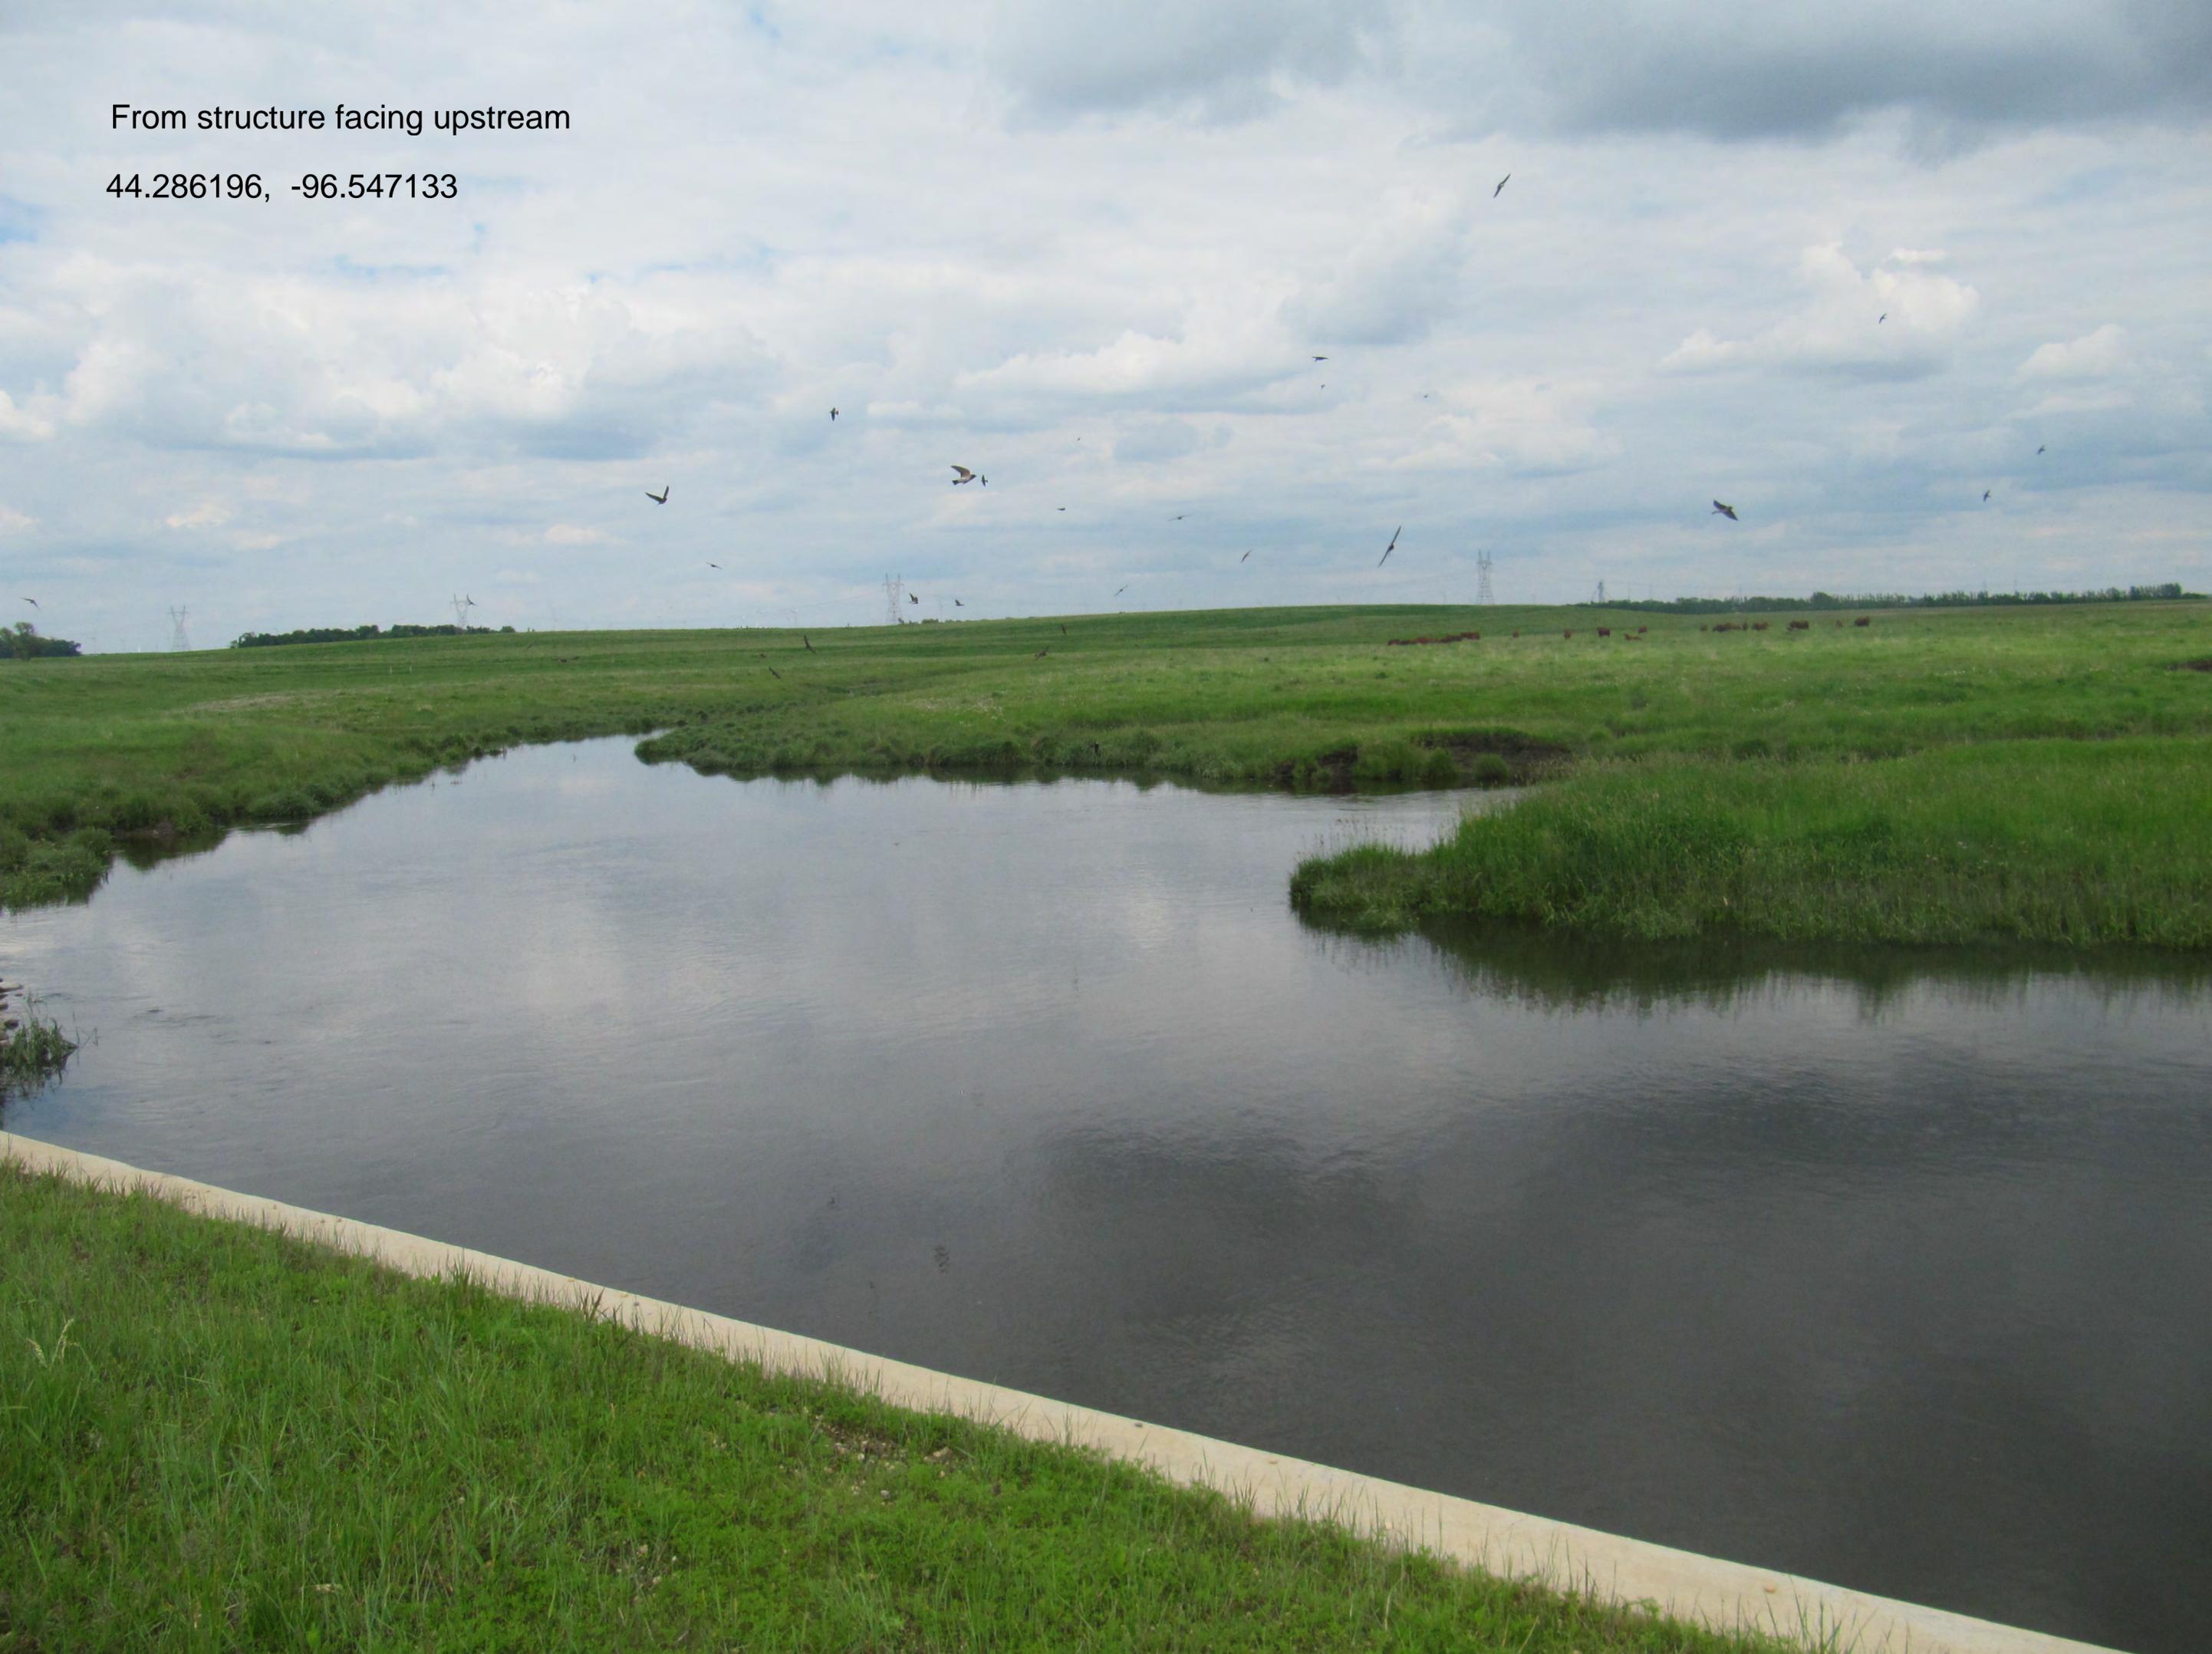
44.286196, -96.547133

From structure facing upstream

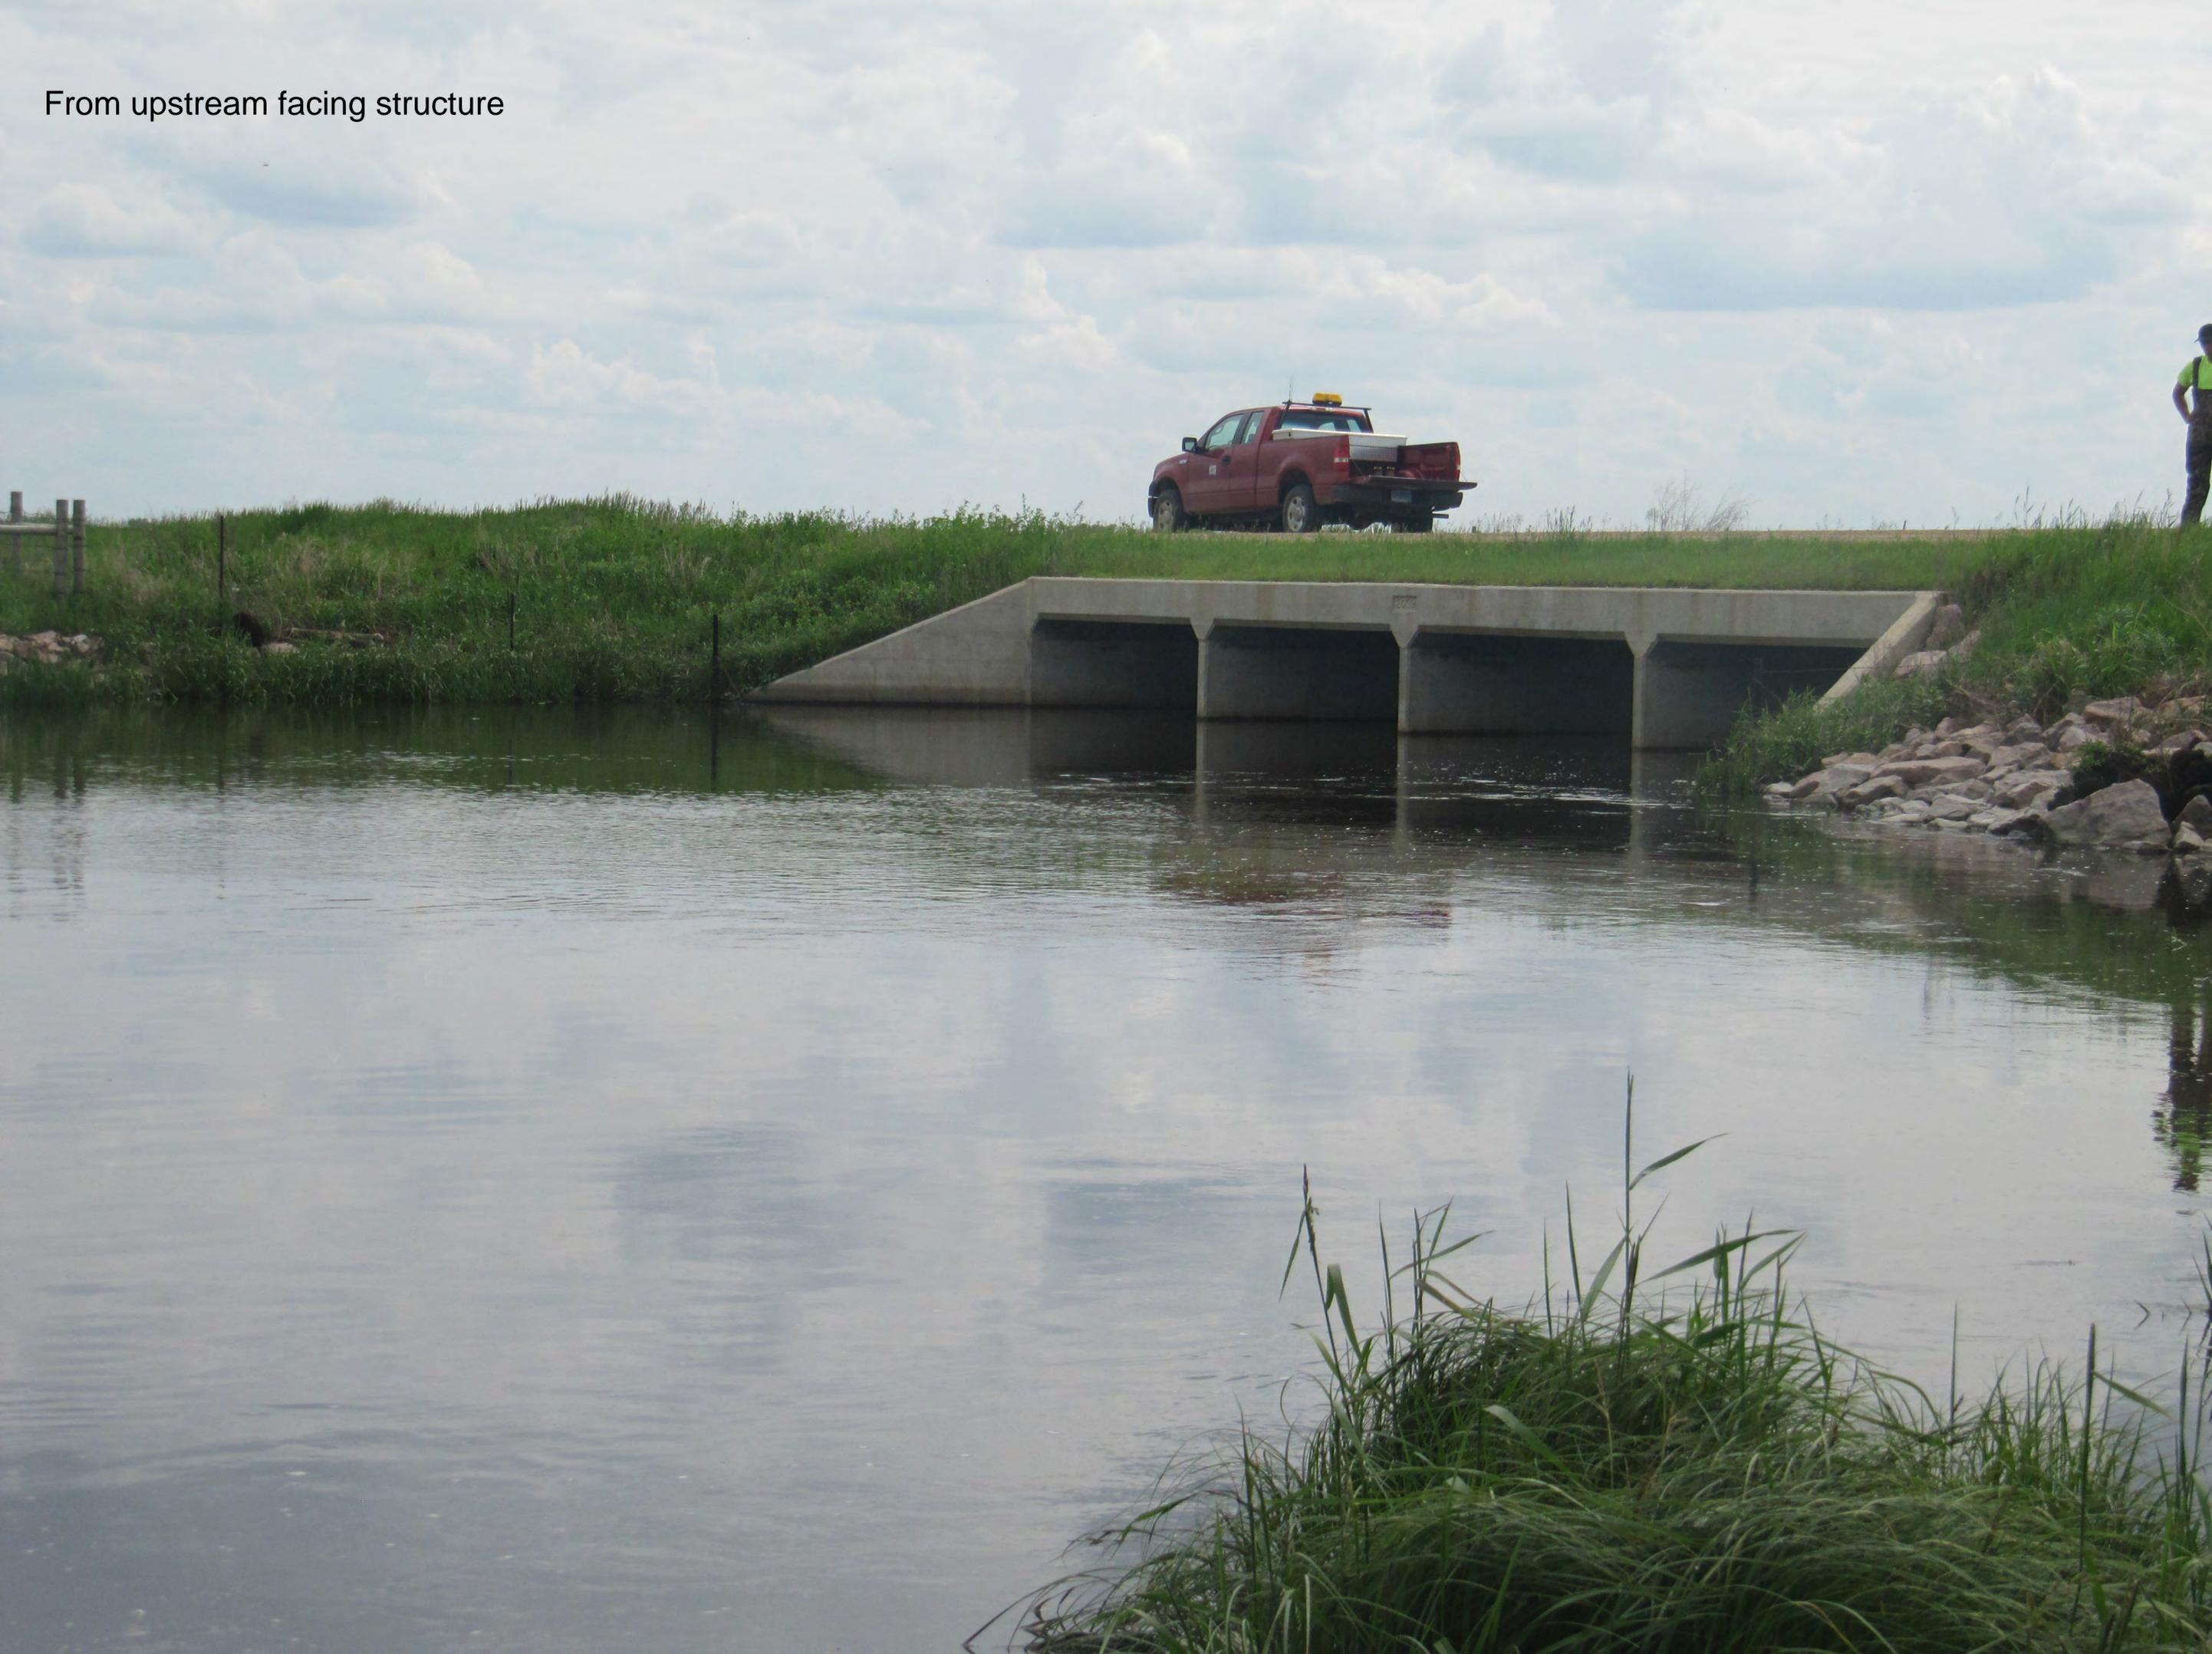
From upstream facing structure
