**REPORT FINDINGS**

PRJ # BRO 8006 (46)		PCN: 6778		Date: 6/10/14		Year Constructed: 2009							
County: Brookings				Structure Location: 06-290-177									
Assessed By: Maier/Boone				Stream Name: Medary Creek									
Structure Type			Structure Shape Comments										
	Number of Barrels X Width (ft) X Height (ft)		Inlet Type					Outlet Type*					
Box	4x12'x8'		Projecting					At Stream Grade					x
Arch			Wing wall					Cascade over Riprap					
Pipe Diameter			Headwall					Free Fall into Pool					
<sup>1</sup> Bridge			Apron					Free Fall Onto Rip Rap					
<sup>1</sup> Bridge Deck Length X Width			Riprap					Apron					
			Other:					Other:					
Rapid Visual Assessment:													
Observation												Y / N N.A.

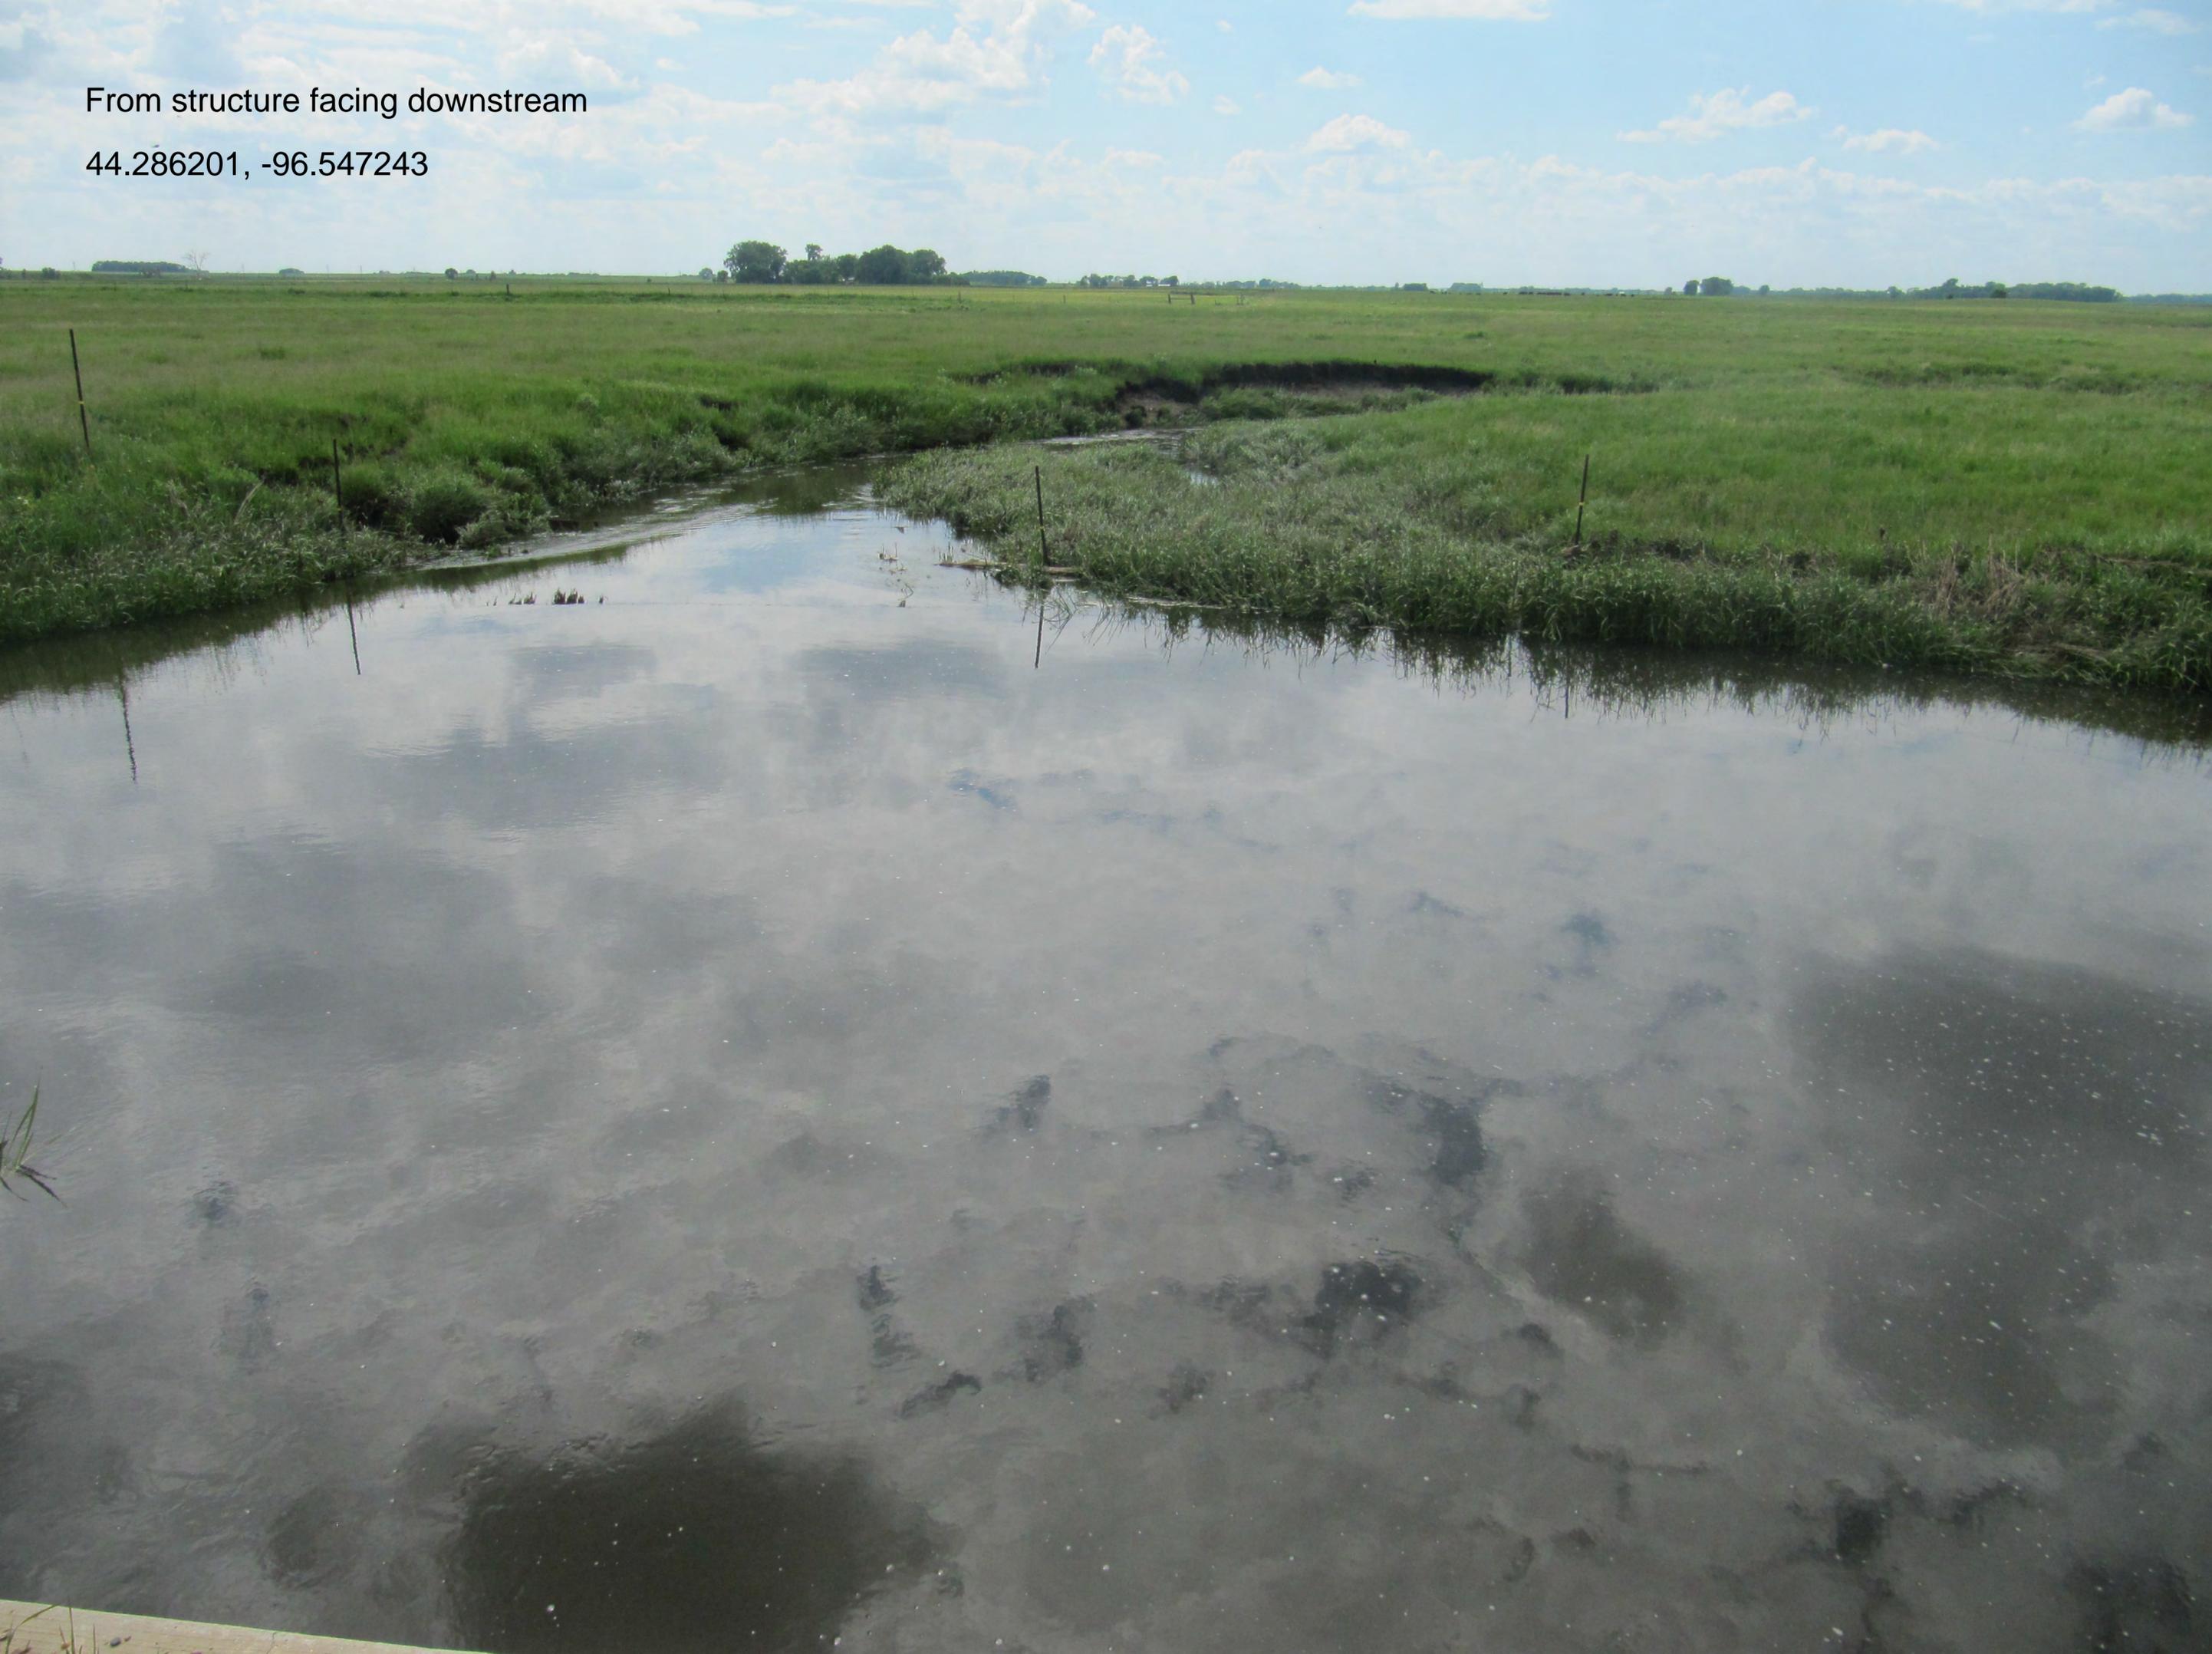
44.286201, -96.547243

From structure facing downstream

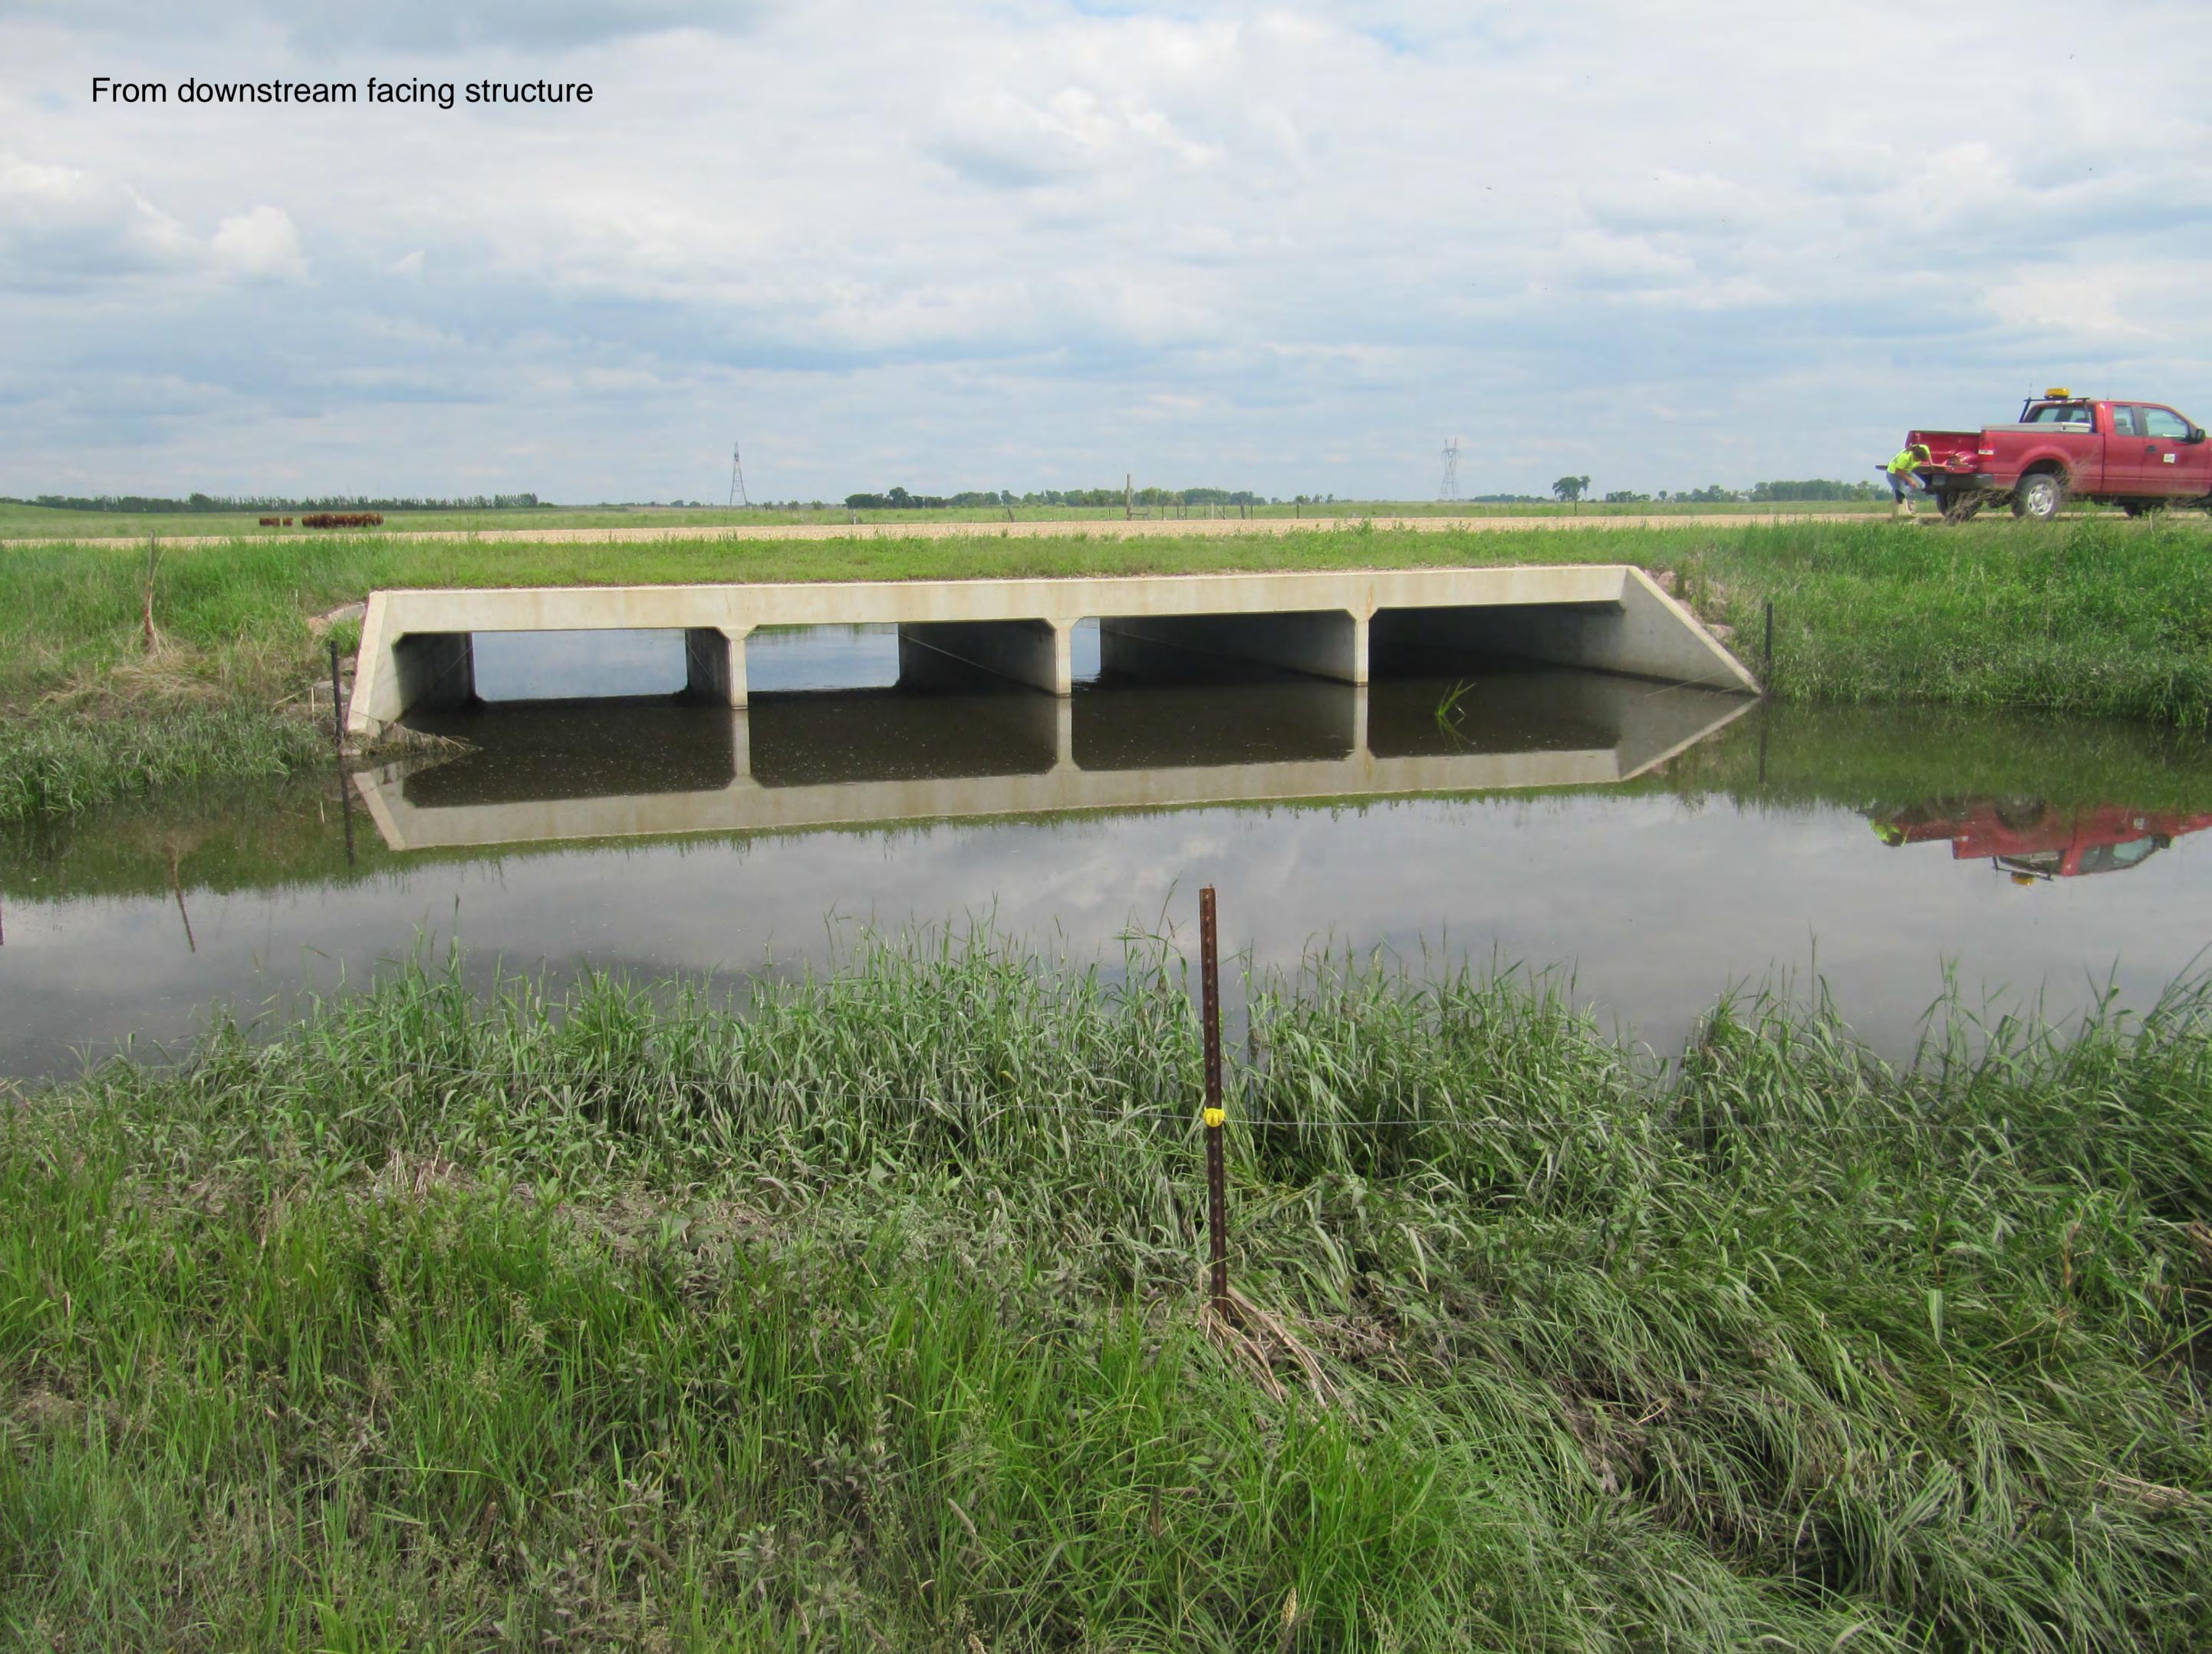
From downstream facing structure
