# CONTAMINATED MATERIALS REVIEW

Northshore Drive Realignment Project  
Northwest of North Sioux City,  
Union County, South Dakota

Project No.: EM 8064(32)  
PCN: 097K

**Project:** Northshore Drive Realignment  
**RE:** CMR Visual Reconnaissance  
**Date:** June 5, 2023

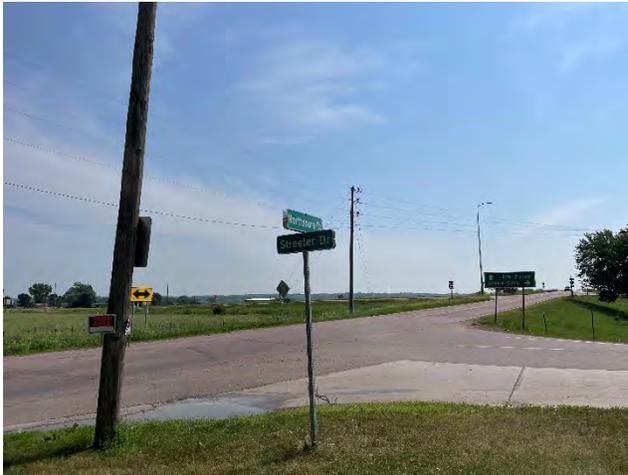
Photo #1 – View northeast toward the east terminus of the project alignment (intersection of Northshore Drive and Streeter Drive).

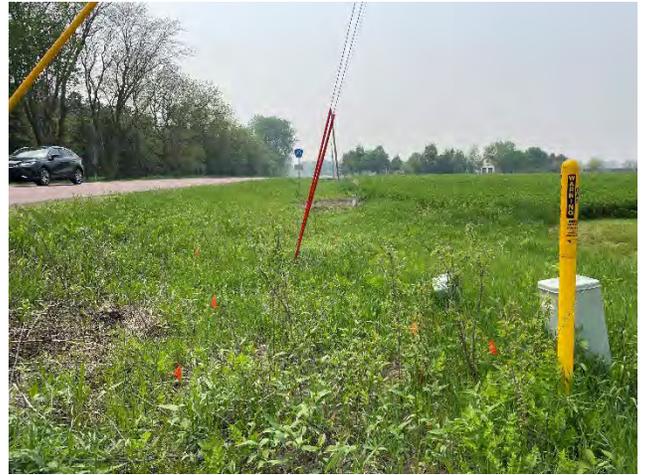
Photo #2 – View west toward utility marker near the west terminus of the project (northwest of intersection of Northshore Drive and Westshore Drive).

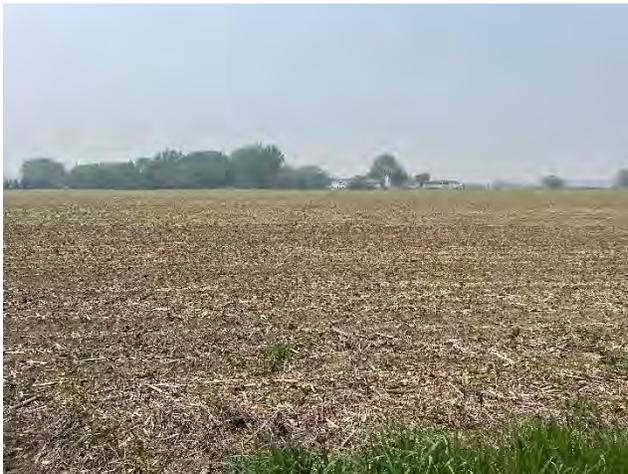
Photo #3 – View west toward empty agricultural field where new roadway will be built.

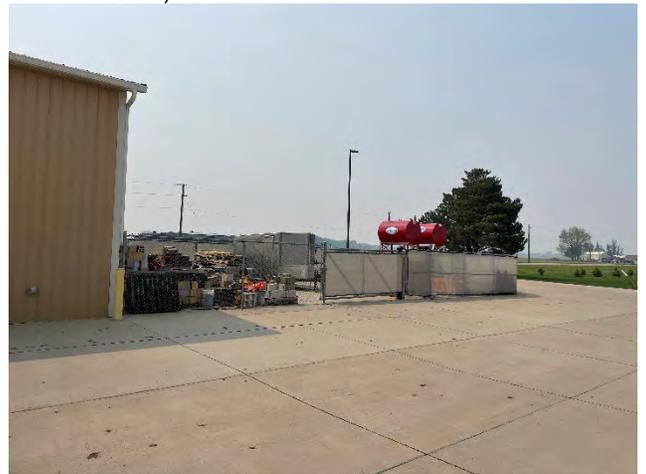
Photo #4 – View northwest toward above ground storage tanks at Dakota Valley High School.

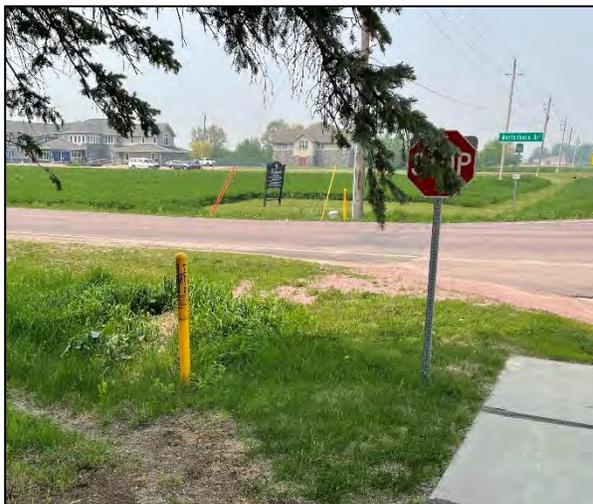
Photo #5 – Looking north toward a utility marker near the west terminus of the project (southwest of intersection of Northshore Drive and Westshore Drive).

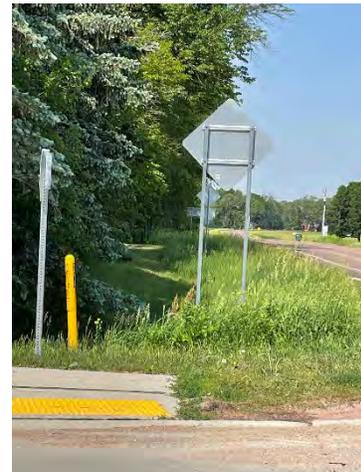
Photo #6 – Looking west toward same utility marker as Photo #5, located near the west terminus of the project (southwest of intersection of Northshore Drive and Westshore Drive).

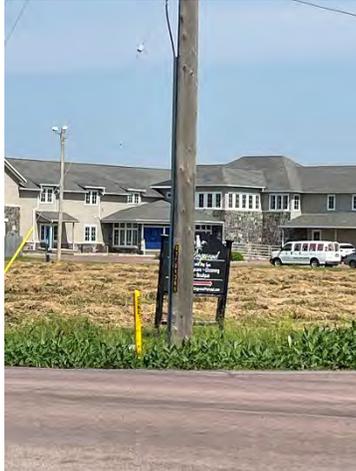
Photo #7 – Looking northwest toward same utility marker depicted in Photo #2 near the west terminus of the project (northwest of intersection of Northshore Drive and Westshore Drive).

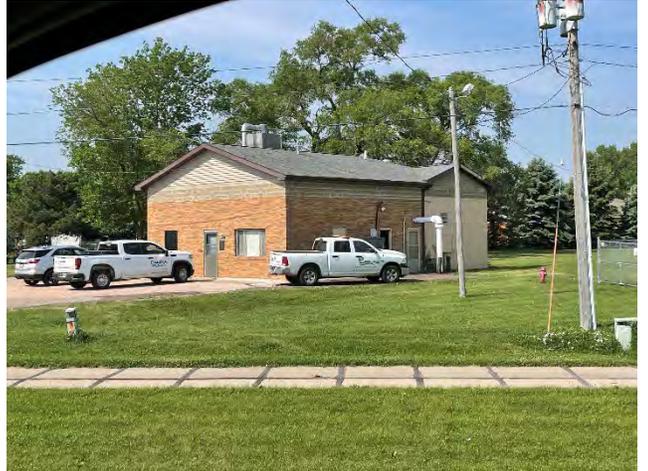
Photo #8 – Looking west toward City of North Sioux City Water Department (chlorine storage) on the west side of Streeter Drive.

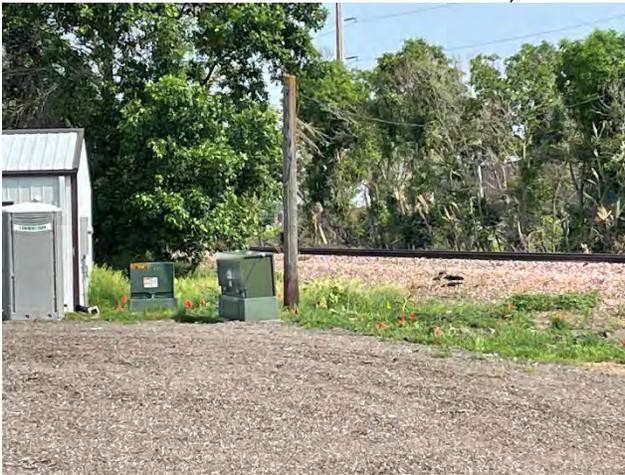
Photo #9 – Looking north toward utility boxes near the railroad east of I-29 and north of Northshore Drive. No stockpiles of railroad ties or surface staining were observed.

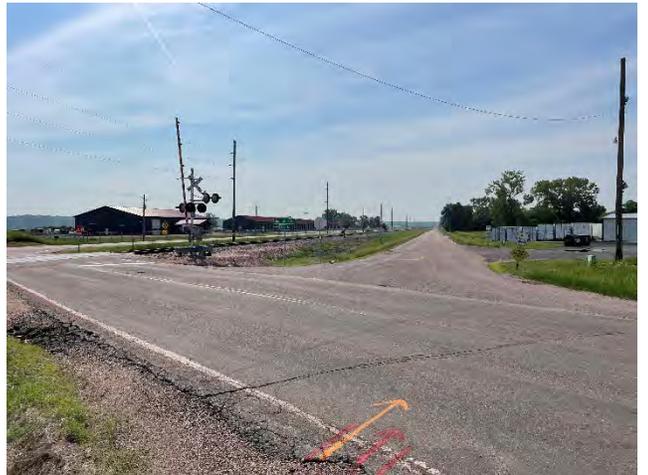
Photo #10 – Looking southeast toward the railroad from the intersection of Northshore Drive with Military Road. The storage unit business was fenced.

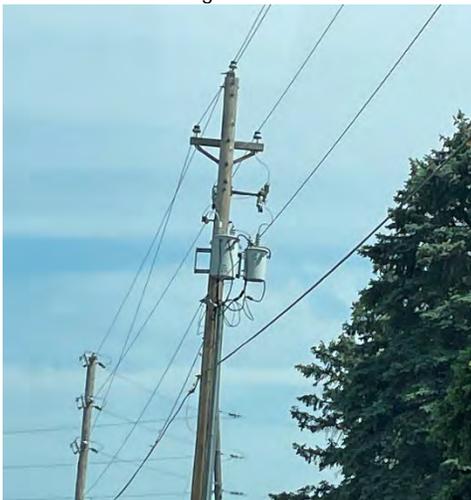
Photo #11 – Looking toward pole-mounted transformers which occur along the existing Northshore Drive.

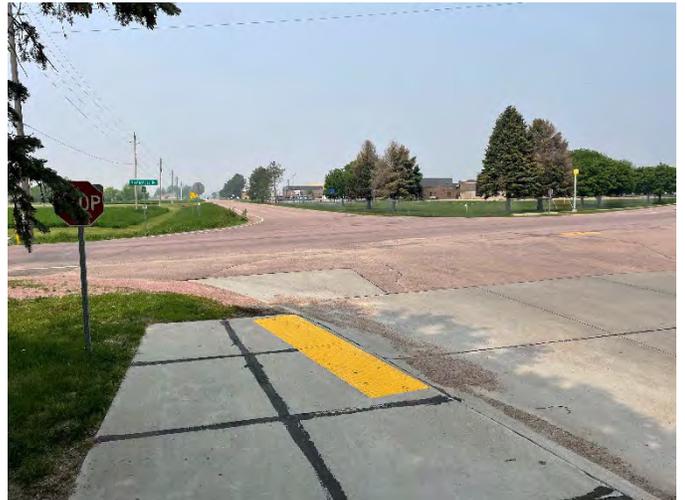
Photo #12 – Looking north toward the west terminus of the project alignment at the intersection of Northshore Drive and Westshore Drive.

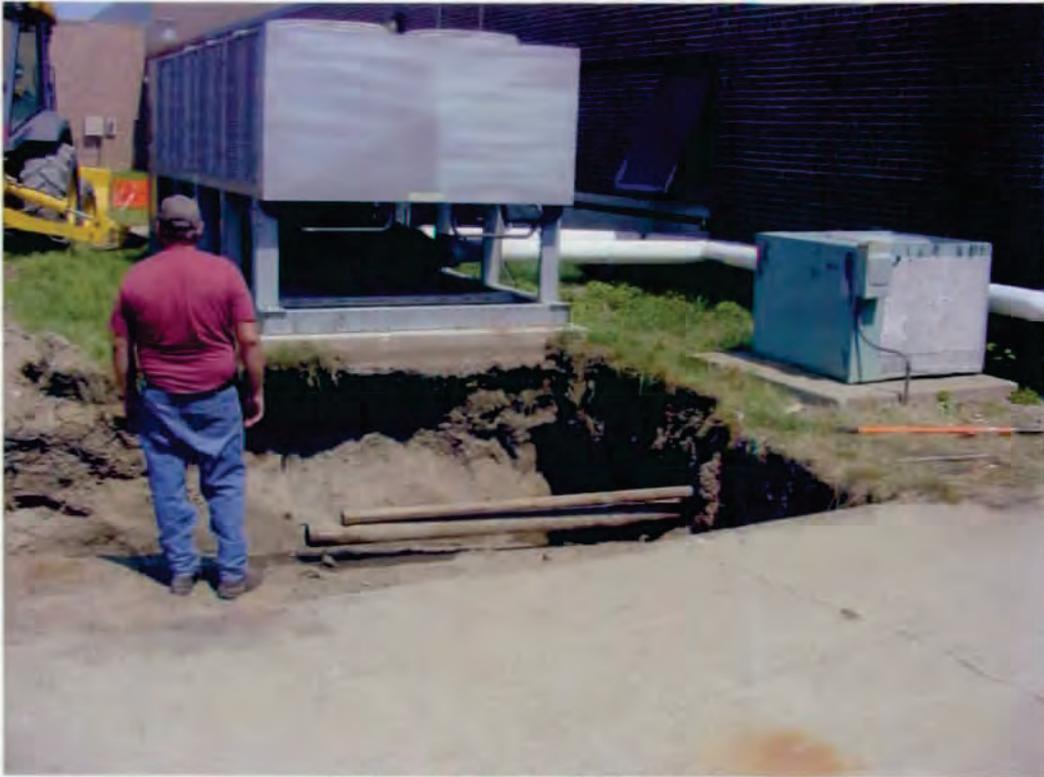
*Although signed up as an 8,000-gallon tank, the tank volume was actually 20,000 gallons. The tank basin is primarily within weathered clay till. Soil was moist from 10 feet to the max depth of 15 feet below ground surface. PID readings did not exceed instrument detection limits. Field observations did not indicate that petroleum-hydrocarbon concentrations were present in the soil under and adjacent to the tank system.*

Looking North at UST Location

*Laboratory-analysis results for selected samples indicated that petroleum-hydrocarbon concentrations were detected in one base soil sample. The reported TPH as fuel oil concentrations of 11. ppm barely exceeded the laboratory detection limit and is well below the Tier 1 trigger level of 500 ppm. No receptors or exposure pathways are likely to be affected near this tank location. Site Closure is recommended.*

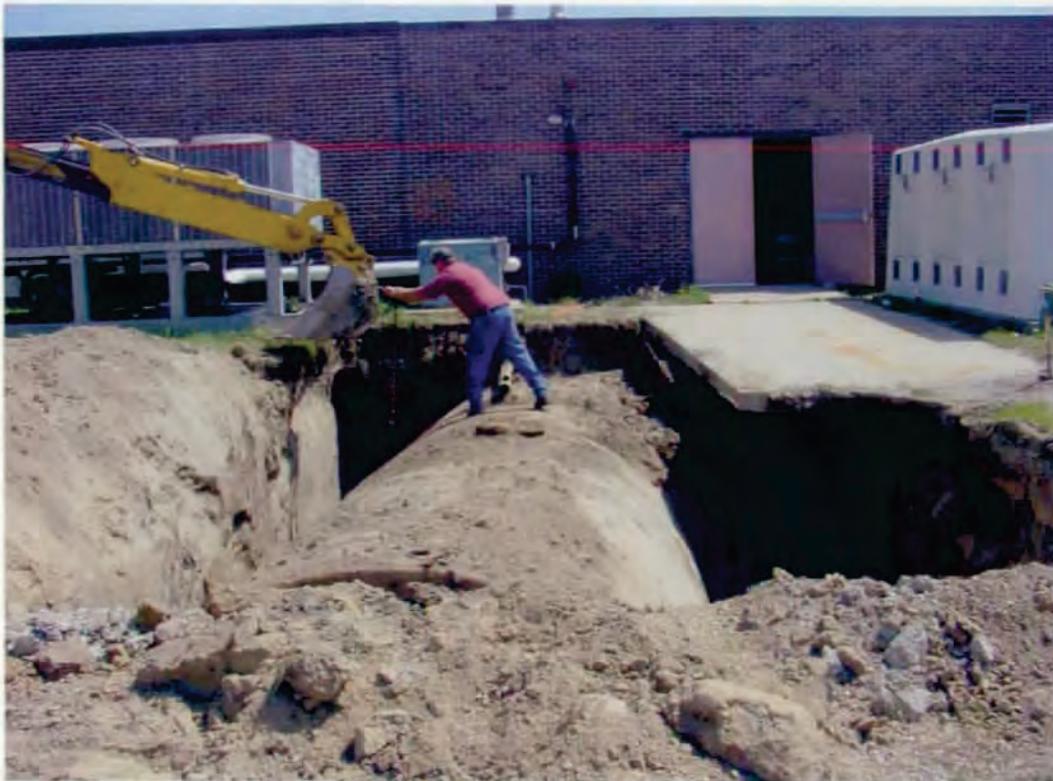
Looking East at UST Location
