SDDOT INTERSECTION SAFETY STUDY

South Dakota DOT
700 E. Broadway Ave.
Pierre, South Dakota 57501

Felsburg Holt & Ullevig
11422 Miracle Hills Drive, Suite 115
Omaha, Nebraska 68154
402-445-4405

FHU Reference No. 14-066
April 2015

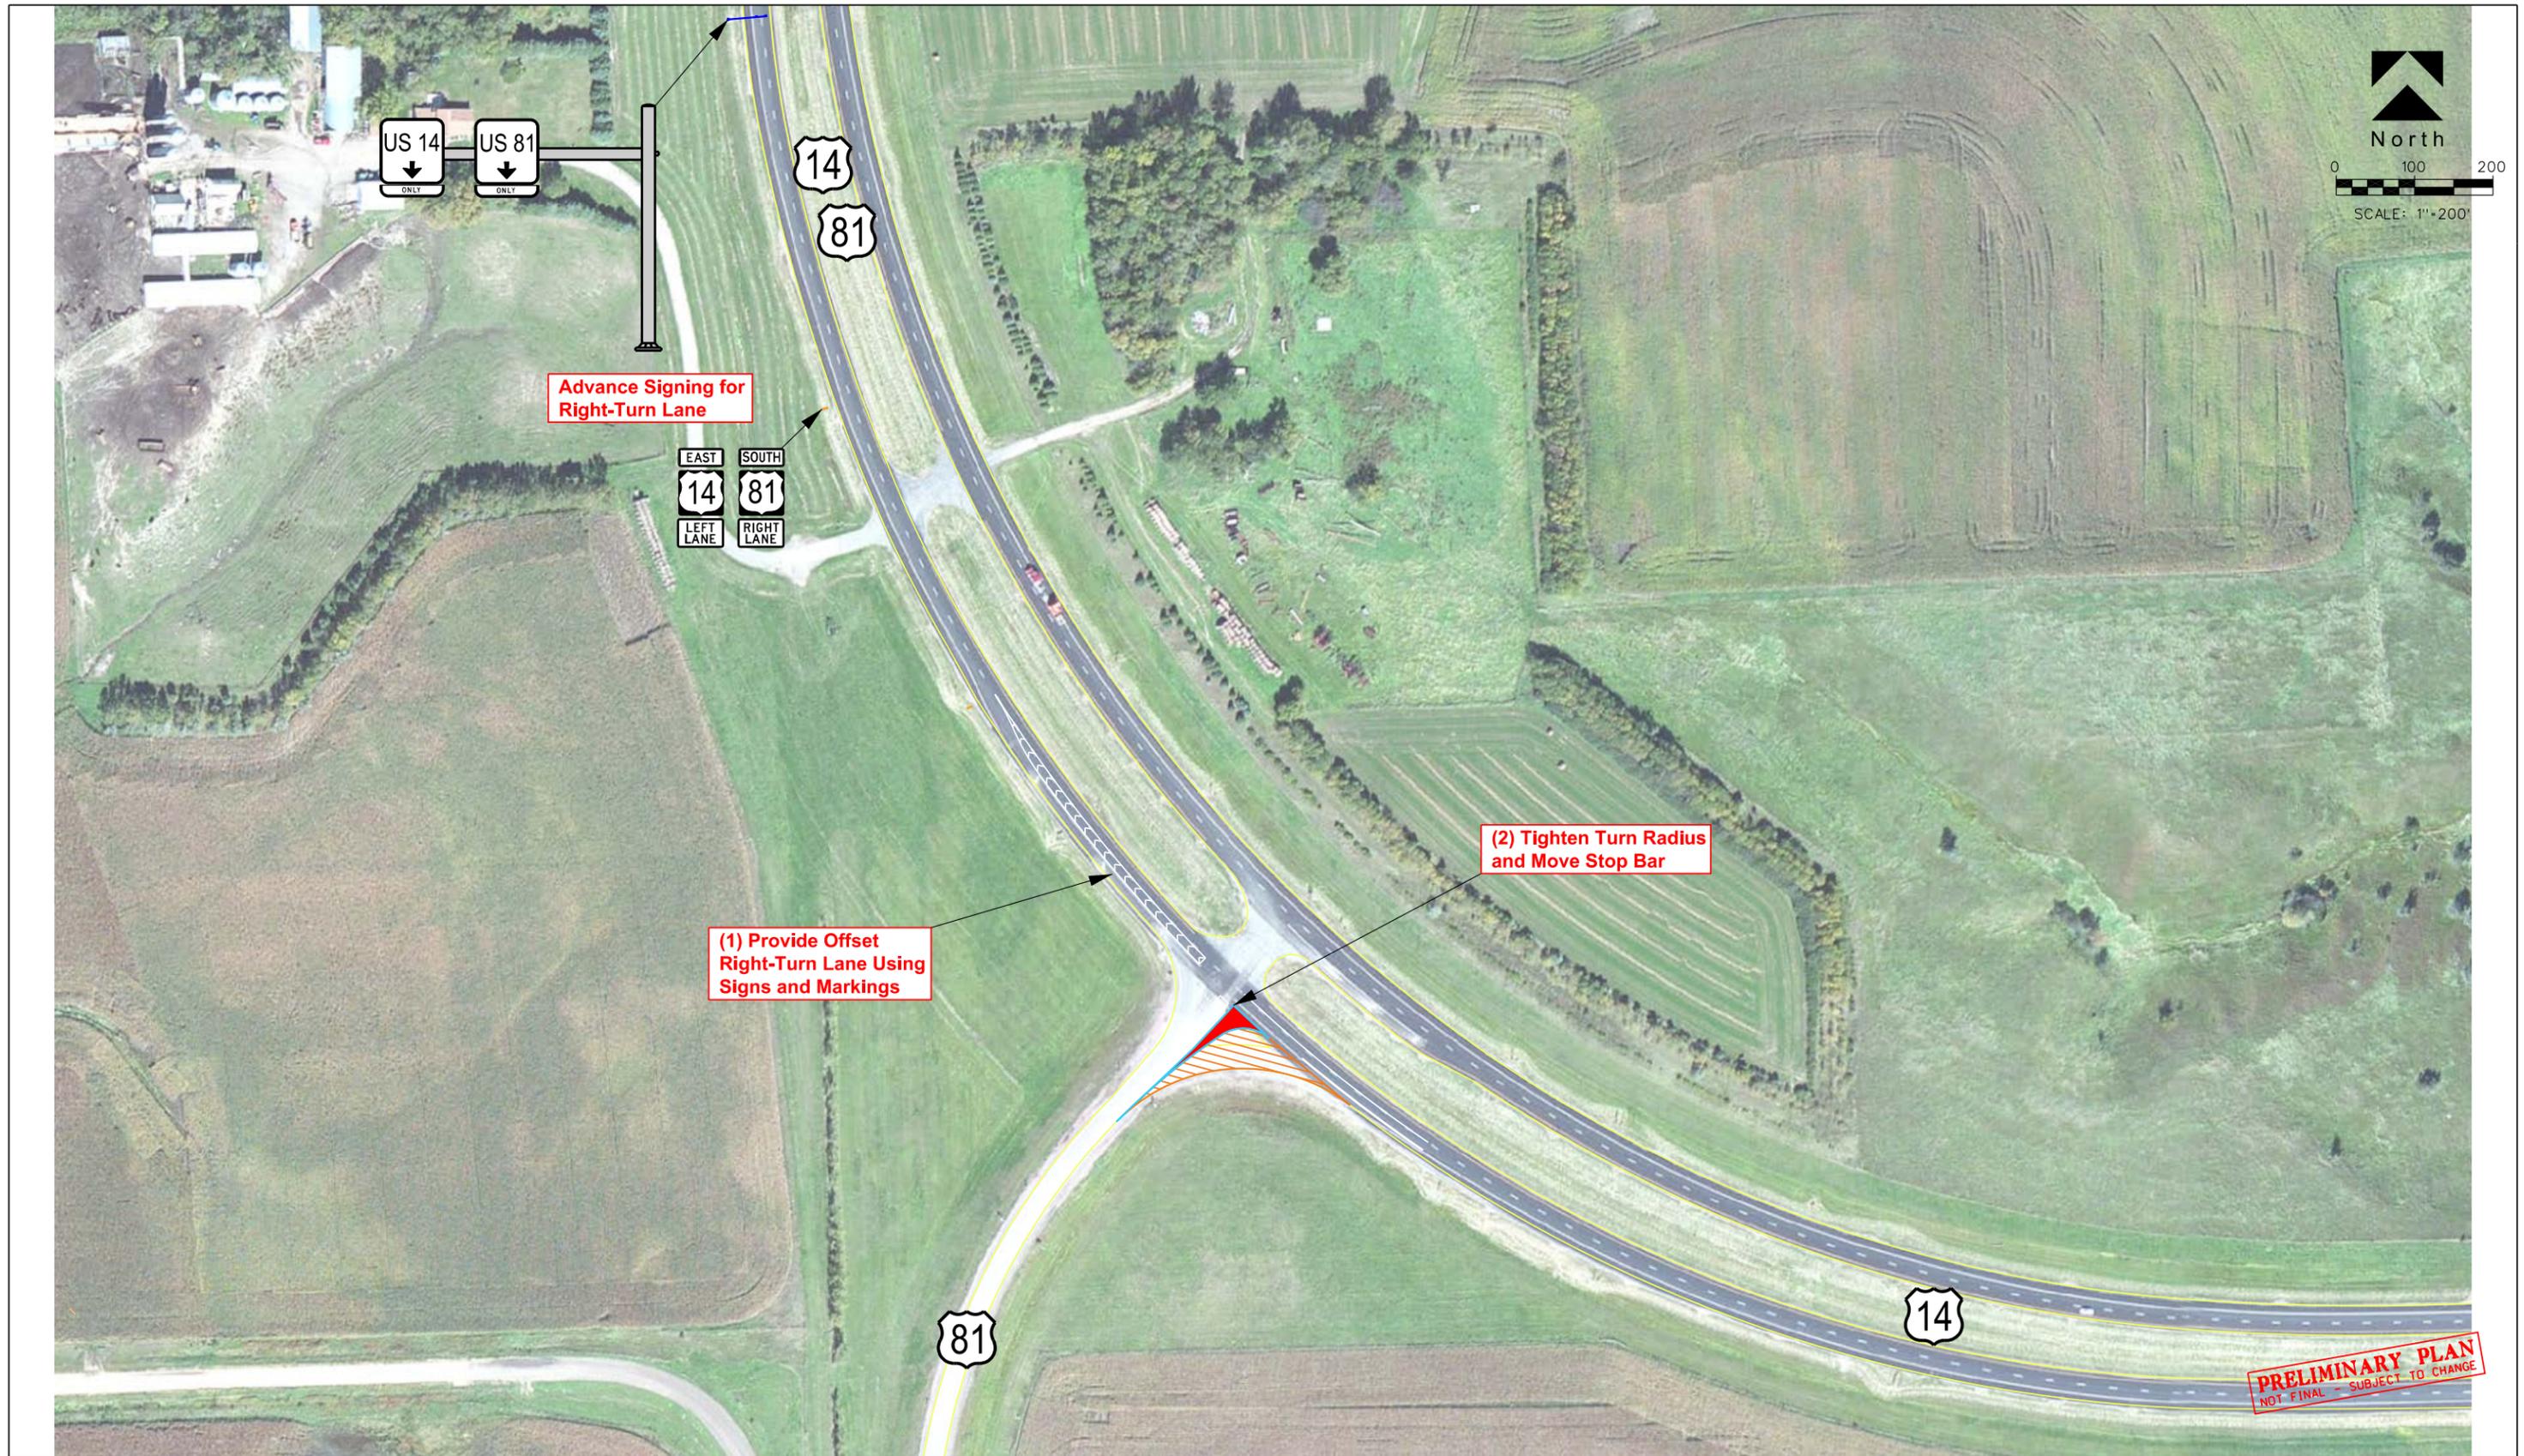
Figure 1.3
Intersection #1
Intersection Recommendations
US 14 / US 81

1 – It is recommended that an eastbound to southbound offset right-turn lane be provided with signs and markings. By dropping a southbound lane north of the intersection, a single through lane southbound can be carried through the intersection.

CONCEPTUAL DESIGN - OPTION 1

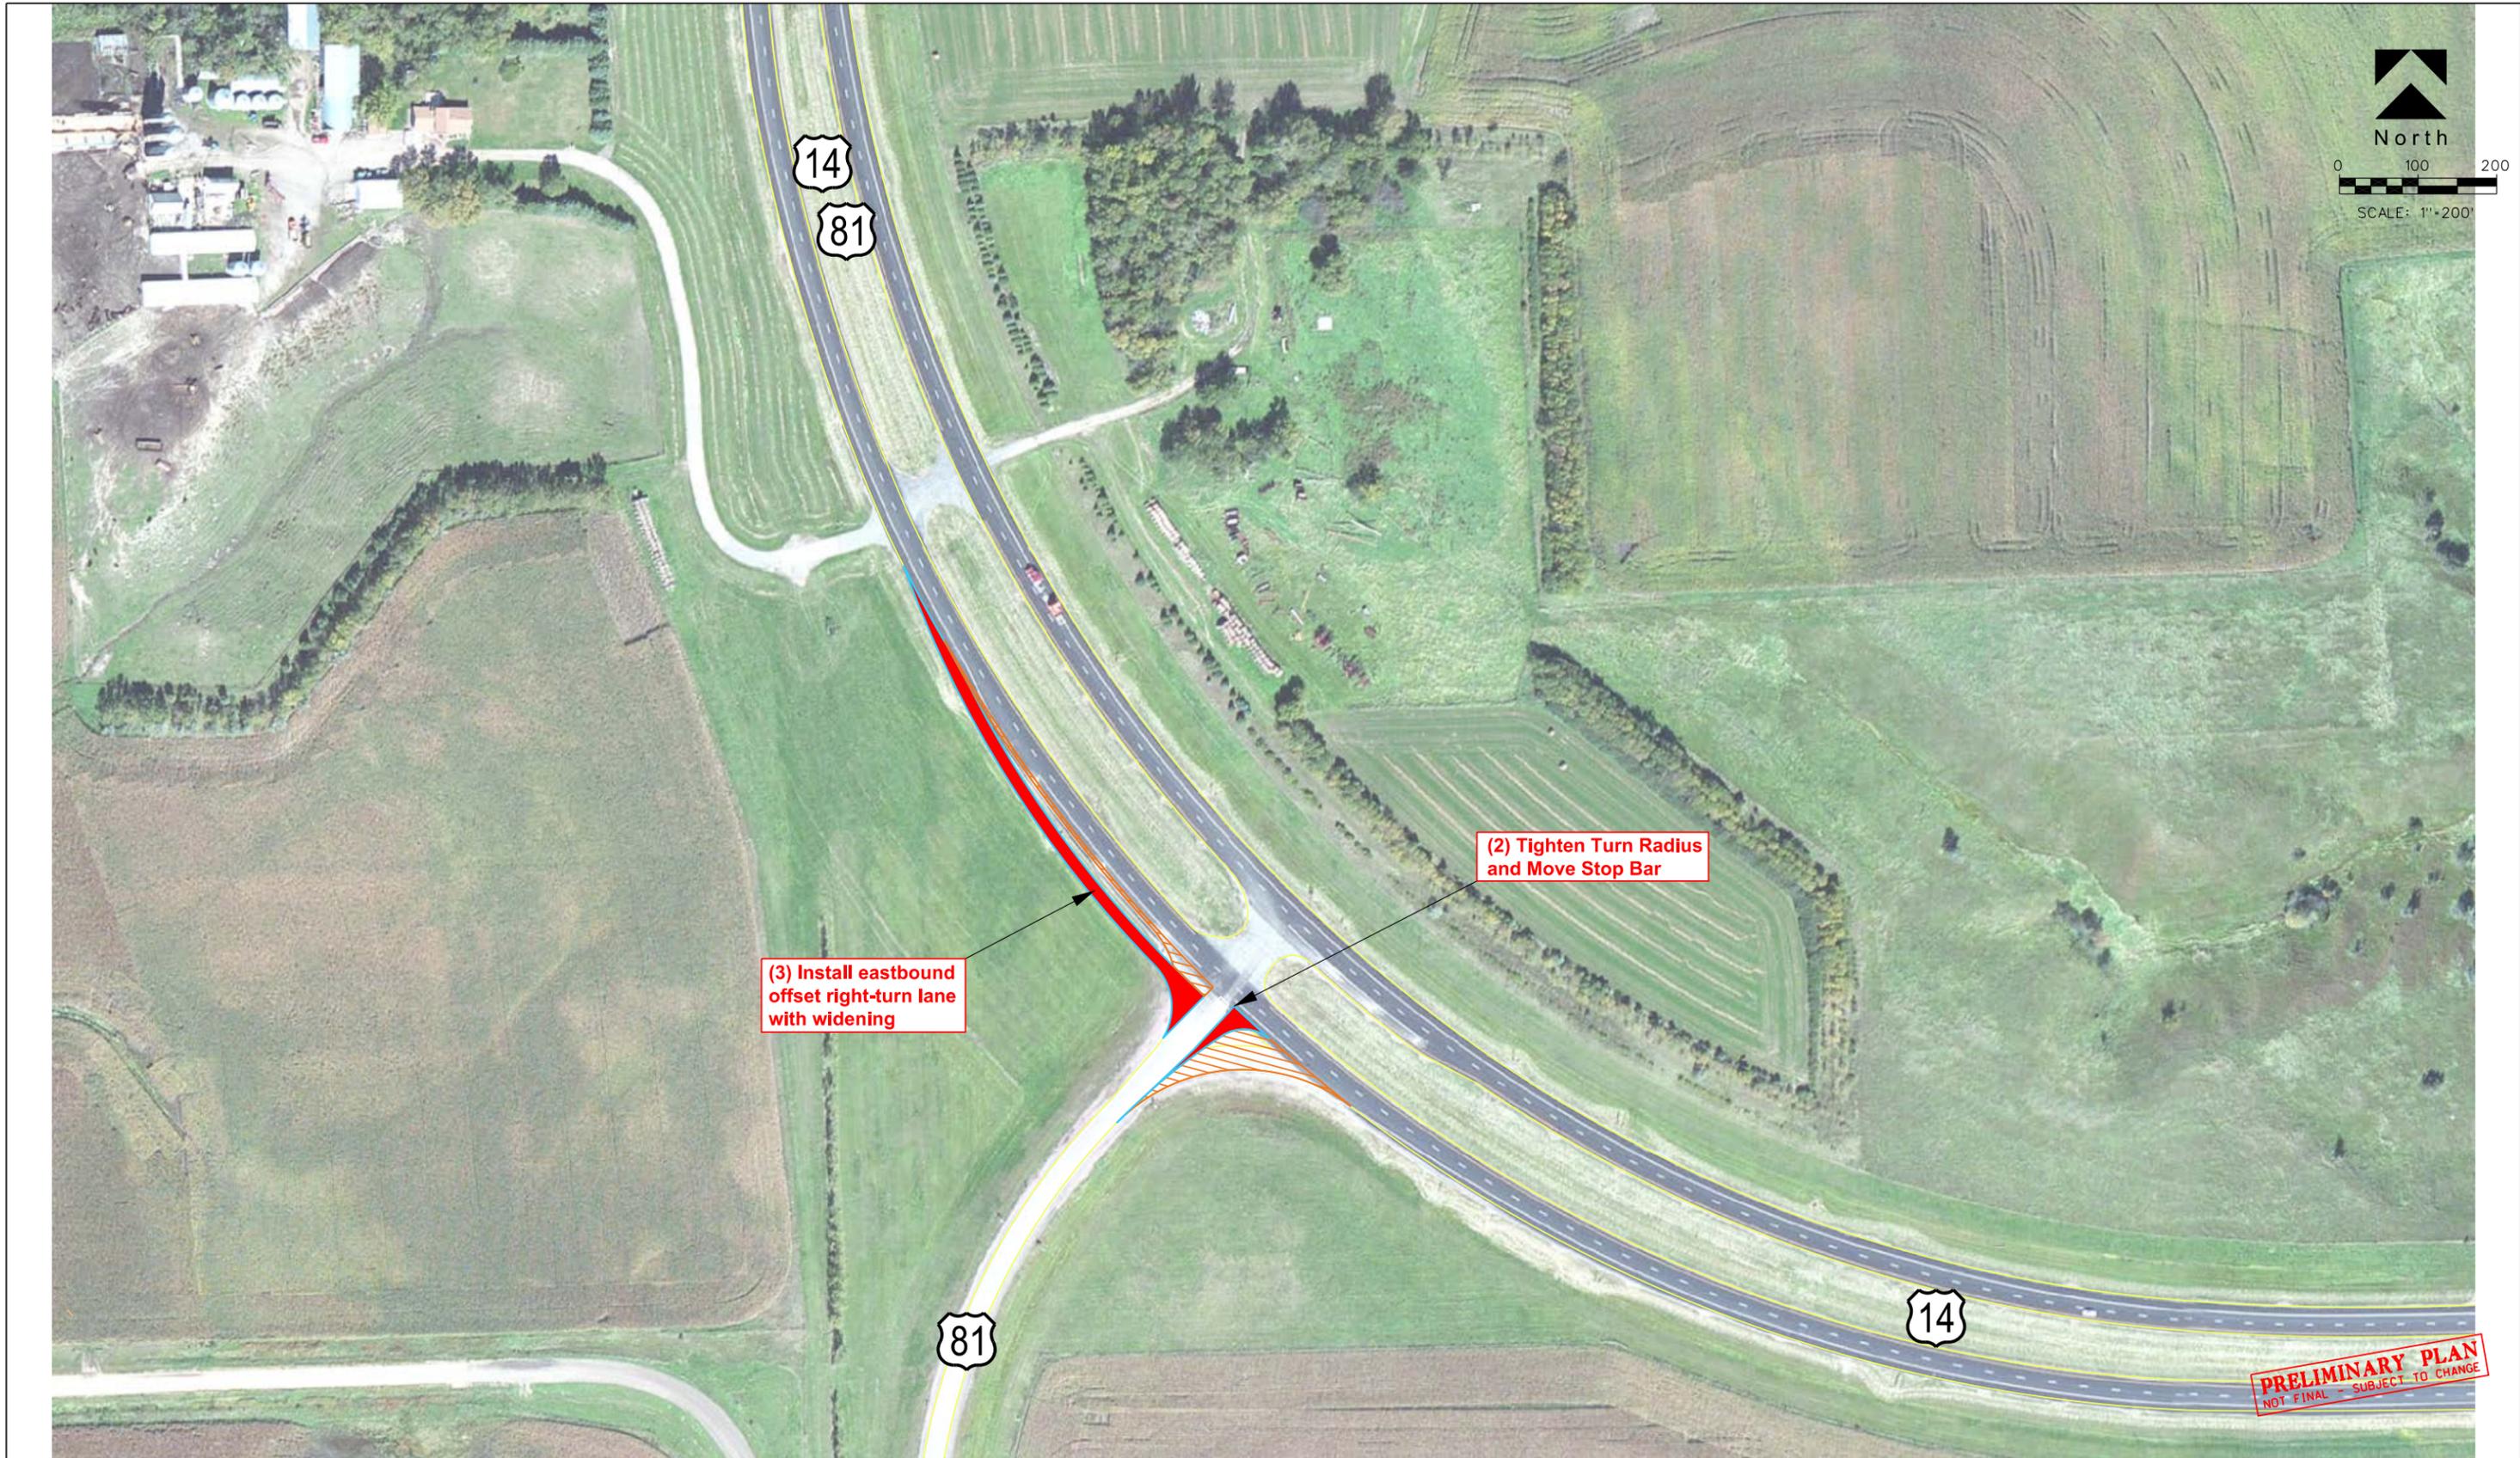
Figure 1.4
 Intersection #1
 Intersection Recommendations
 US 14 / US 81

(3) Install eastbound offset right-turn lane with widening

(2) Tighten Turn Radius and Move Stop Bar

CONCEPTUAL DESIGN - OPTION 2

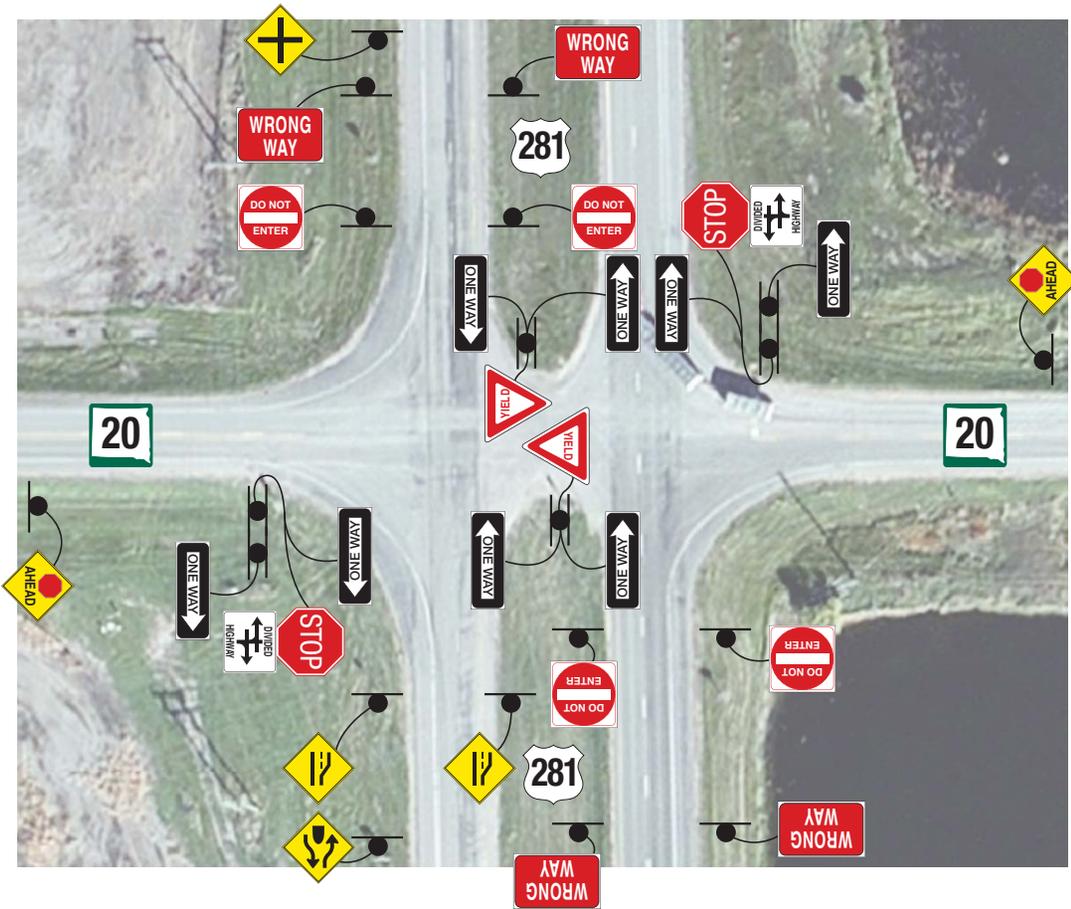
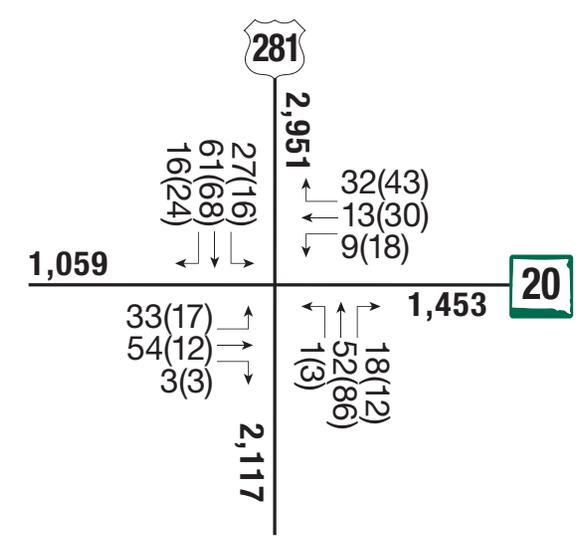
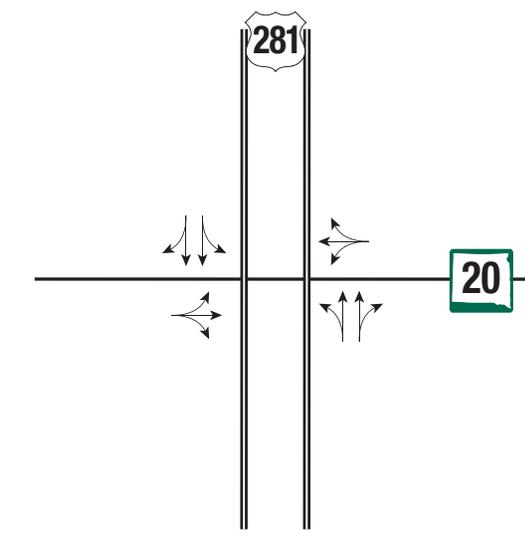
Figure 2.1
US 281/US 20 Traffic Conditions

The intersection has a truck percentage of 24%. Also shown on **Figure 2.1** are the lane geometry, traffic control, and signage for existing traffic conditions at the intersection.

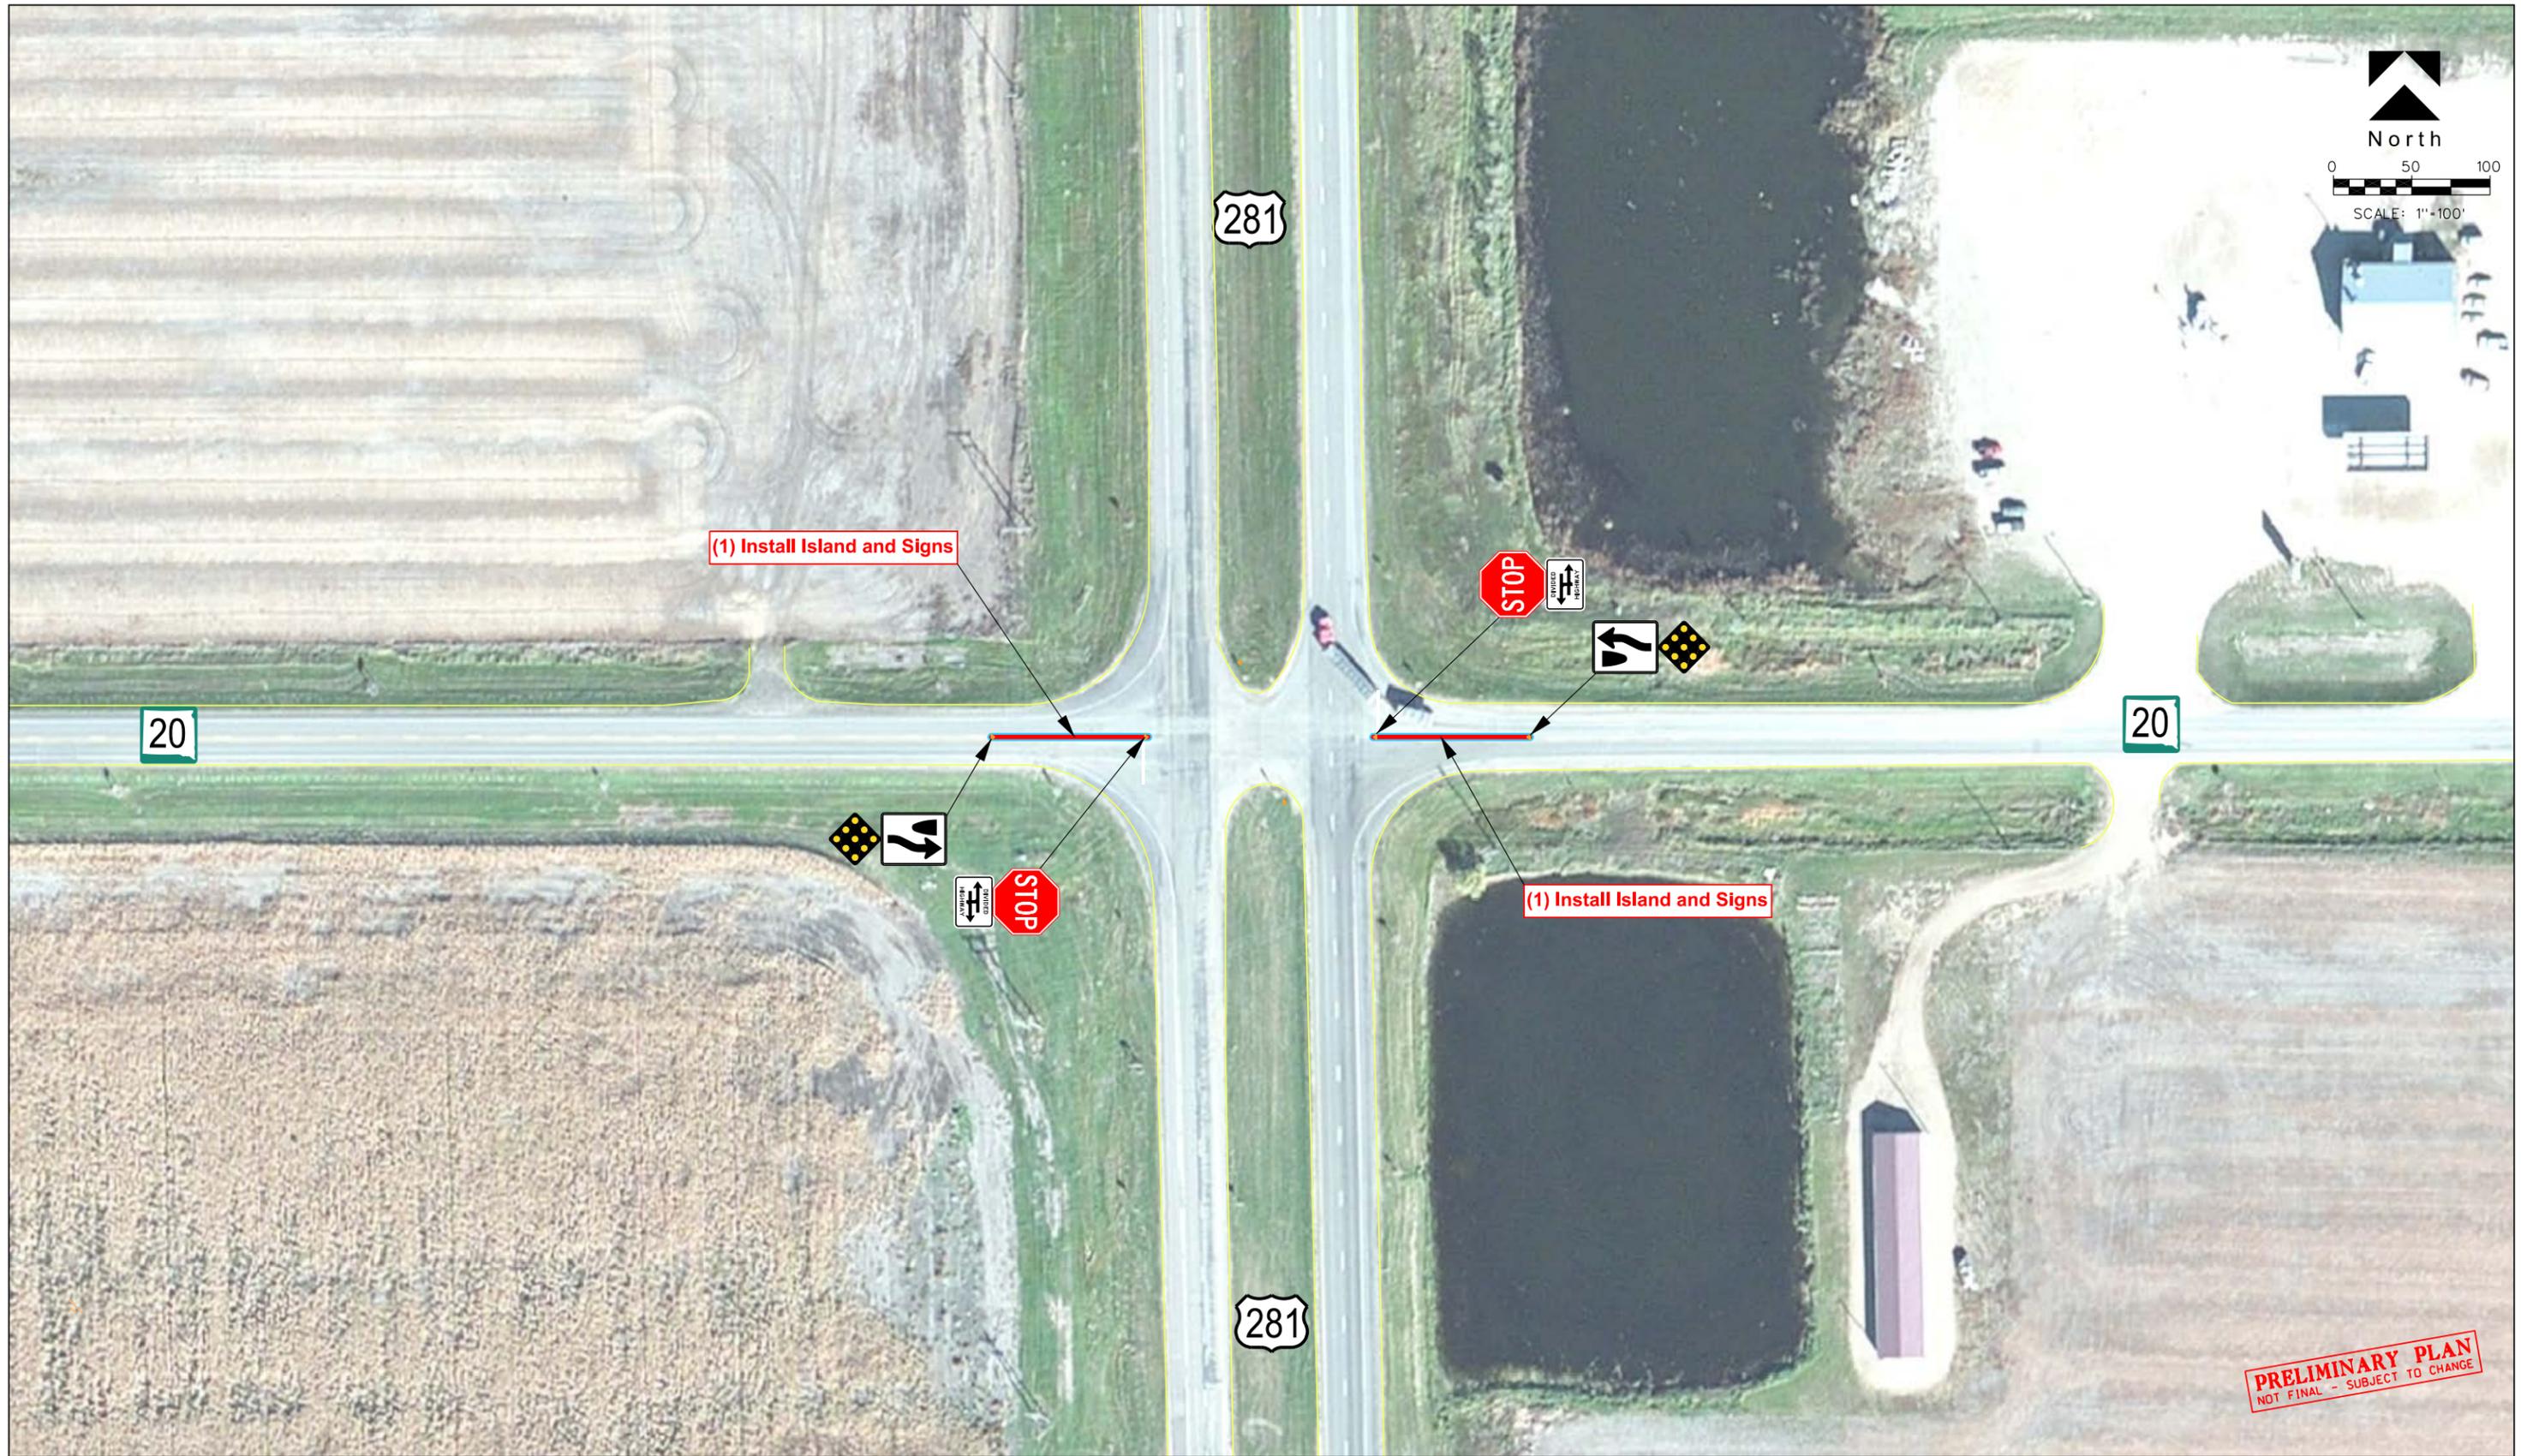
Figure 2.3
Intersection #2
Intersection Recommendations
US 281 / SD 20

1 – It is recommended that a Rural Intersection Conflict Warning System be installed at the intersection. This showed a greater benefit than the splitter islands in addressing the same crashes. (2)

CONCEPTUAL DESIGN - OPTION 1

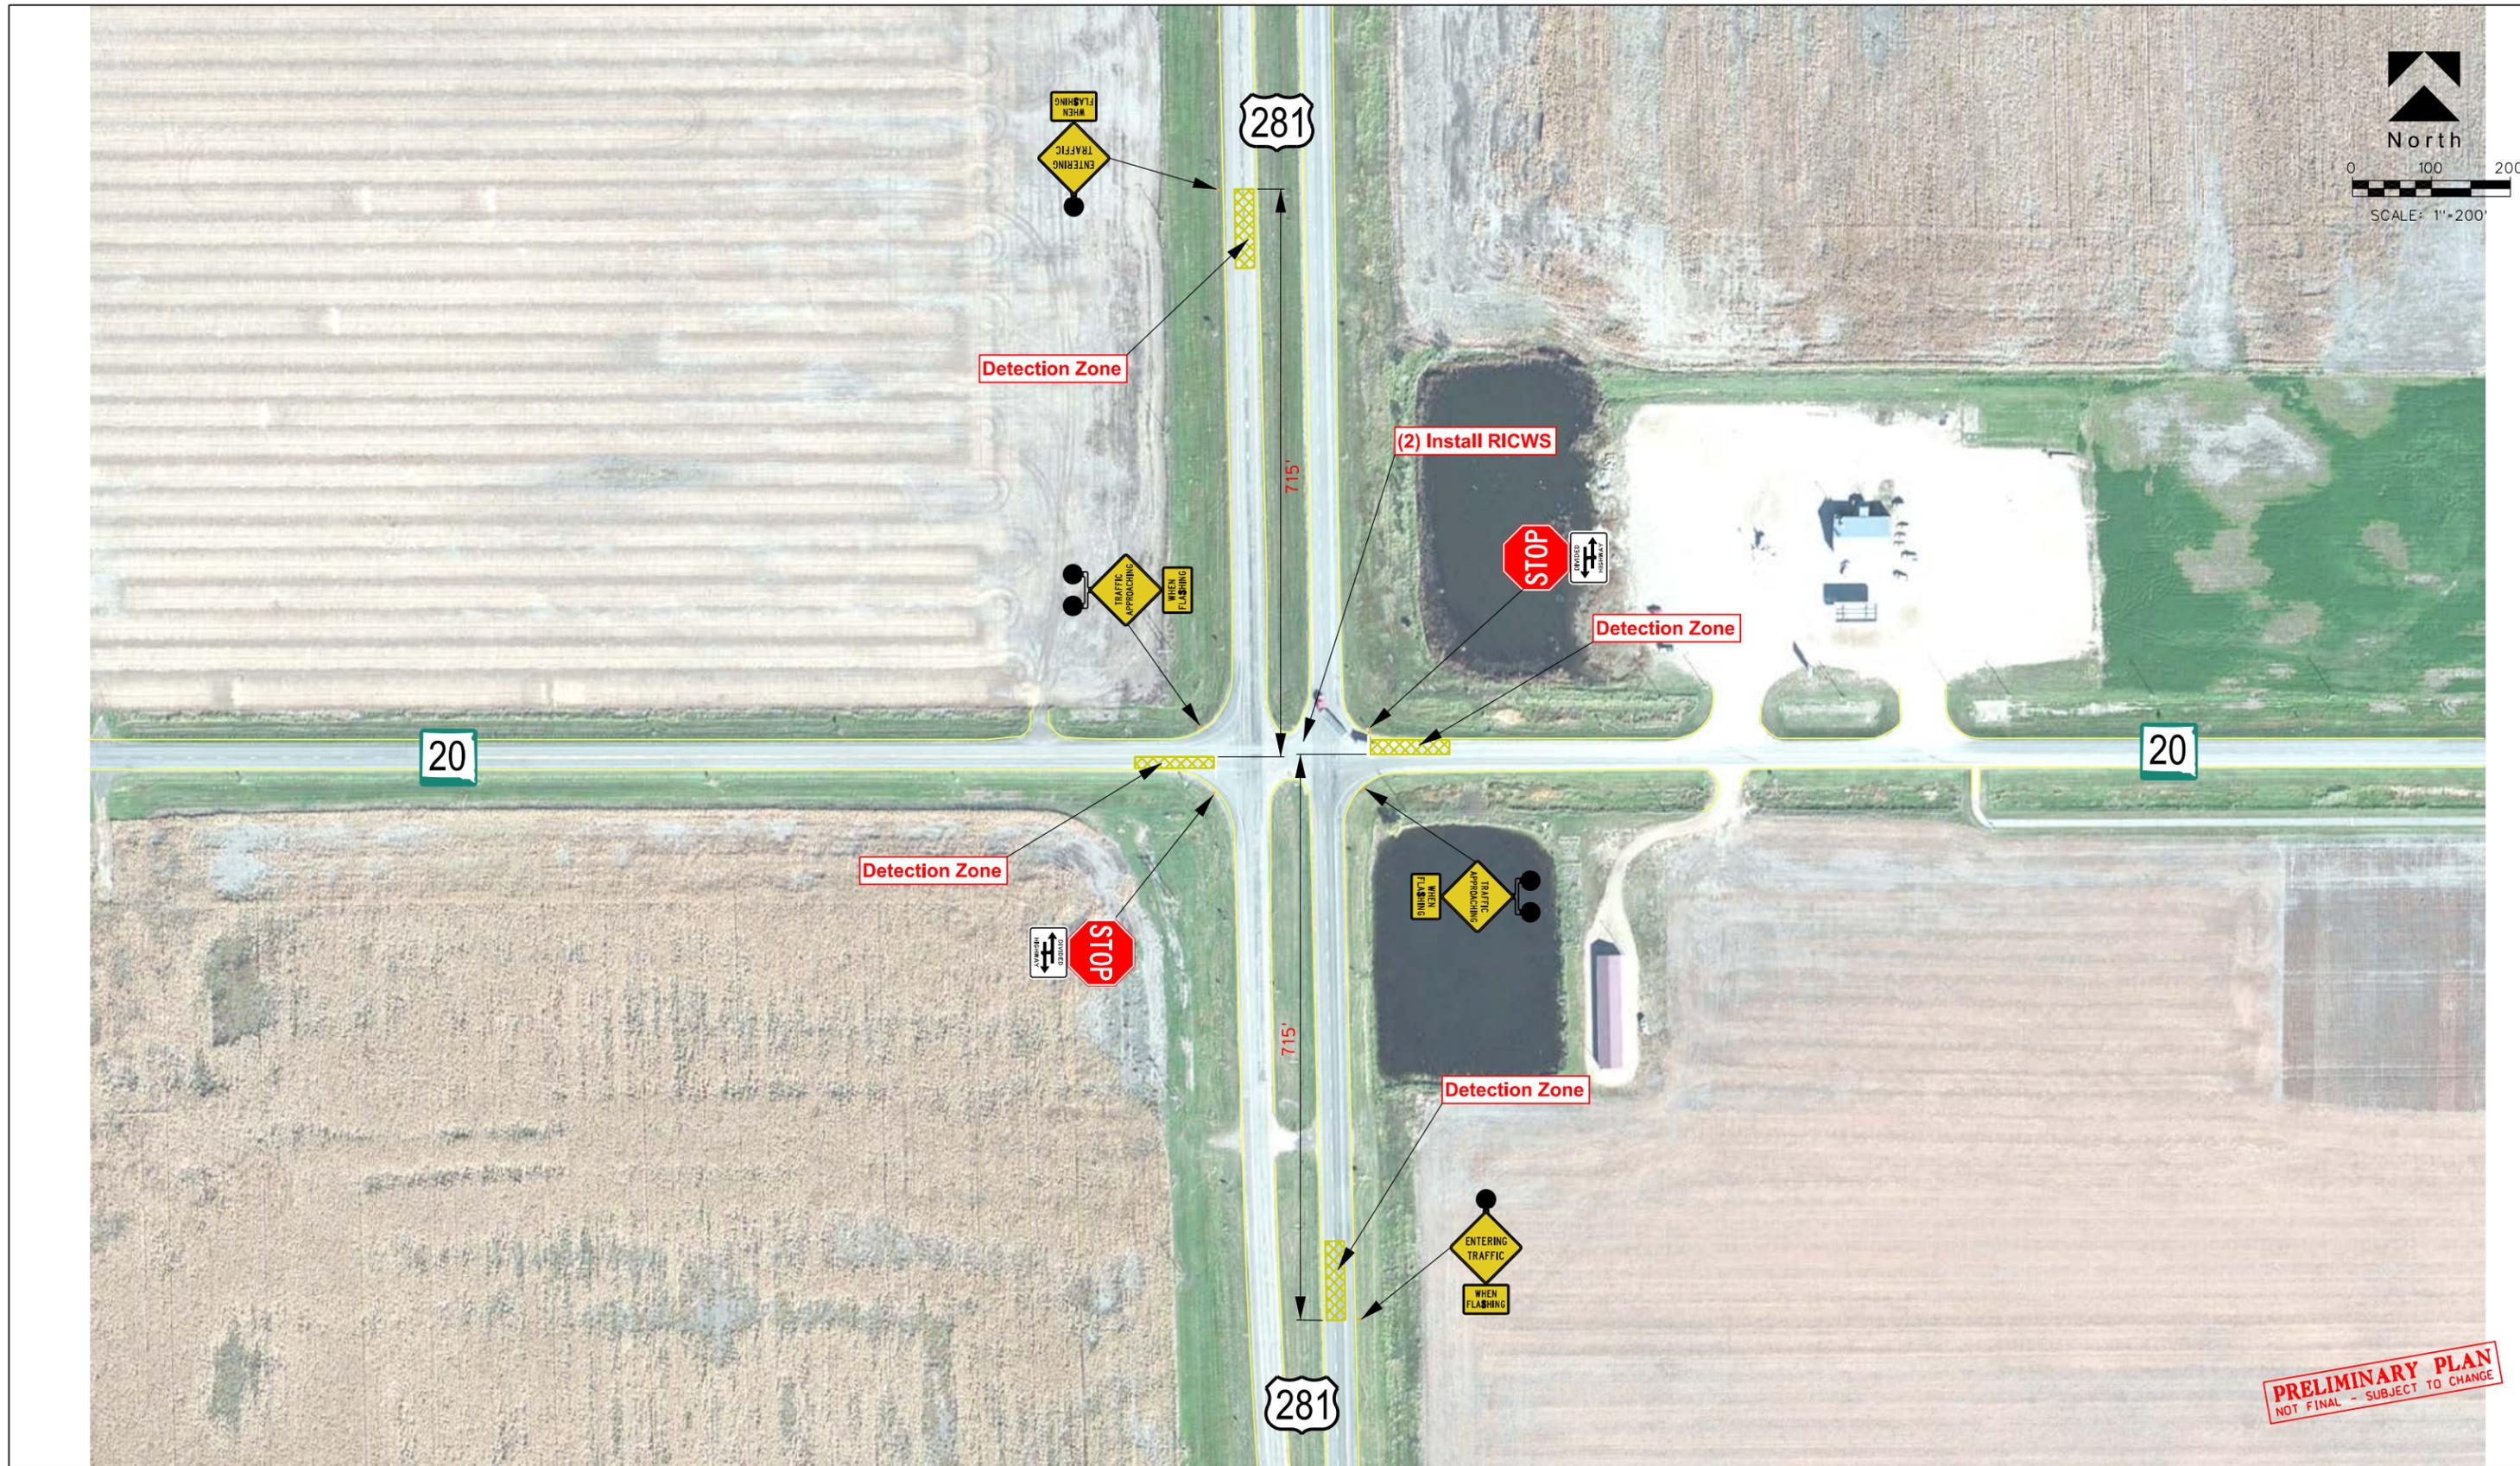
Figure 2.4
Intersection #2
Intersection Recommendations
US 281 / SD 20

CONCEPTUAL DESIGN - OPTION 2

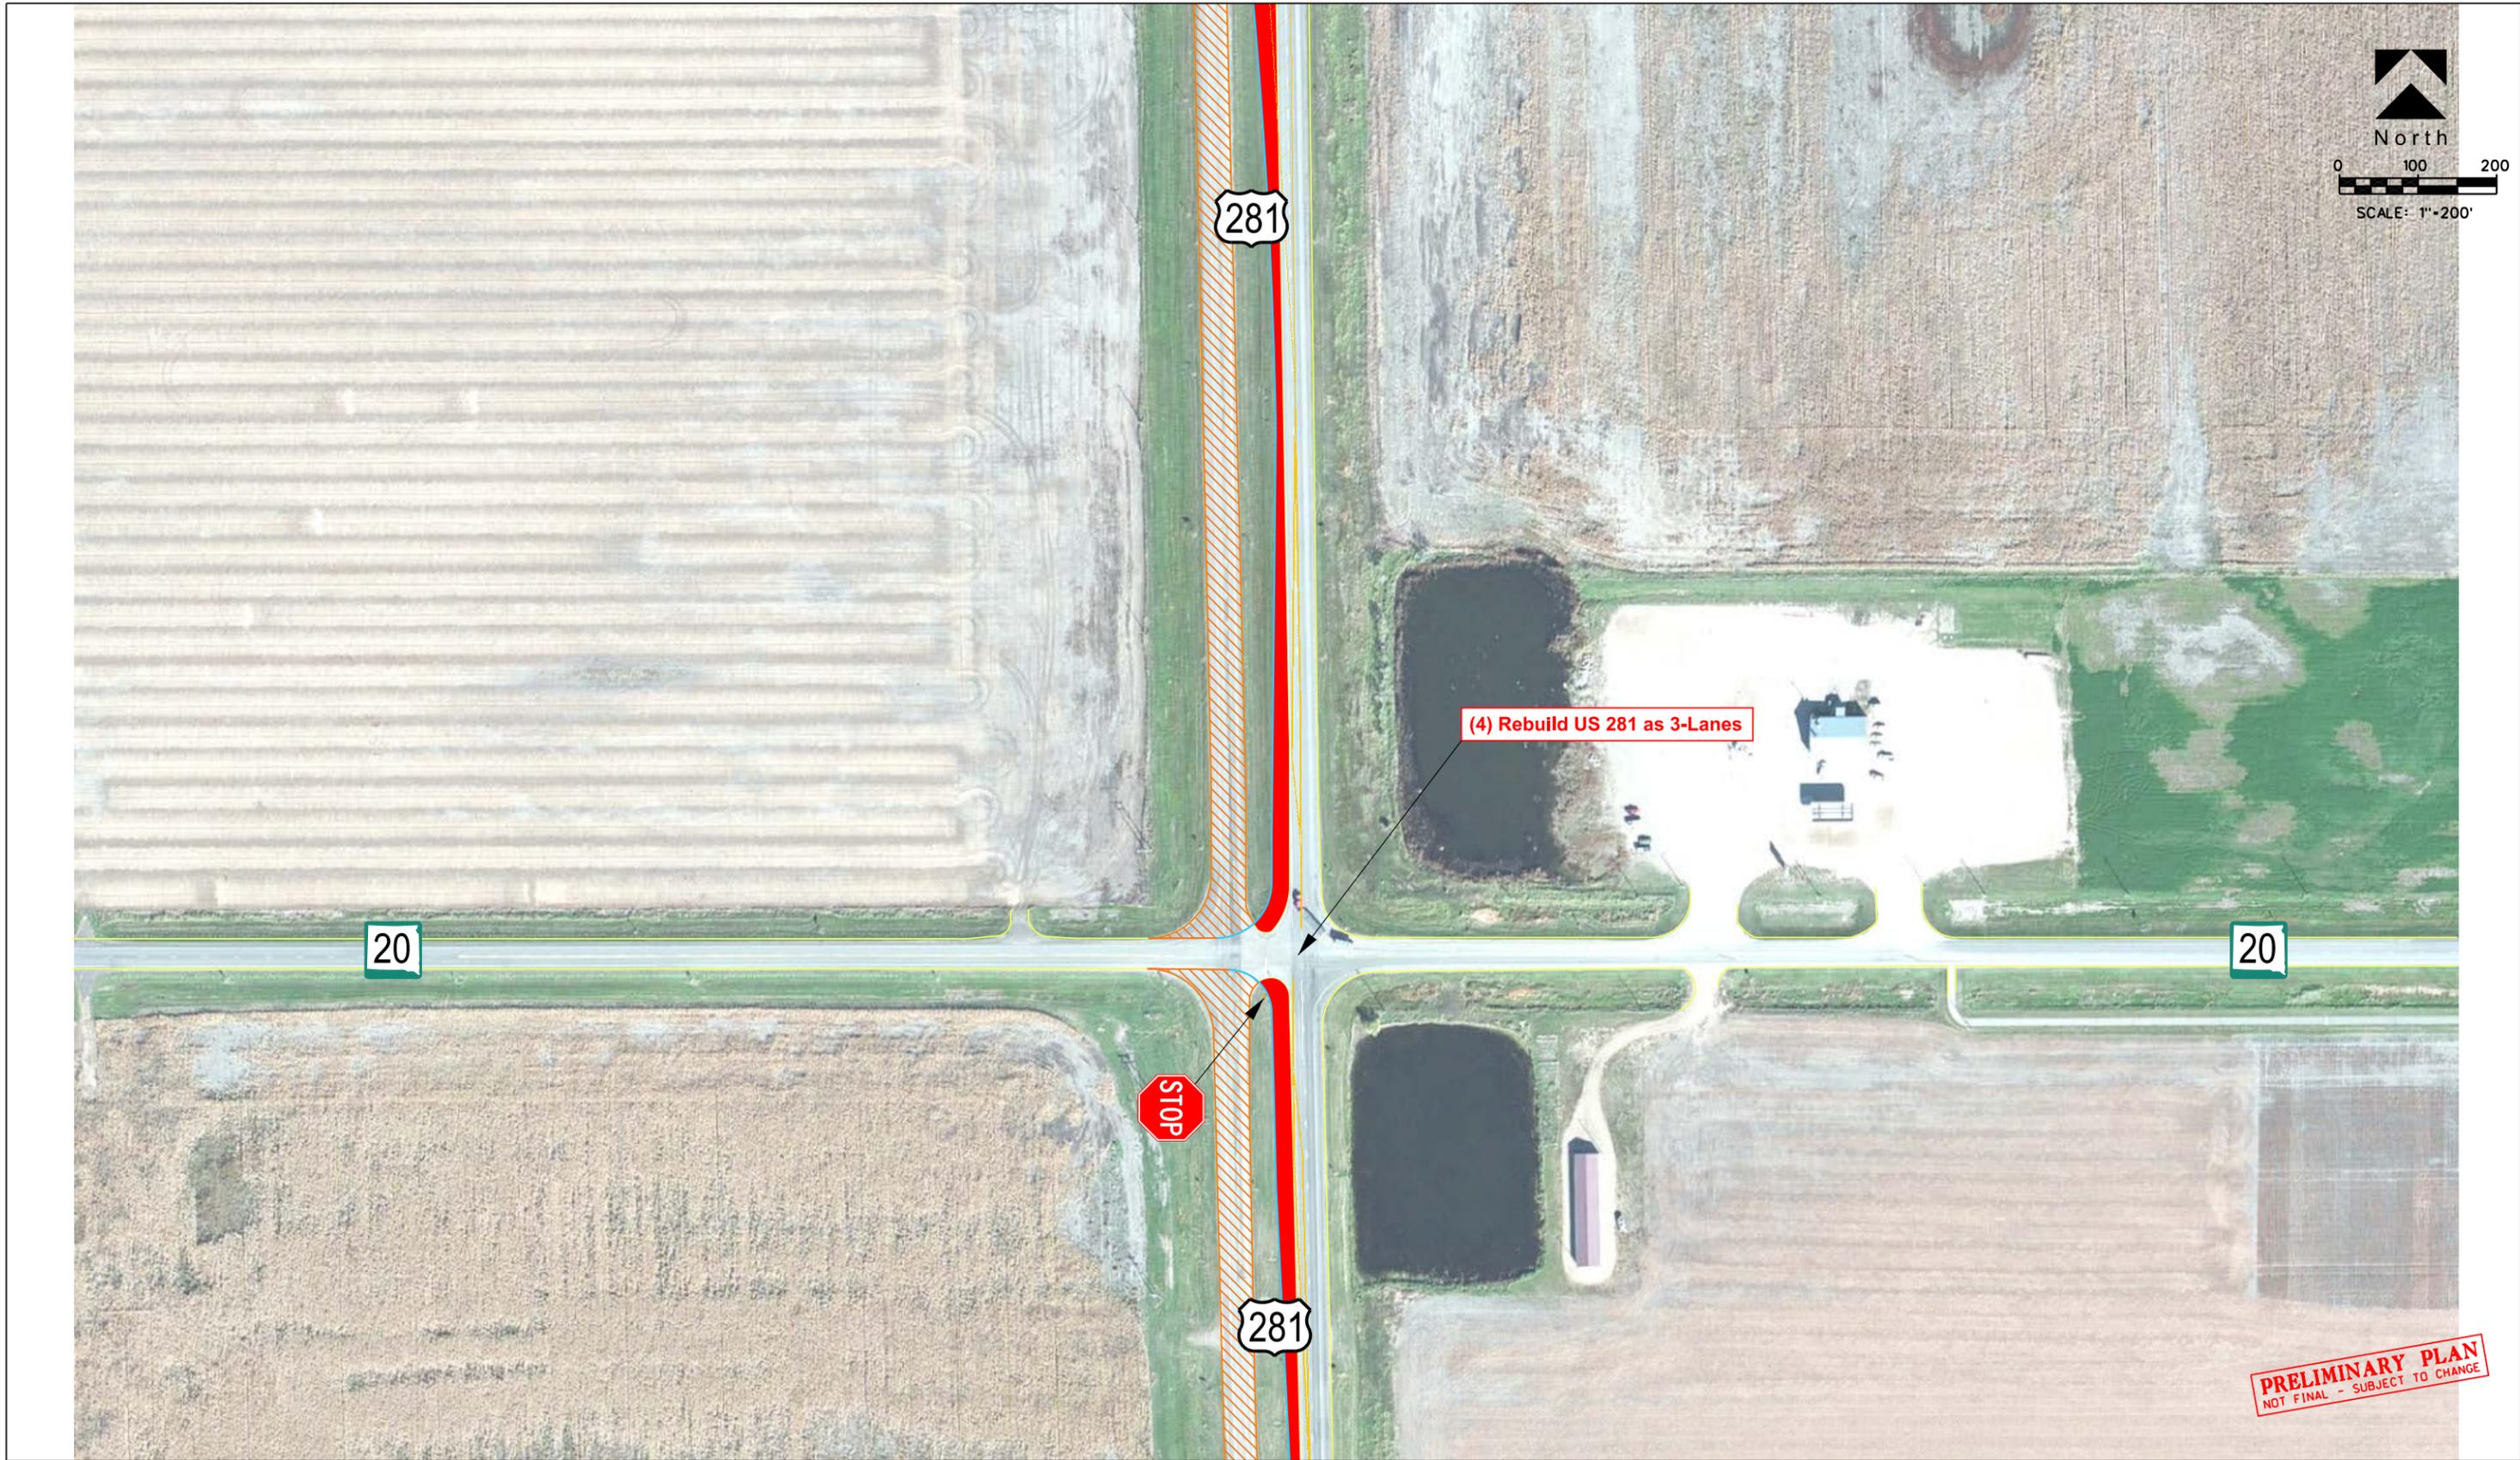
Figure 2.5
Intersection #2
Intersection Recommendations
US 281 / SD 20

CONCEPTUAL DESIGN - OPTION 3

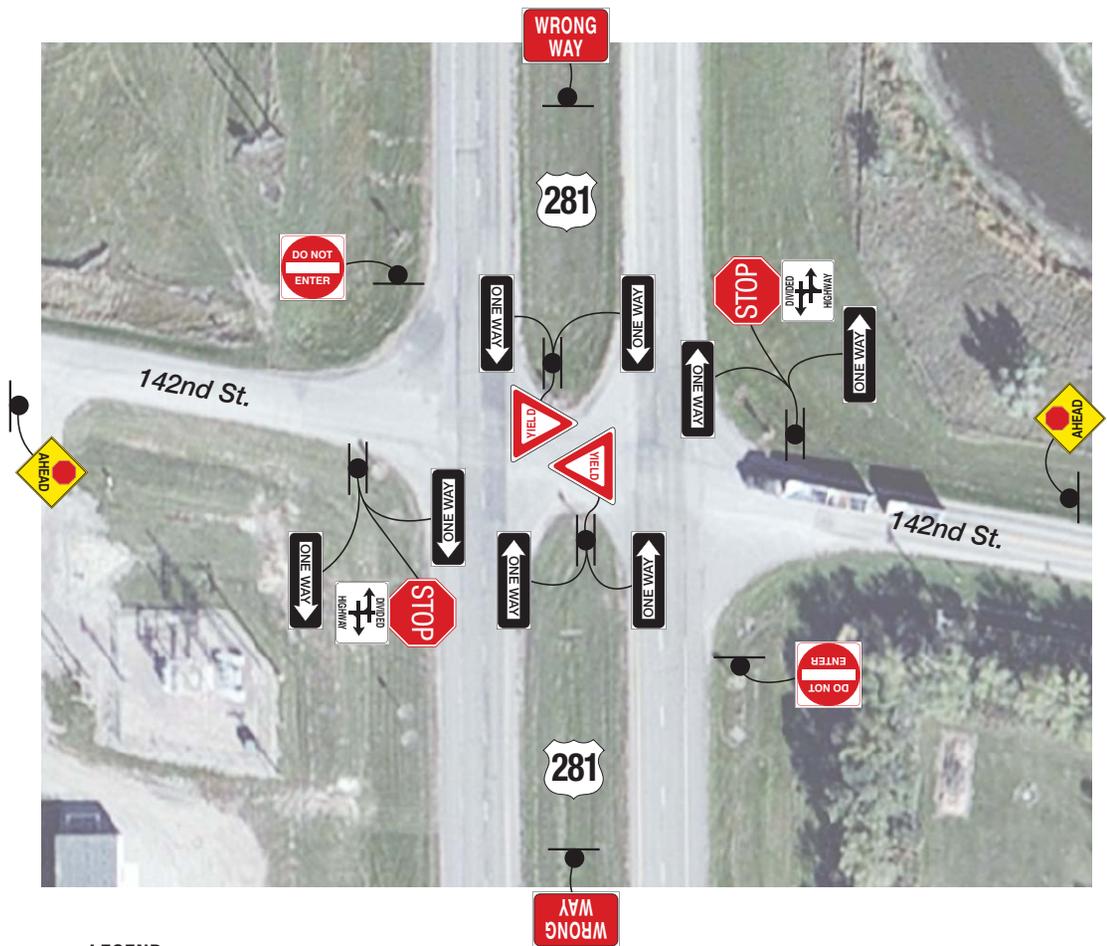
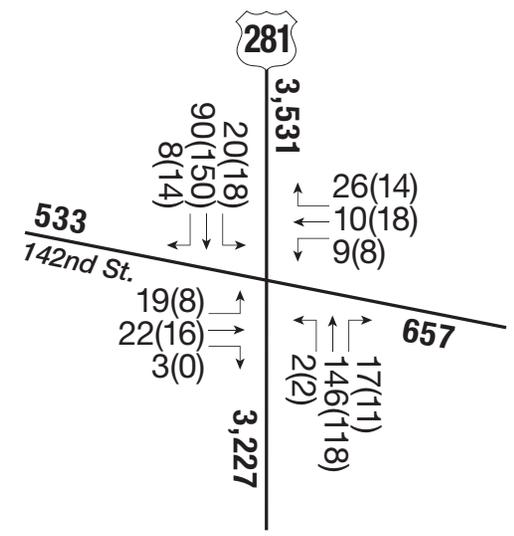
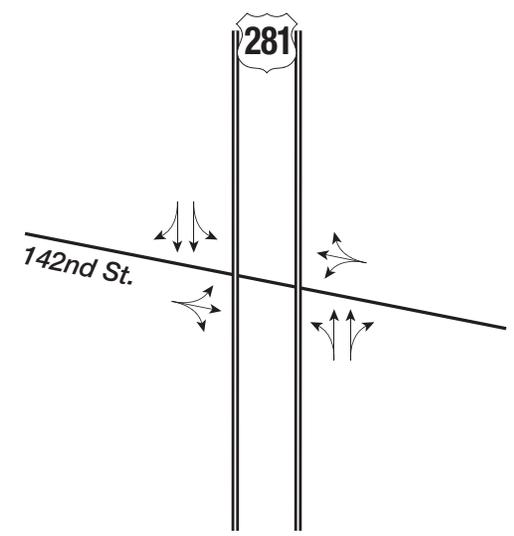
Figure 3.1
US 281/142nd Street Traffic Conditions

The intersection has a truck percentage of 19%. Also shown on **Figure 3.1** are the lane geometry, traffic control, and signage for existing traffic conditions at the intersection.
