SDDOT INTERSECTION SAFETY STUDY

South Dakota DOT
700 E. Broadway Ave.
Pierre, South Dakota 57501

Felsburg Holt & Ullevig
11422 Miracle Hills Drive, Suite 115
Omaha, Nebraska 68154
402-445-4405

FHU Reference No. 14-066
April 2015

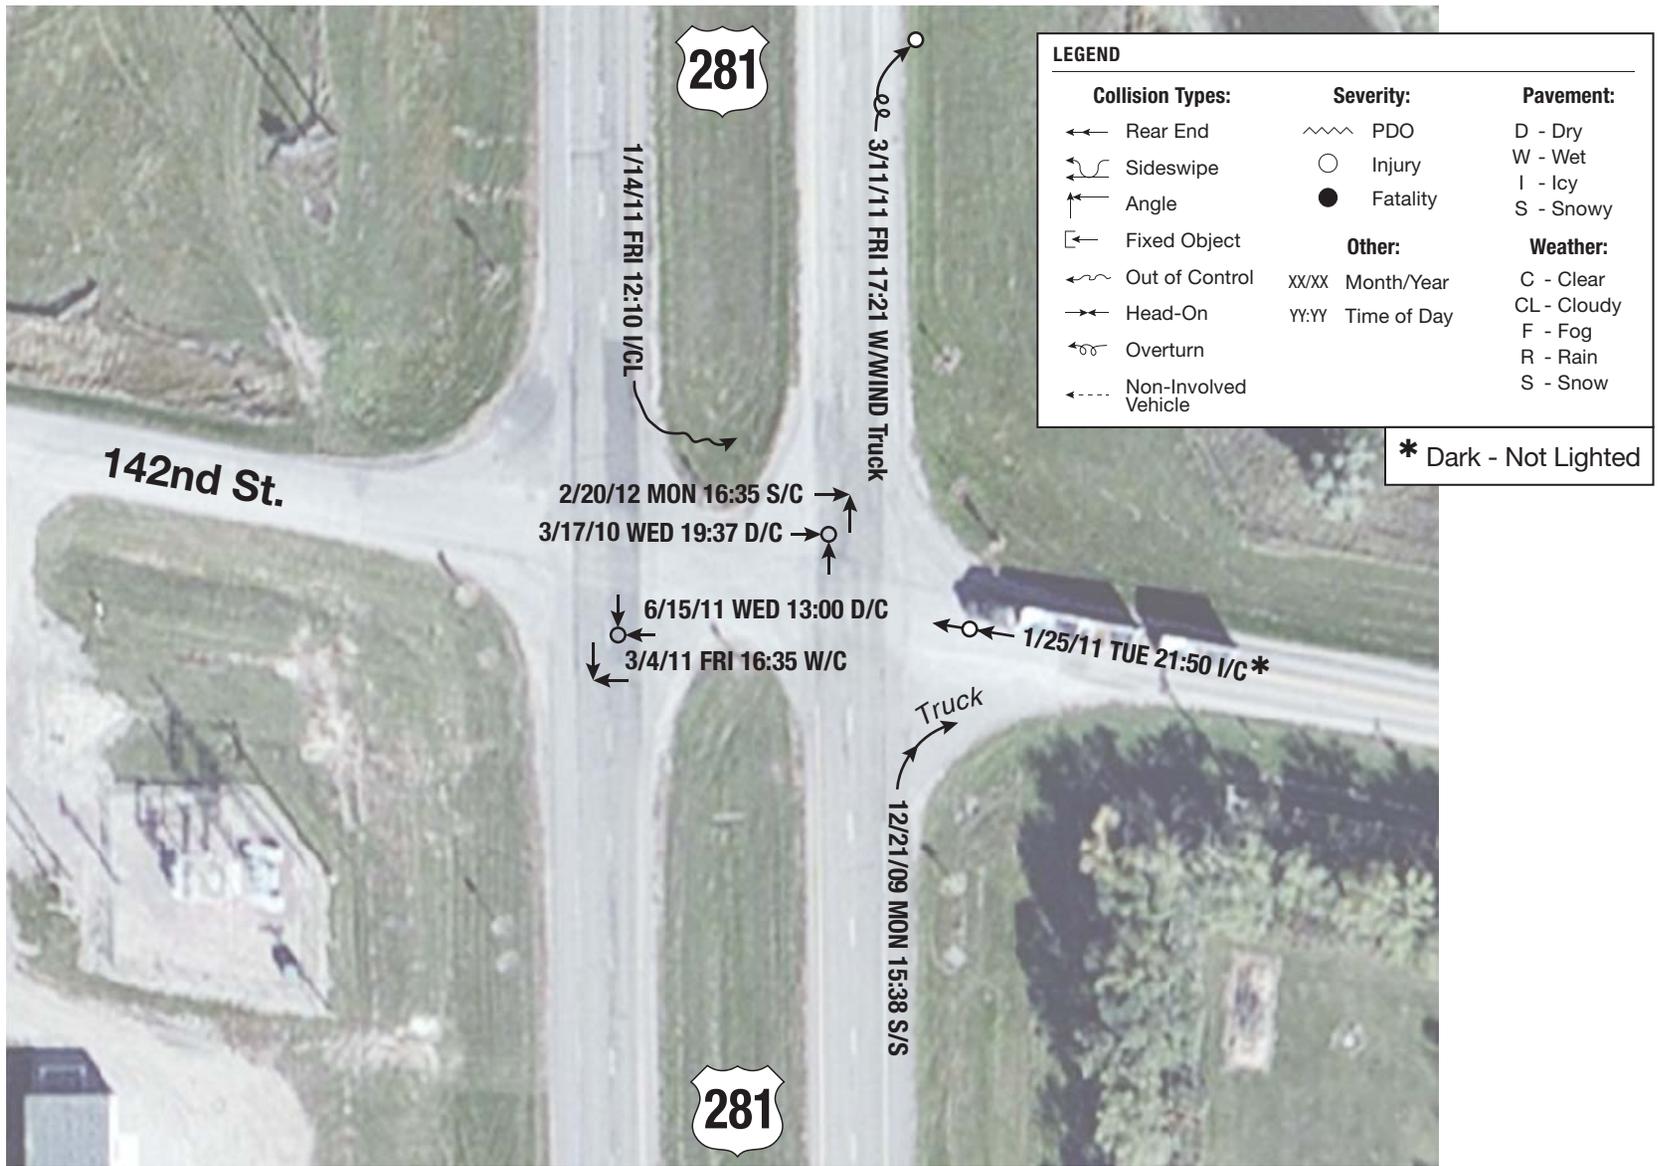
Figure 3.2
US 281/142nd Street Crash Diagram

A detailed review of the crash history at the intersection indicates a pattern of right angle far side crashes. Right angle far sided crashes represent 50.0% of the total crashes during this five-year period. The crashes were also reviewed for patterns by Time of Day, Day of Week, Weather Conditions, Road Surface Conditions, Driver's Age, Driver's Condition, and Vehicle Type; six crashes occurred during the winter months with icy/wet roadway conditions. The crash patterns at the US 281/142nd Street intersection are further depicted in **Figure 3.2** by severity and type.

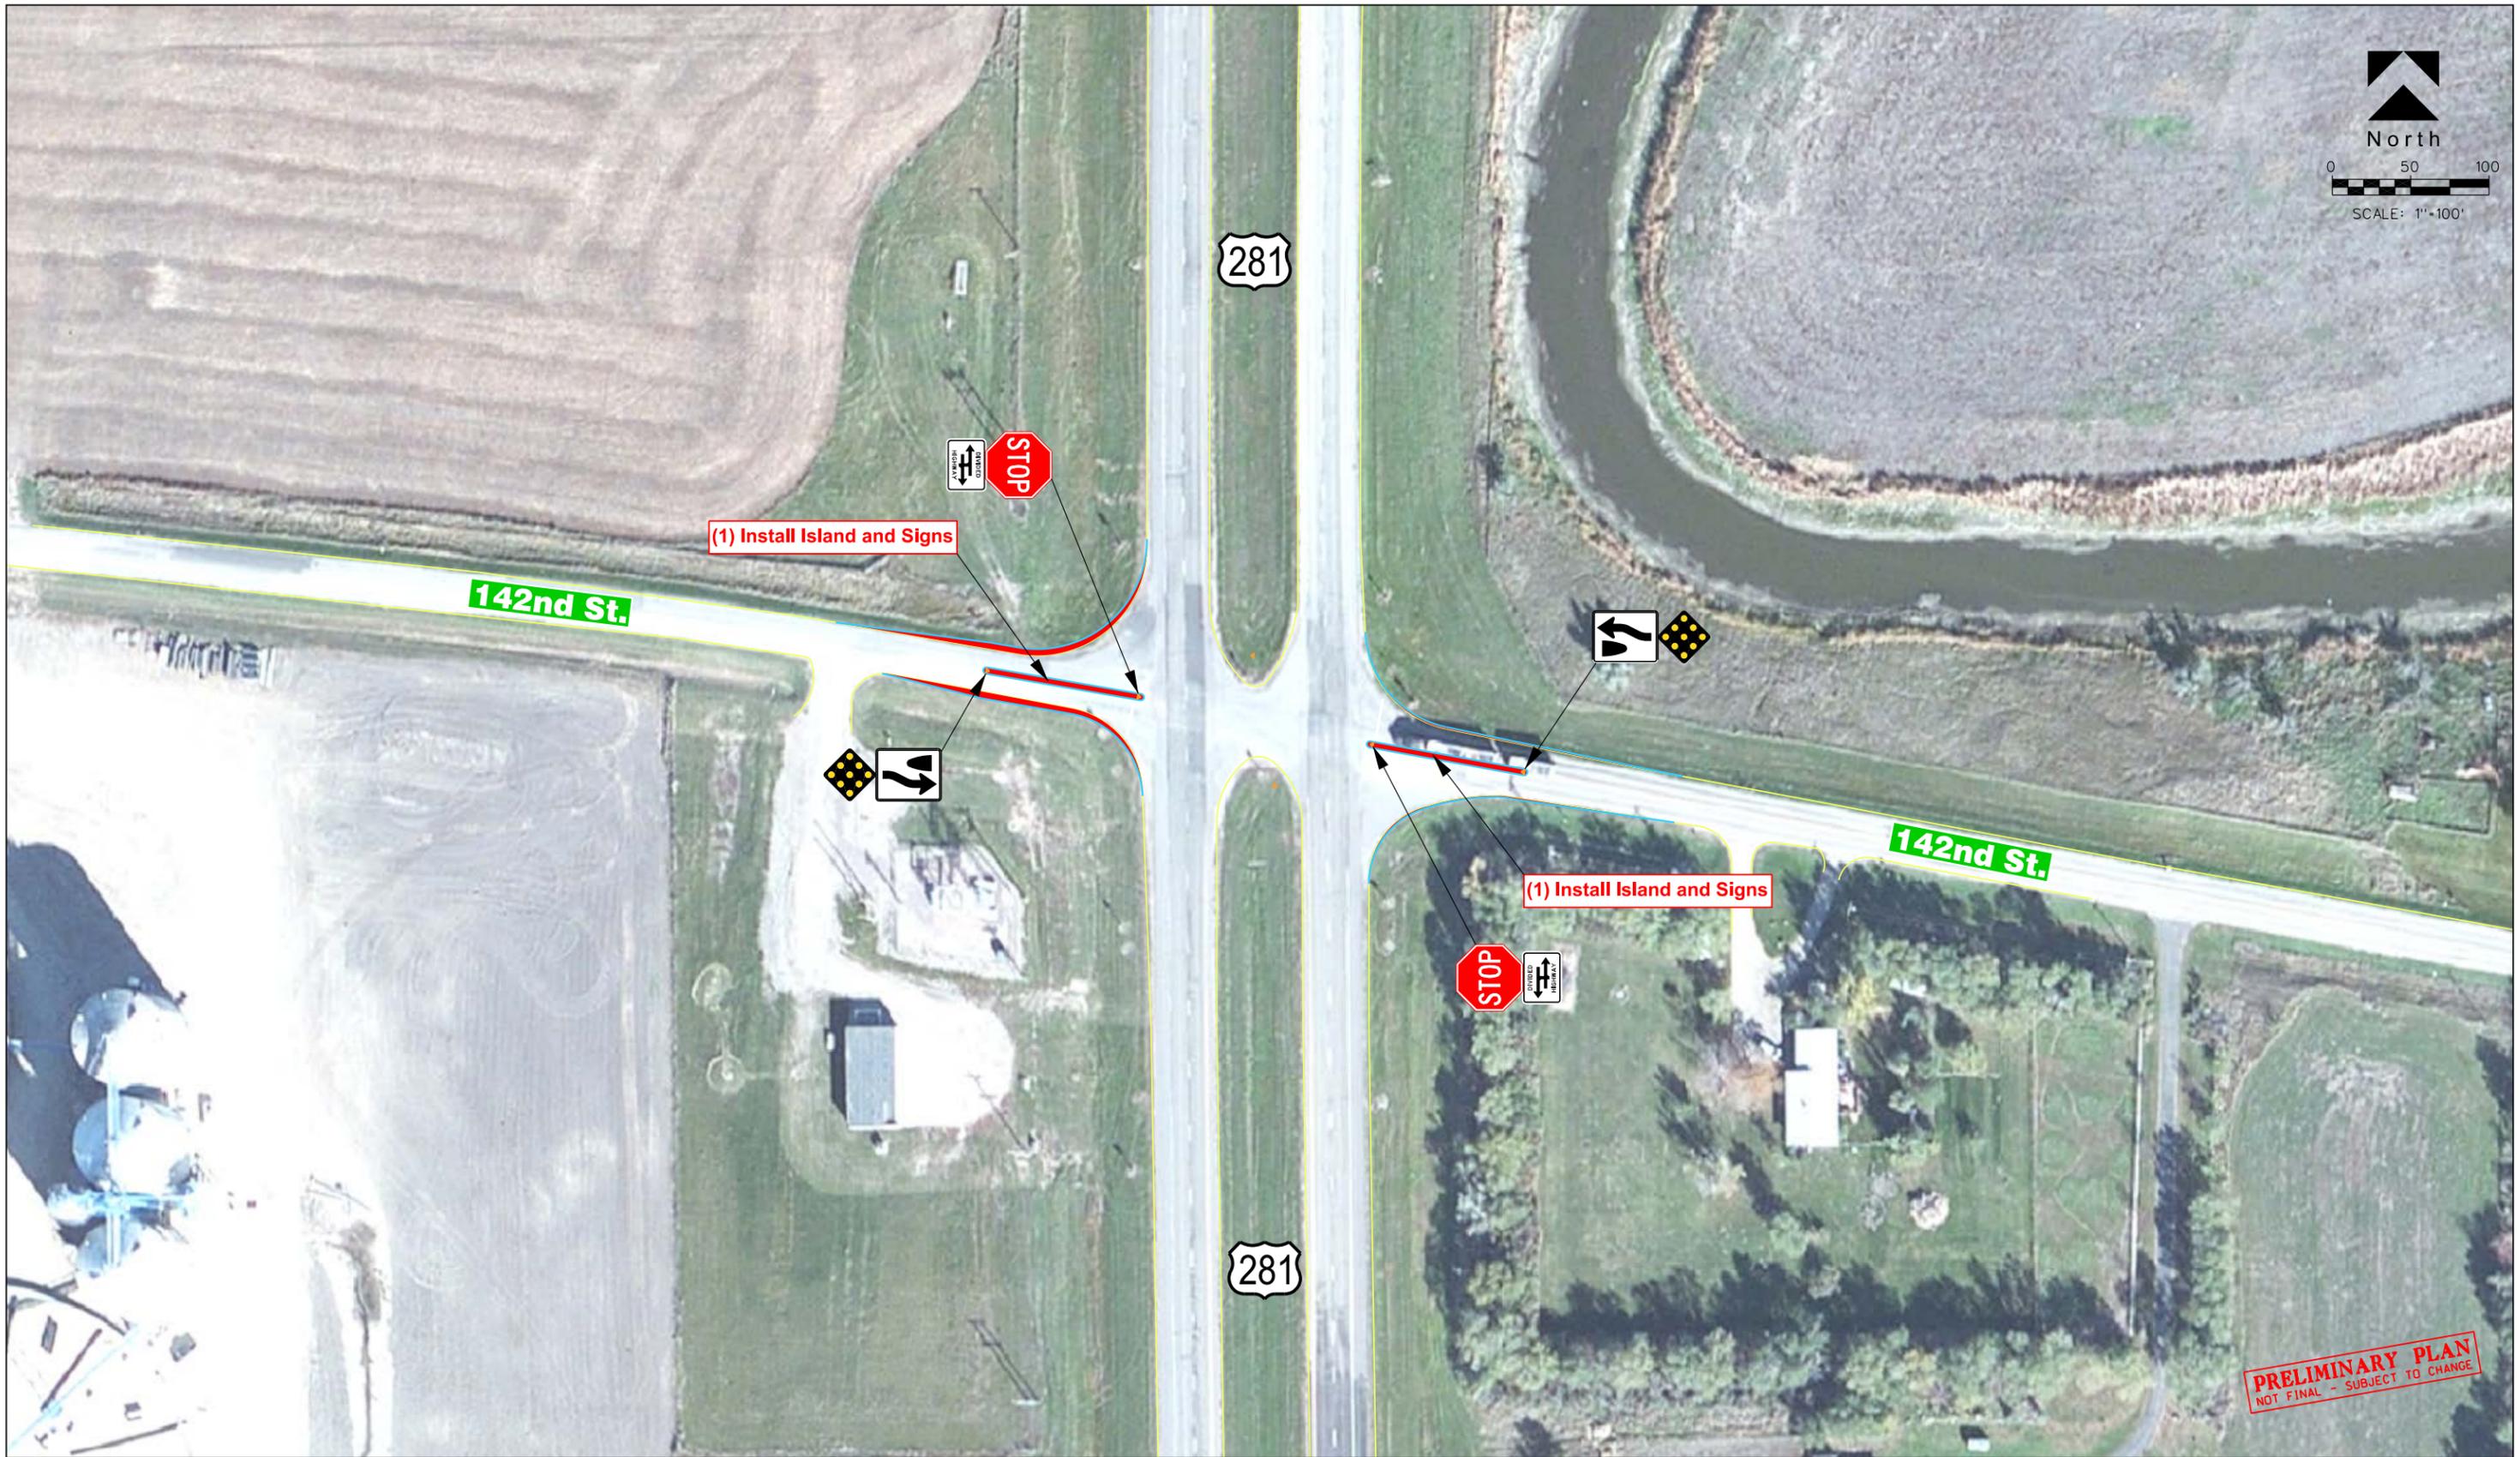
Figure 3.3
Intersection #3
Intersection Recommendations
US 281 / 142nd Street

1 – It is recommended that the median be closed in US 281 at 142nd Street and J-Turn be provided north and south of the current intersection. This has the highest potential for reducing right-angle far side crashes although it would increase travel and delay cost by diverting drivers on 142nd Street. (3)

CONCEPTUAL DESIGN - OPTION 1

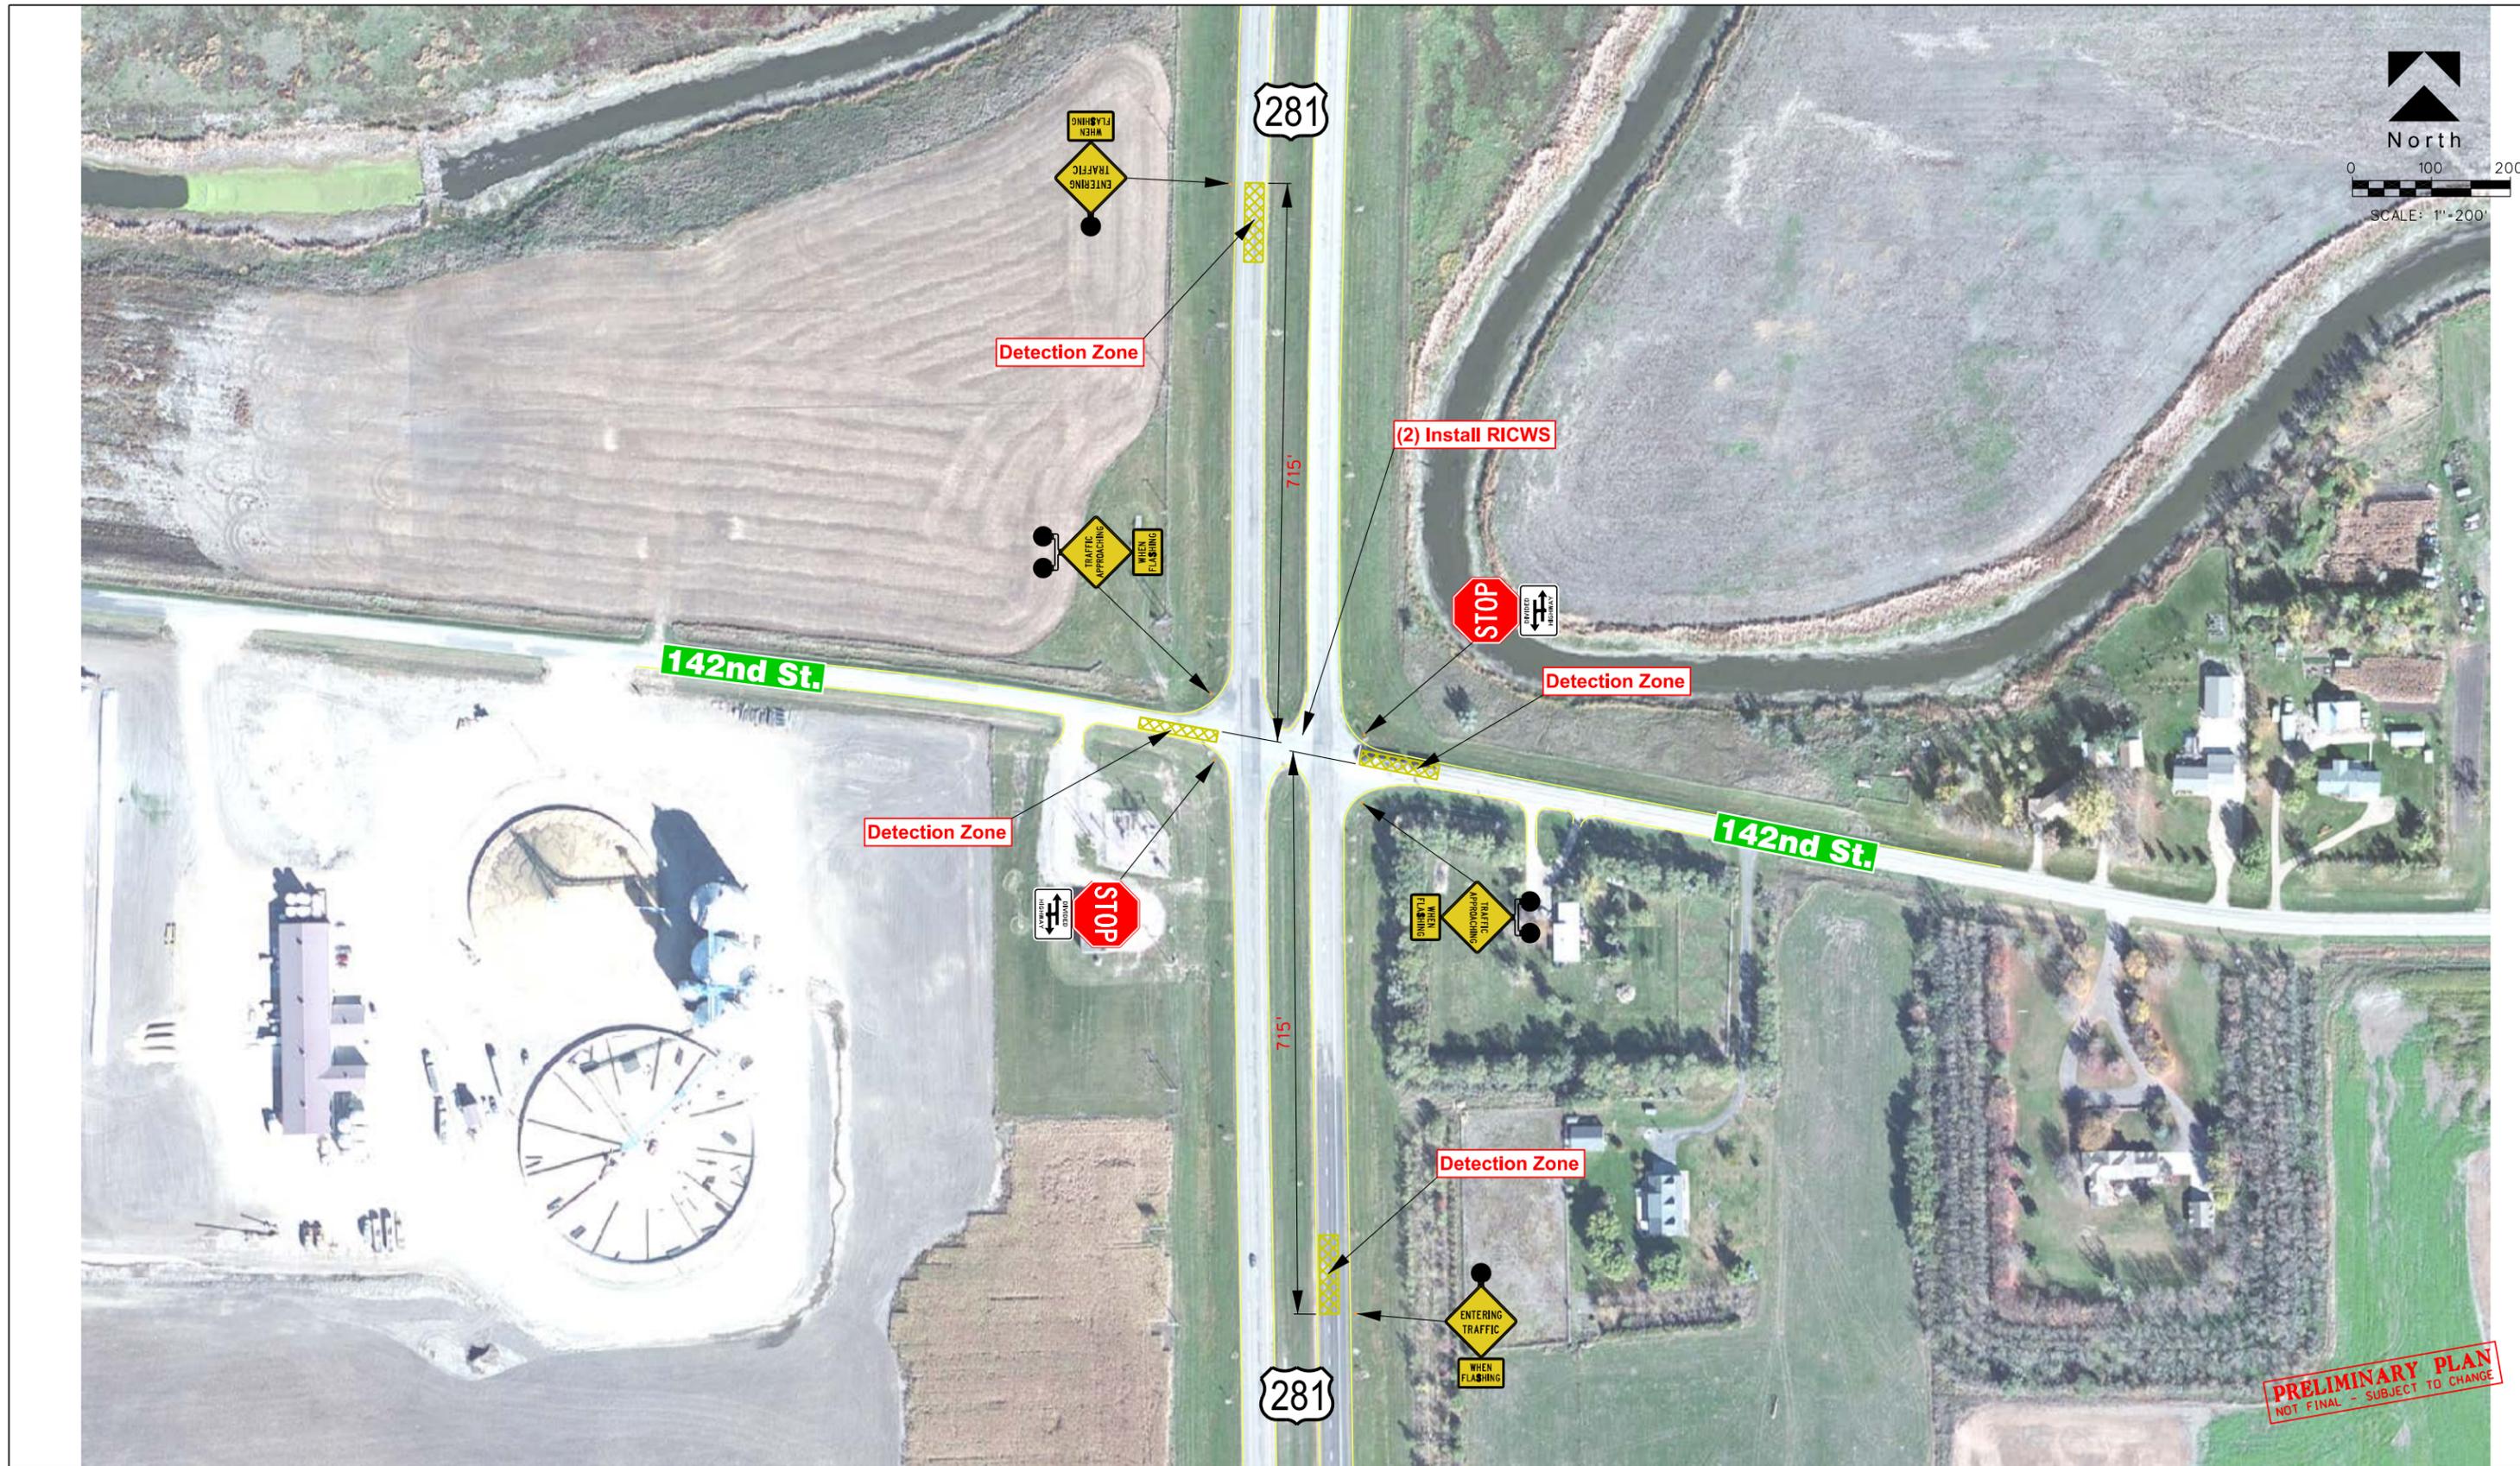
Figure 3.4
Intersection #3
Intersection Recommendations
US 281 / 142nd Street

CONCEPTUAL DESIGN - OPTION 2

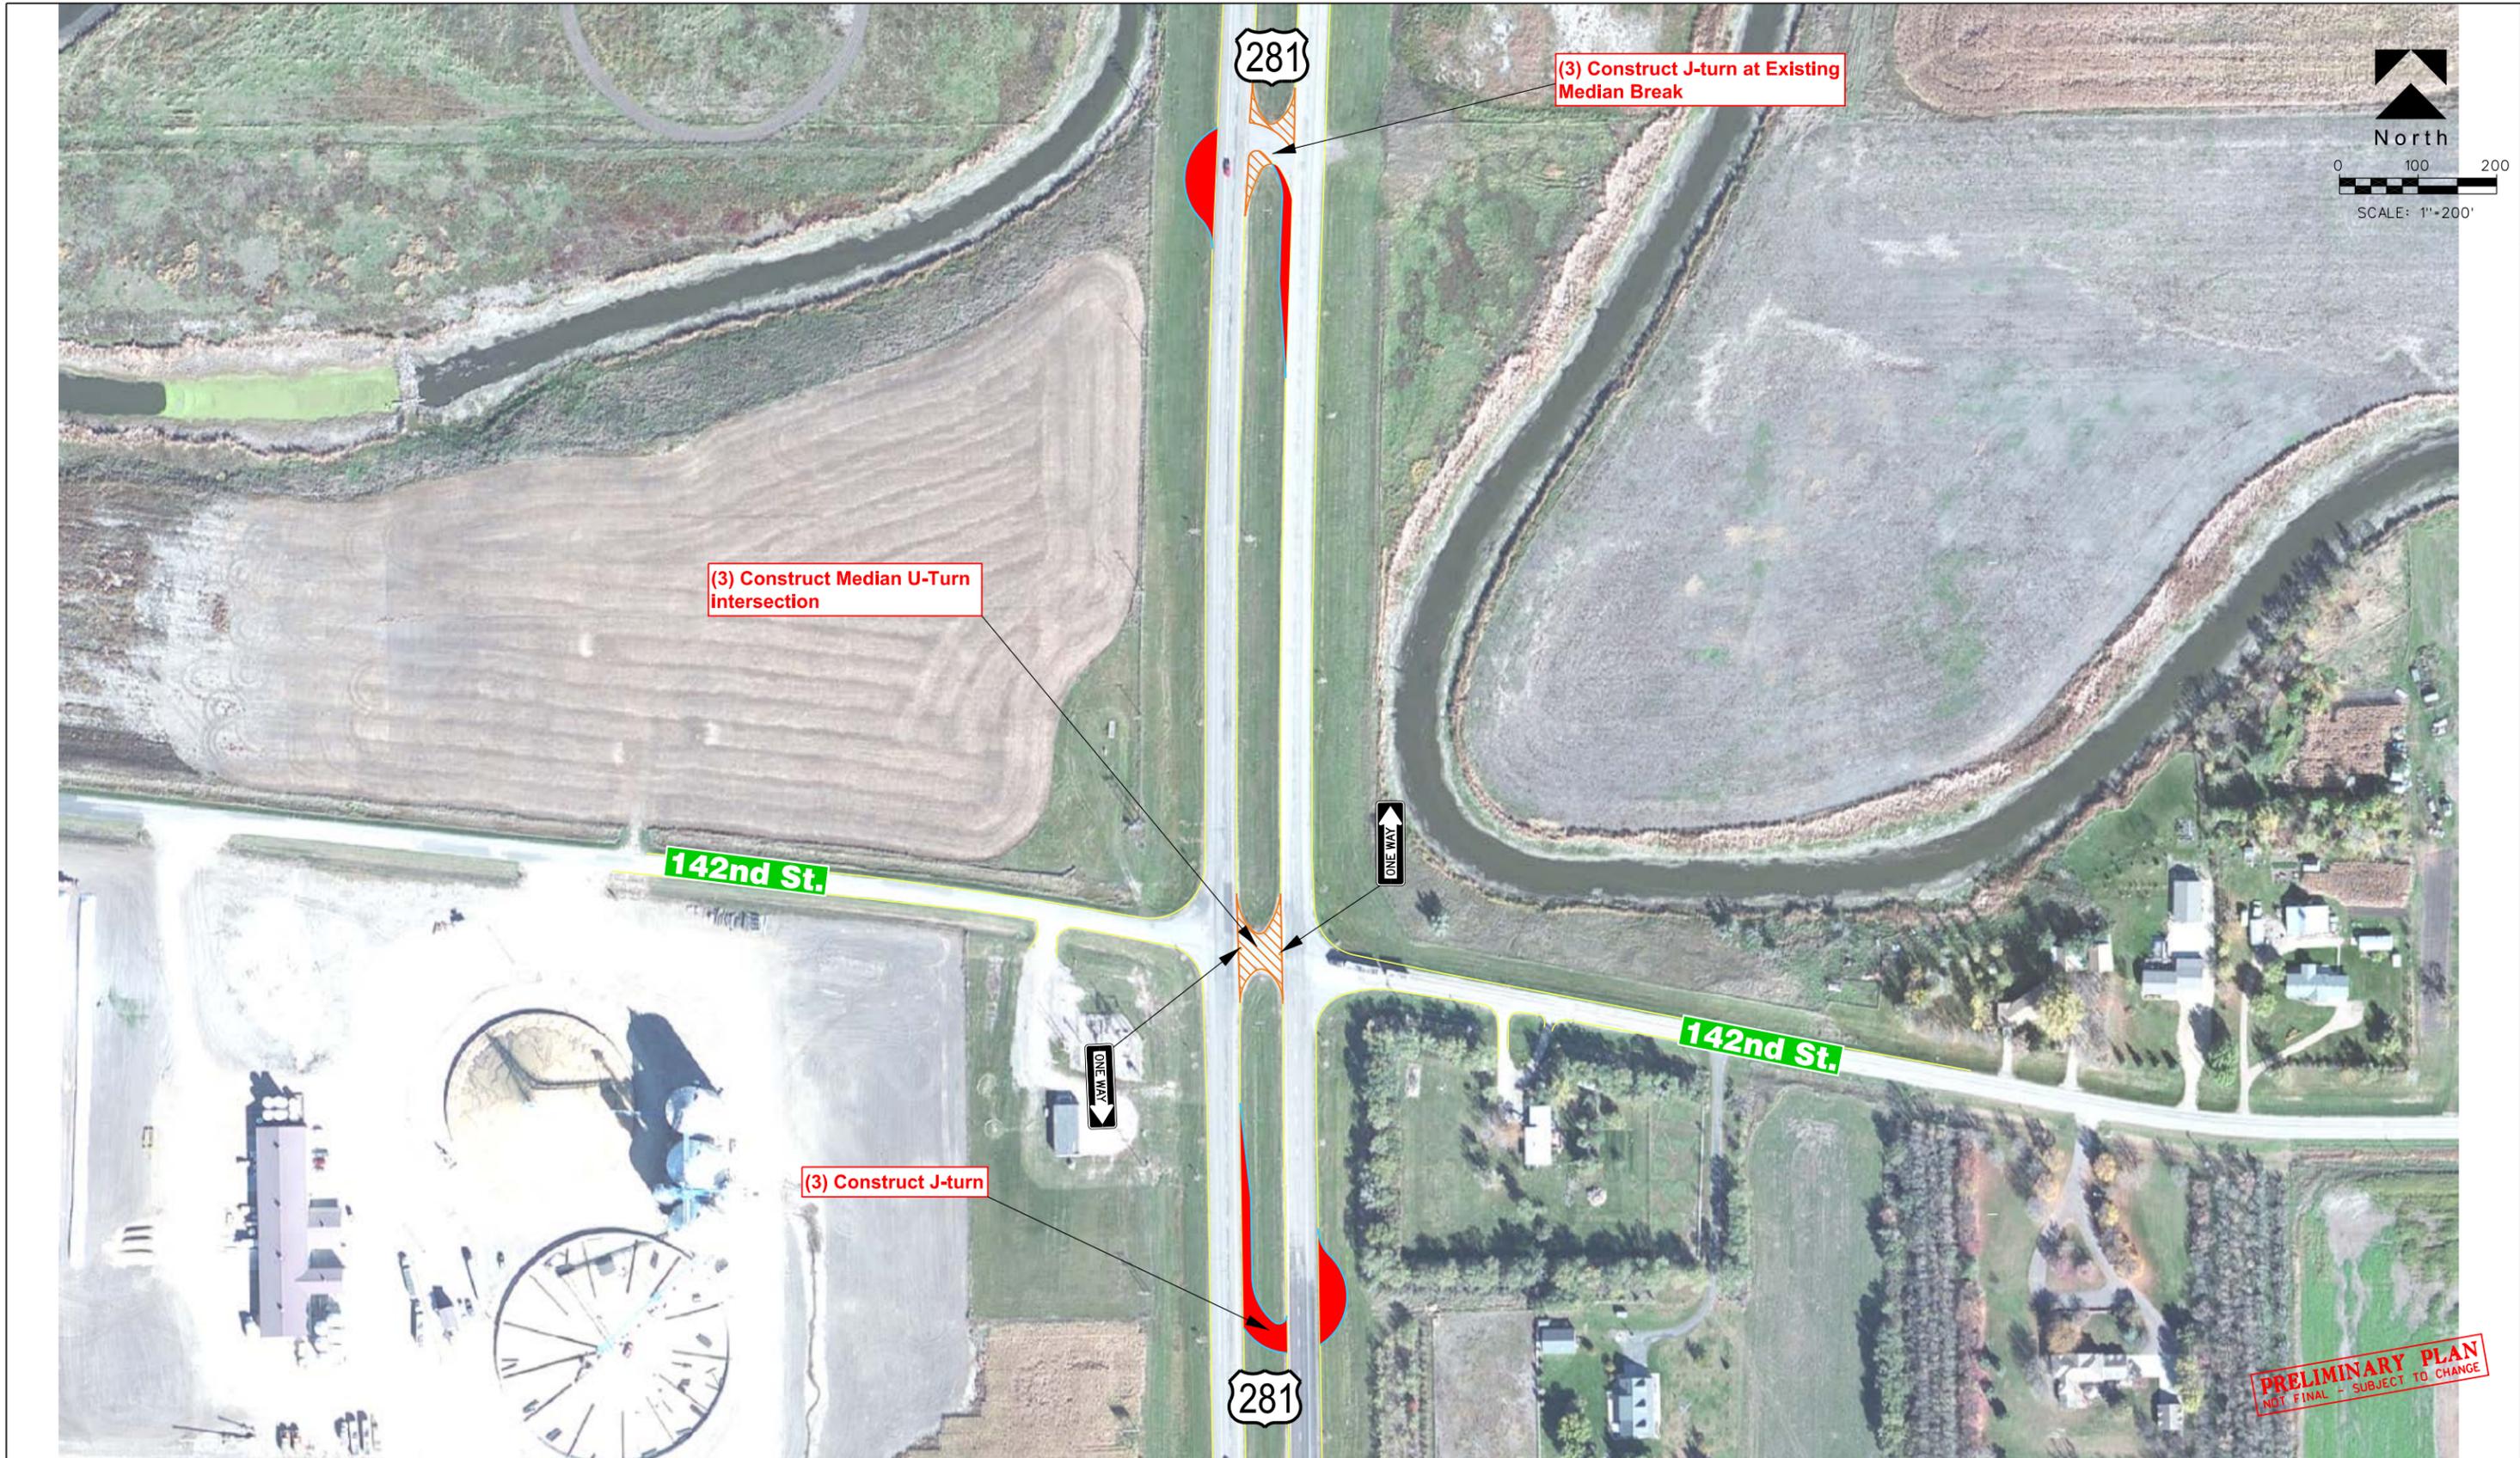
Figure 3.5
 Intersection #3
 Intersection Recommendations
 US 281 / 142nd Street

CONCEPTUAL DESIGN - OPTION 3

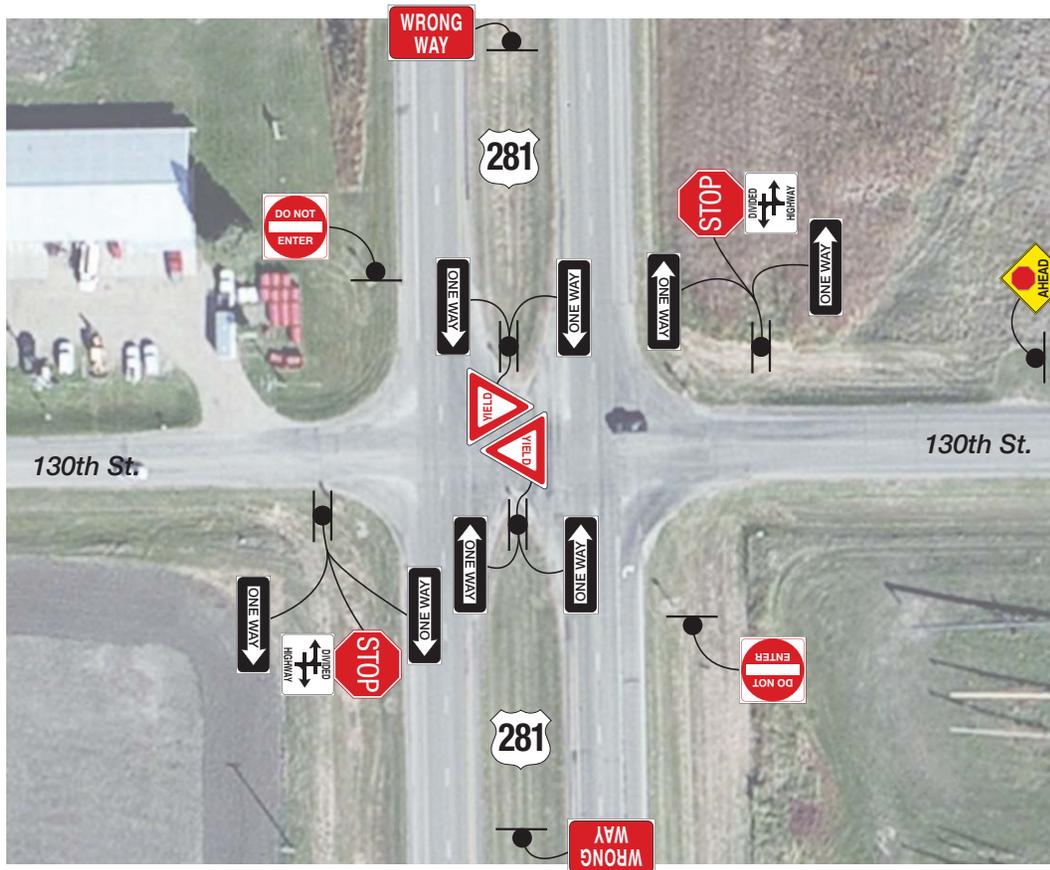
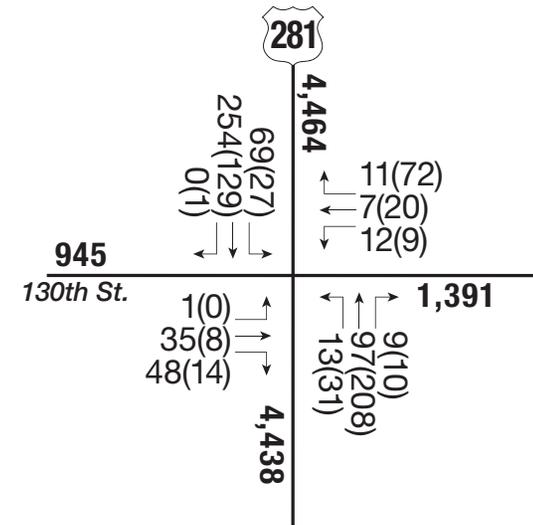
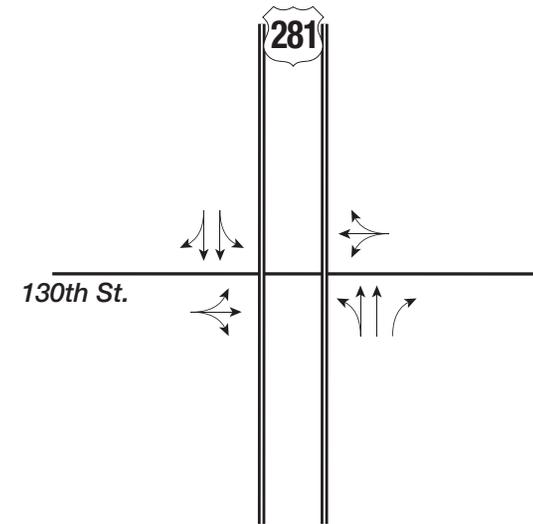
Figure 4.1
US 281/130th Street Traffic Conditions

The intersection has a truck percentage of 13%. Also shown on **Figure 4.1** are the lane geometry, traffic control, and signage for existing traffic conditions at the intersection.

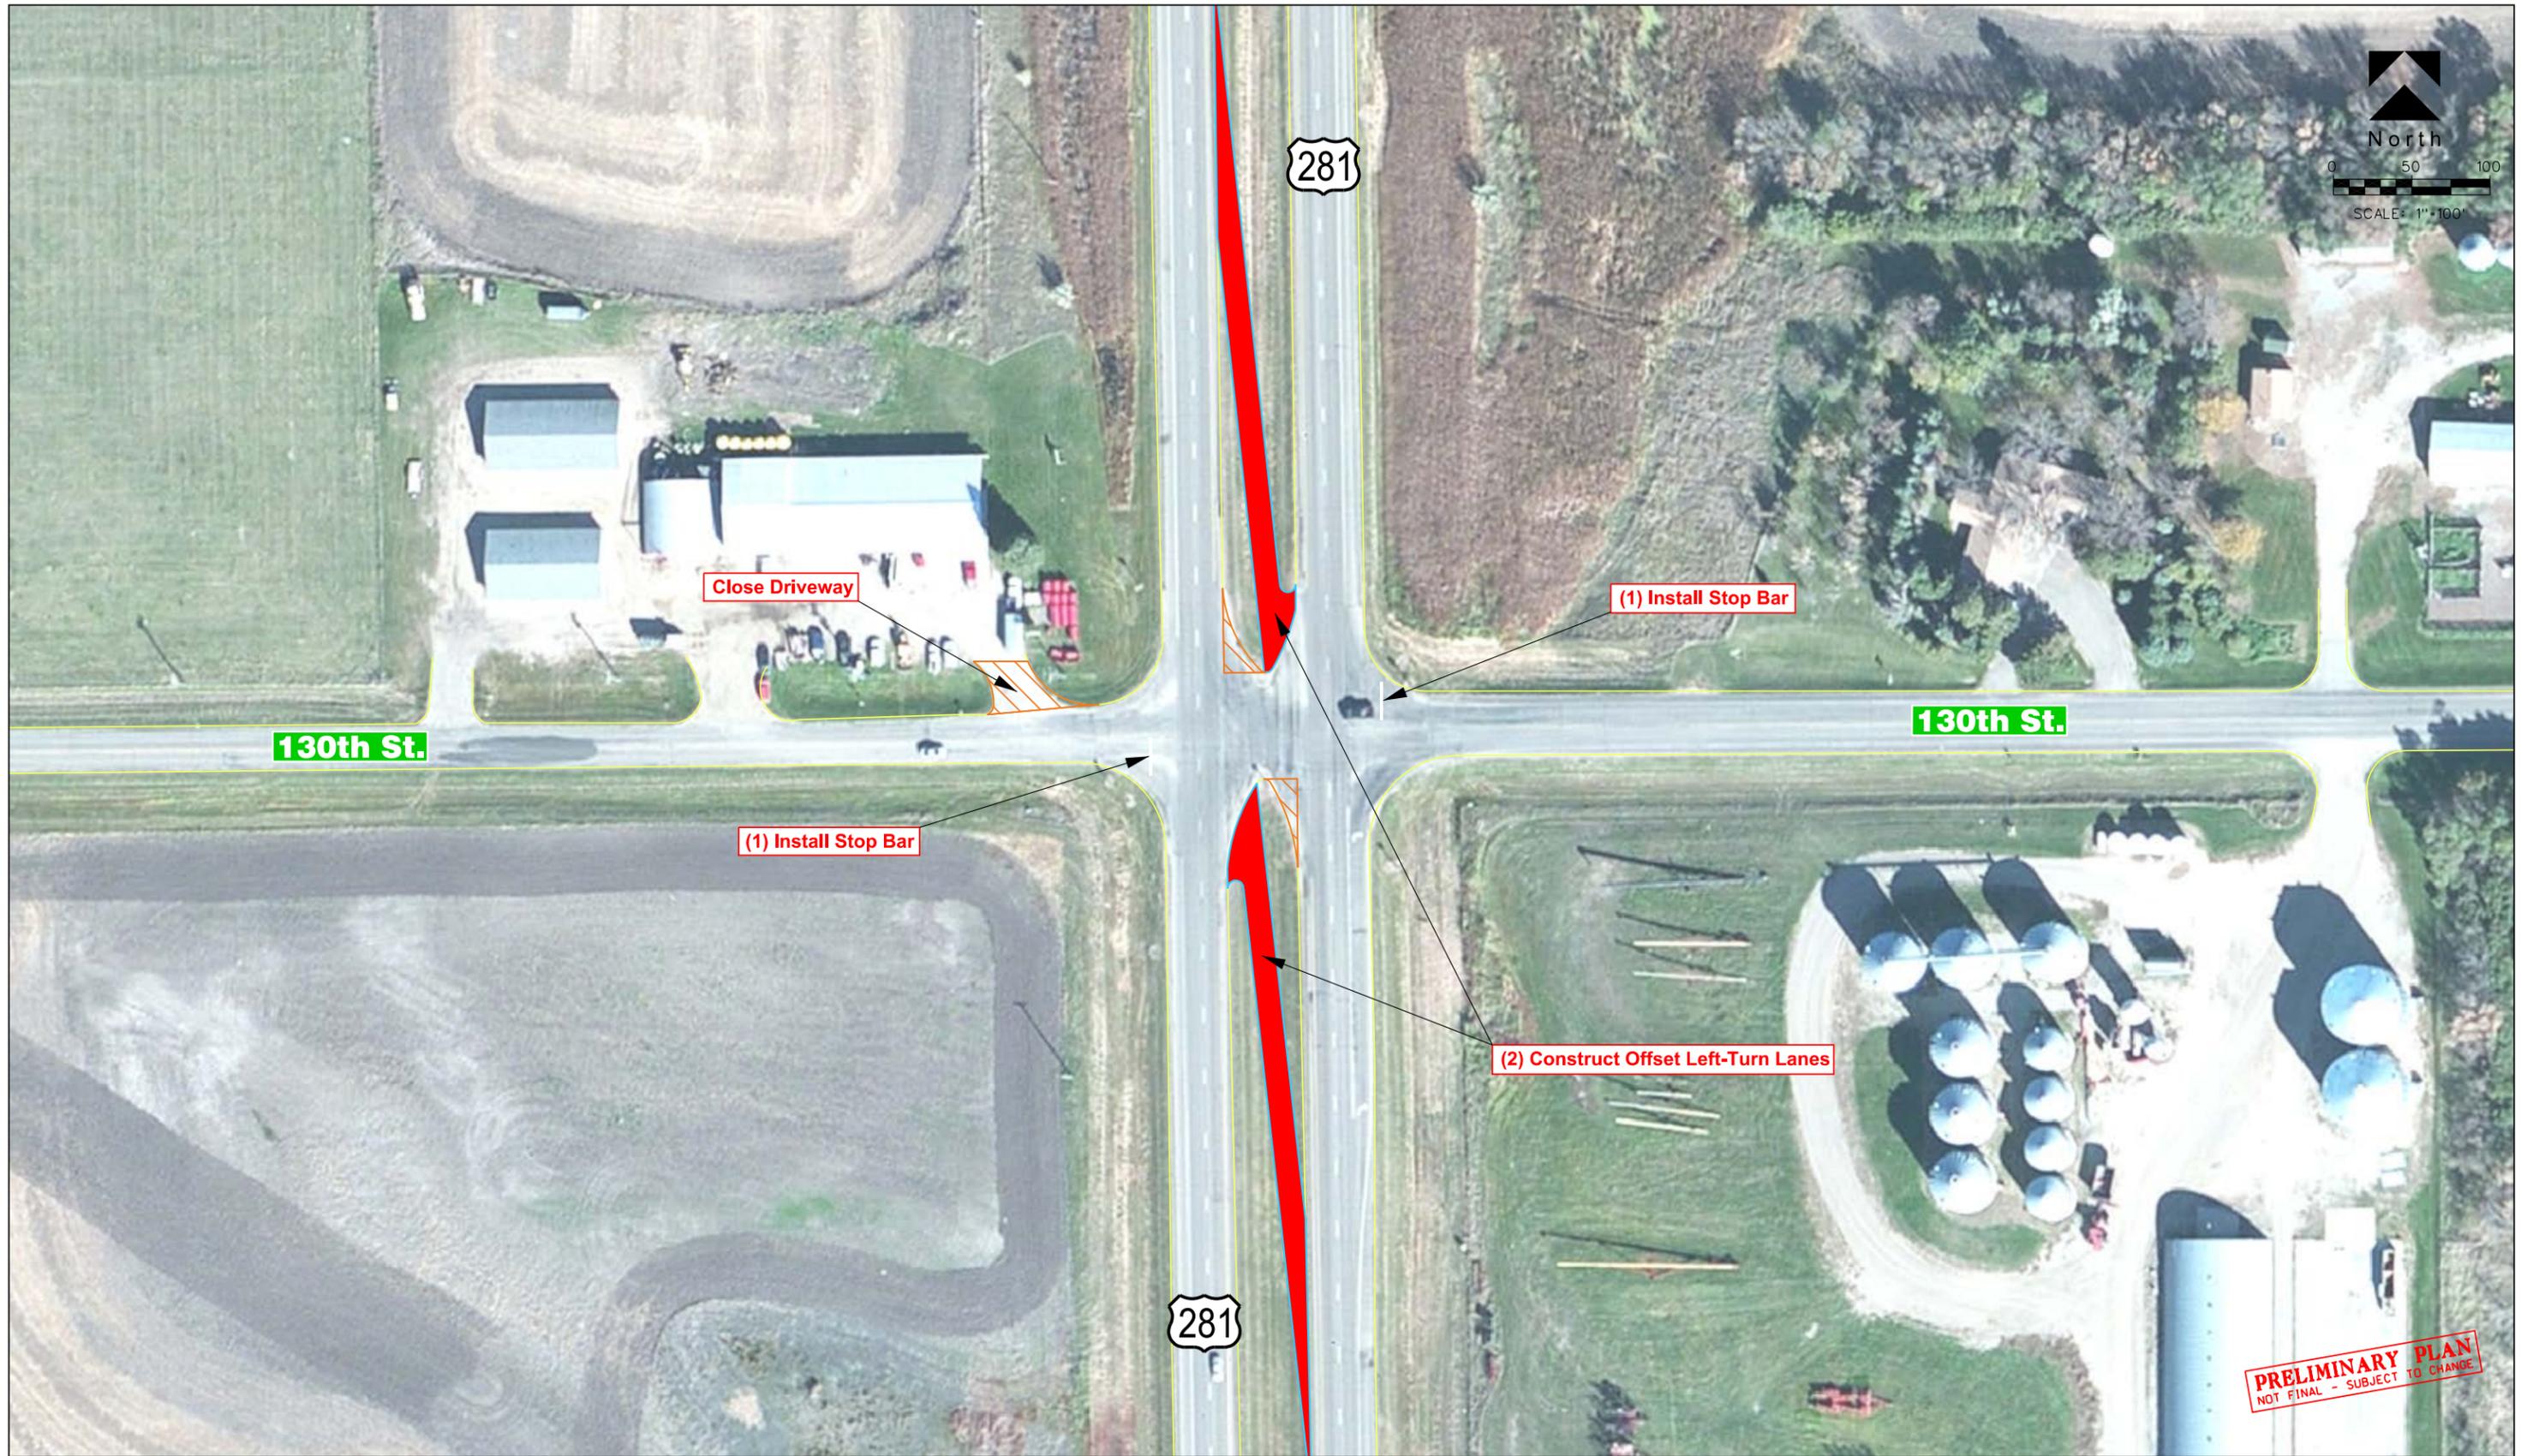
Figure 4.3
Intersection #4
Intersection Recommendations
US 281 / 130th Street

1 – It is recommended that north-south offset left-turn lanes be constructed at this intersection.

2 – It is recommended that Stop Bars be marked on the east-west approaches to the intersection.

3 – It is recommended that the driveway on the northwest corner of the intersection be closed to reduce the potential for conflicts.

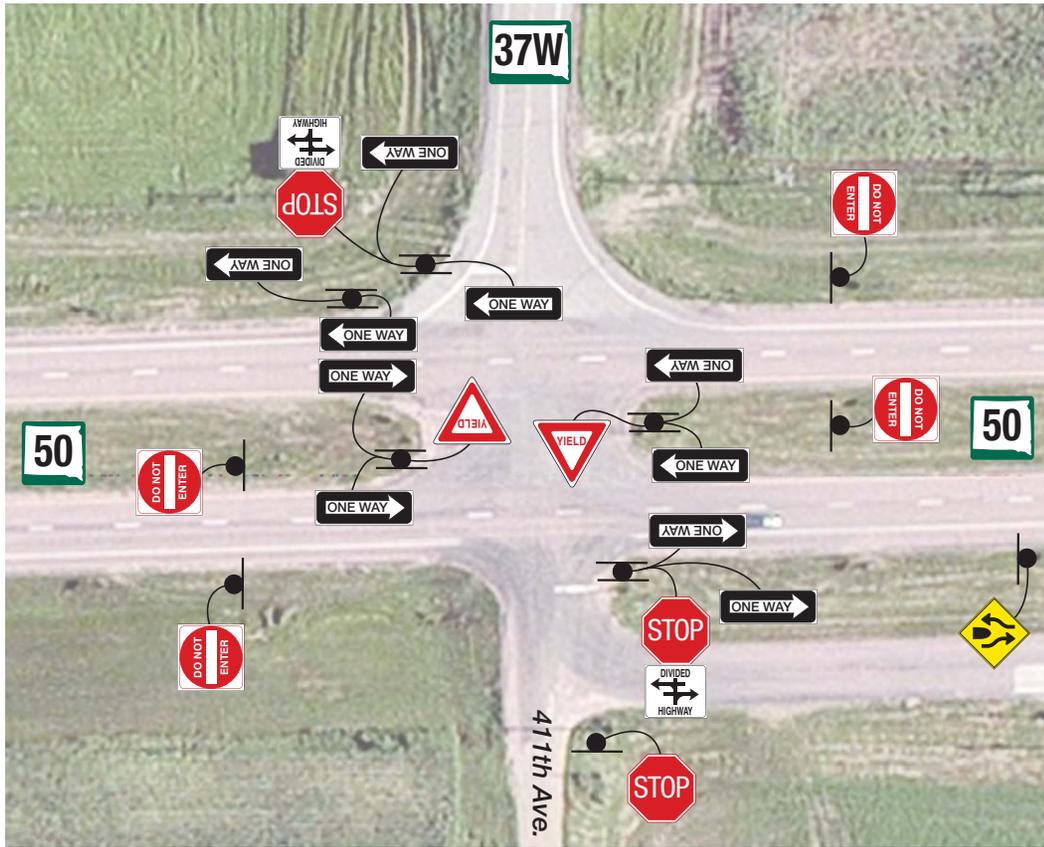
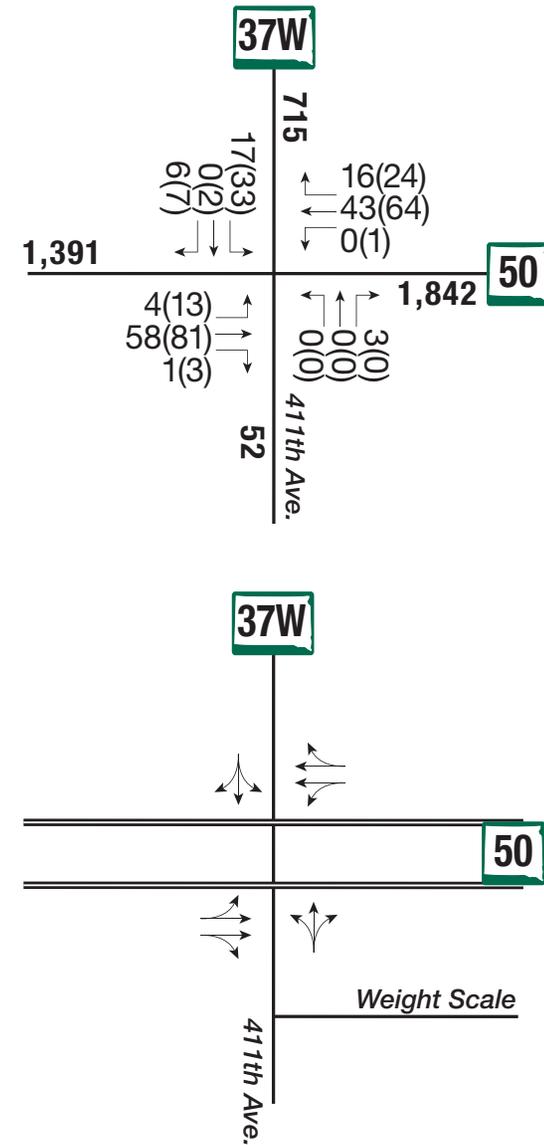
SD 50/SD 37W Traffic Conditions

The intersection has a truck percentage of 10%. Also shown on **Figure 5.1** are the lane geometry, traffic control, and signage for existing traffic conditions at the intersection.

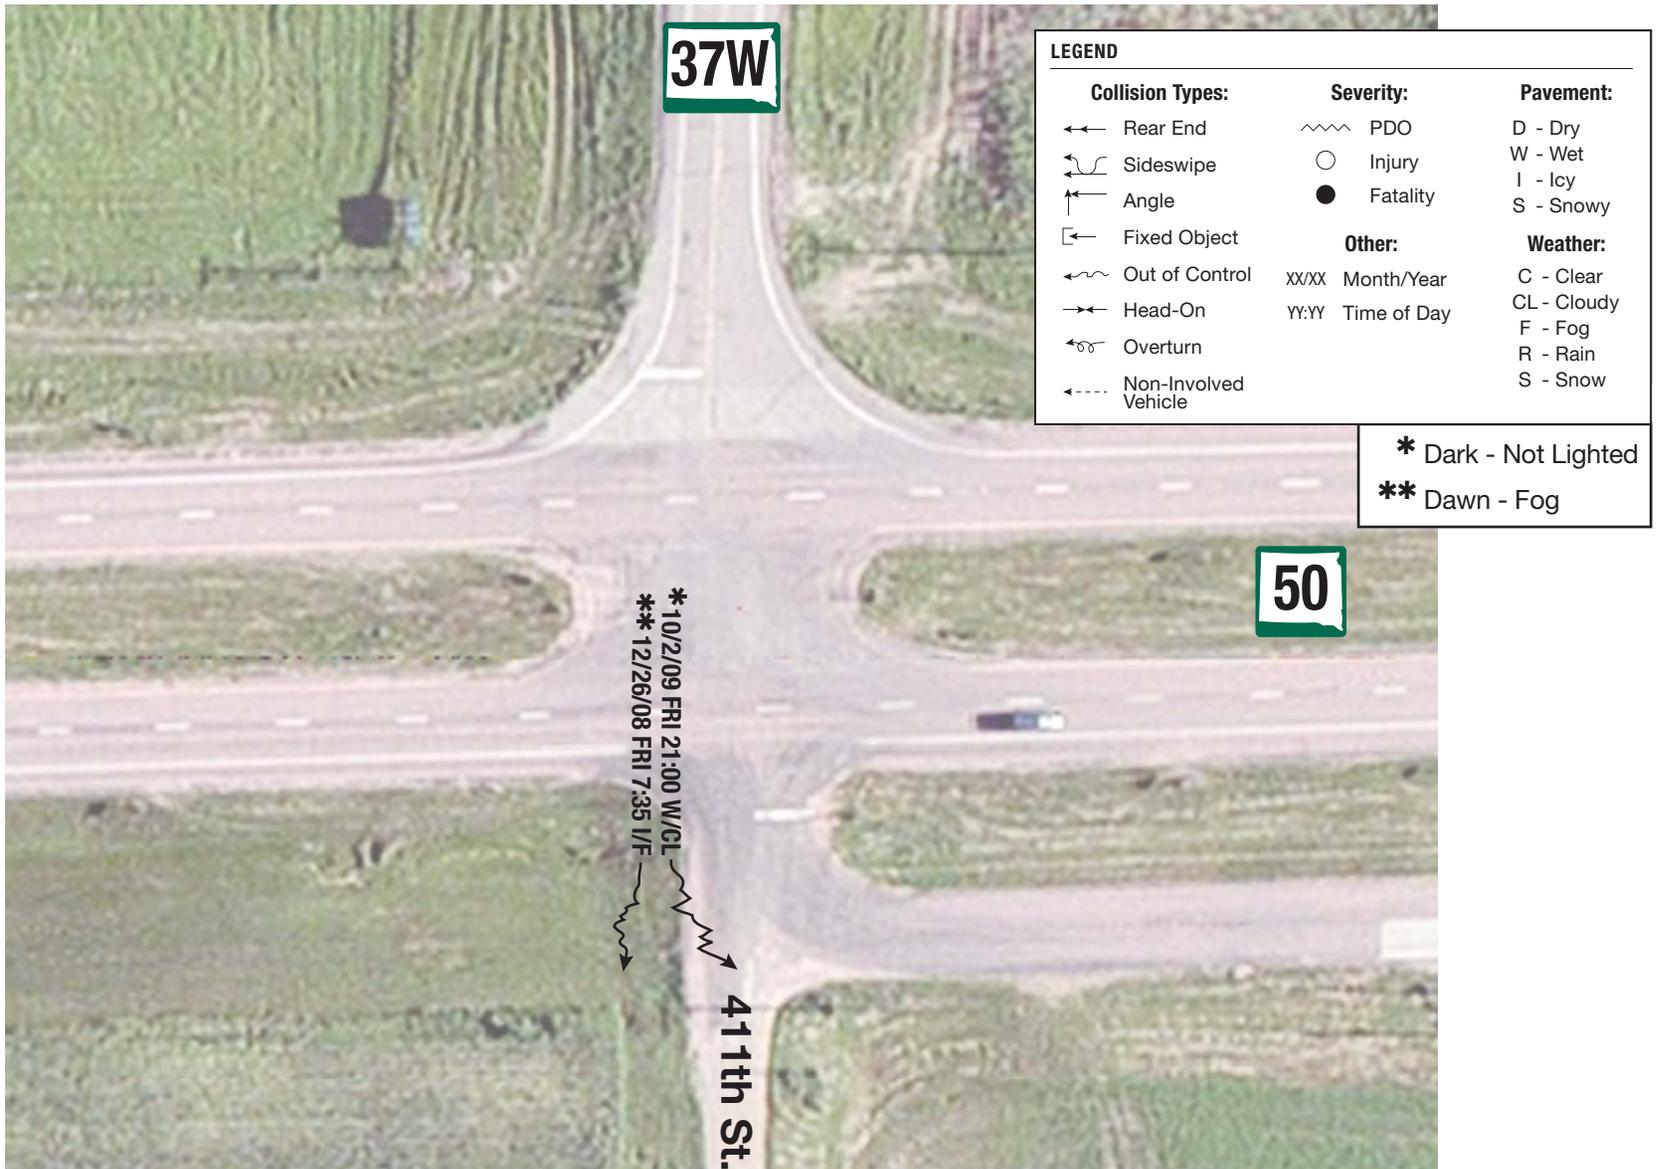
Figure 5.2
SD 50/SD 37W Crash Diagram

Crash Pattern	Contributing Factors	Countermeasures
Leave Roadway	<ul style="list-style-type: none"> • Visibility due to weather/ light conditions 	<ul style="list-style-type: none"> • Install Street Lighting
