SDDOT INTERSECTION SAFETY STUDY

South Dakota DOT
700 E. Broadway Ave.
Pierre, South Dakota 57501

Felsburg Holt & Ullevig
11422 Miracle Hills Drive, Suite 115
Omaha, Nebraska 68154
402-445-4405

FHU Reference No. 14-066
April 2015

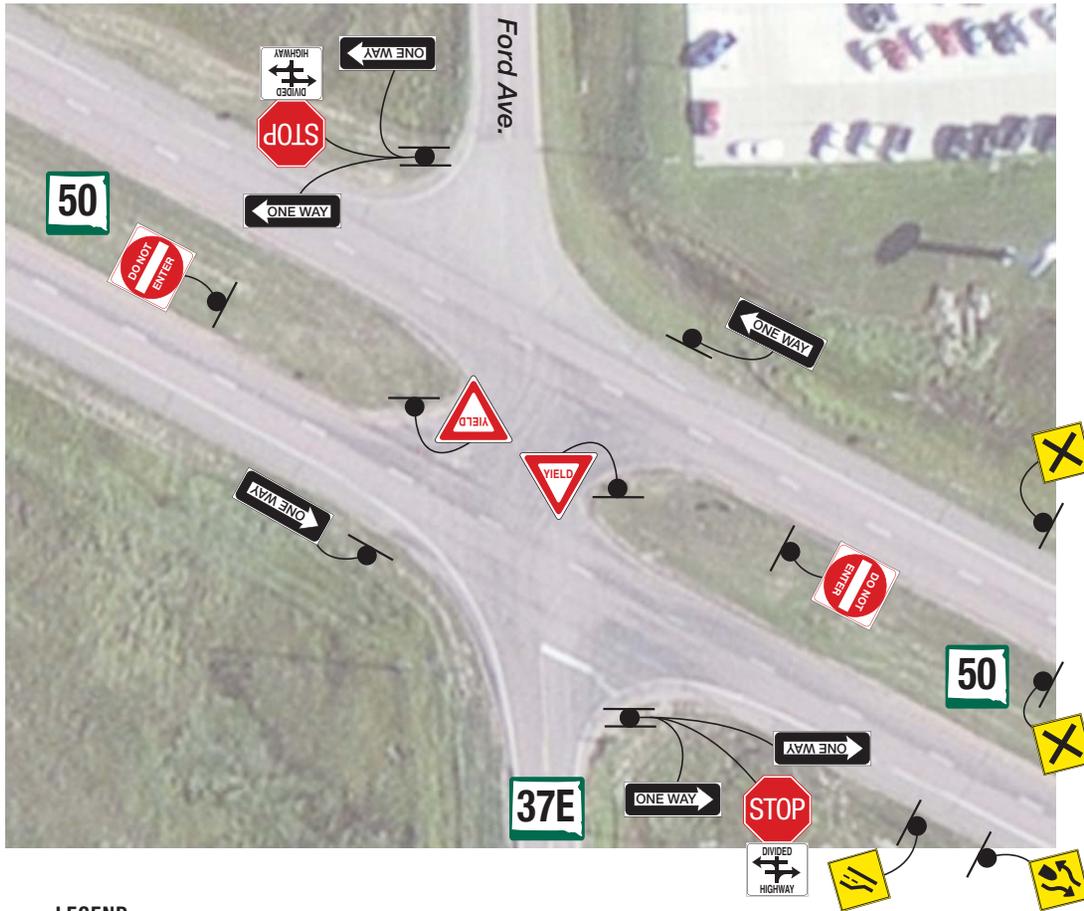
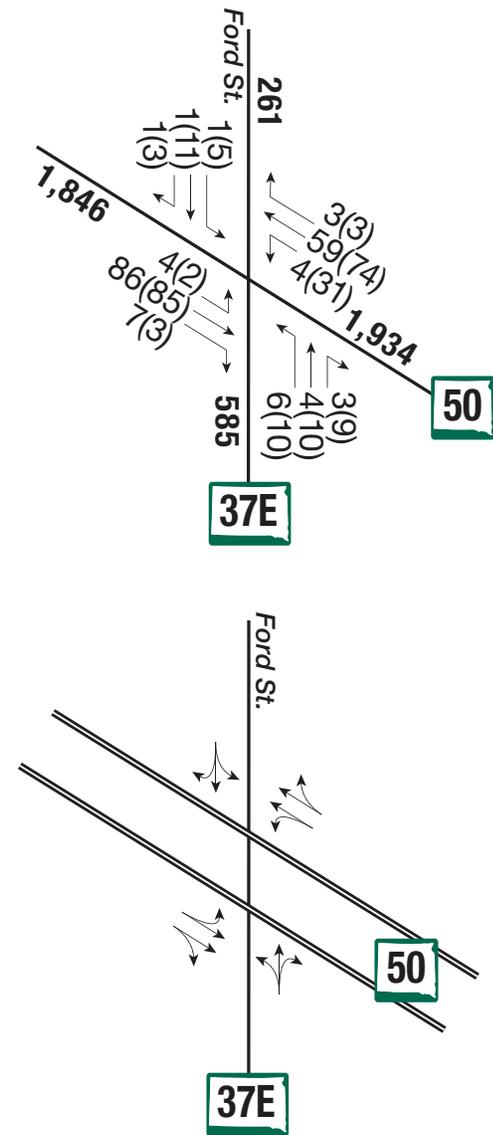
Figure 6.1
SD 50/SD 37E Traffic Conditions

The intersection has a truck percentage of 18%. Also shown on **Figure 6.1** are the lane geometry, traffic control, and signage for existing traffic conditions at the intersection.

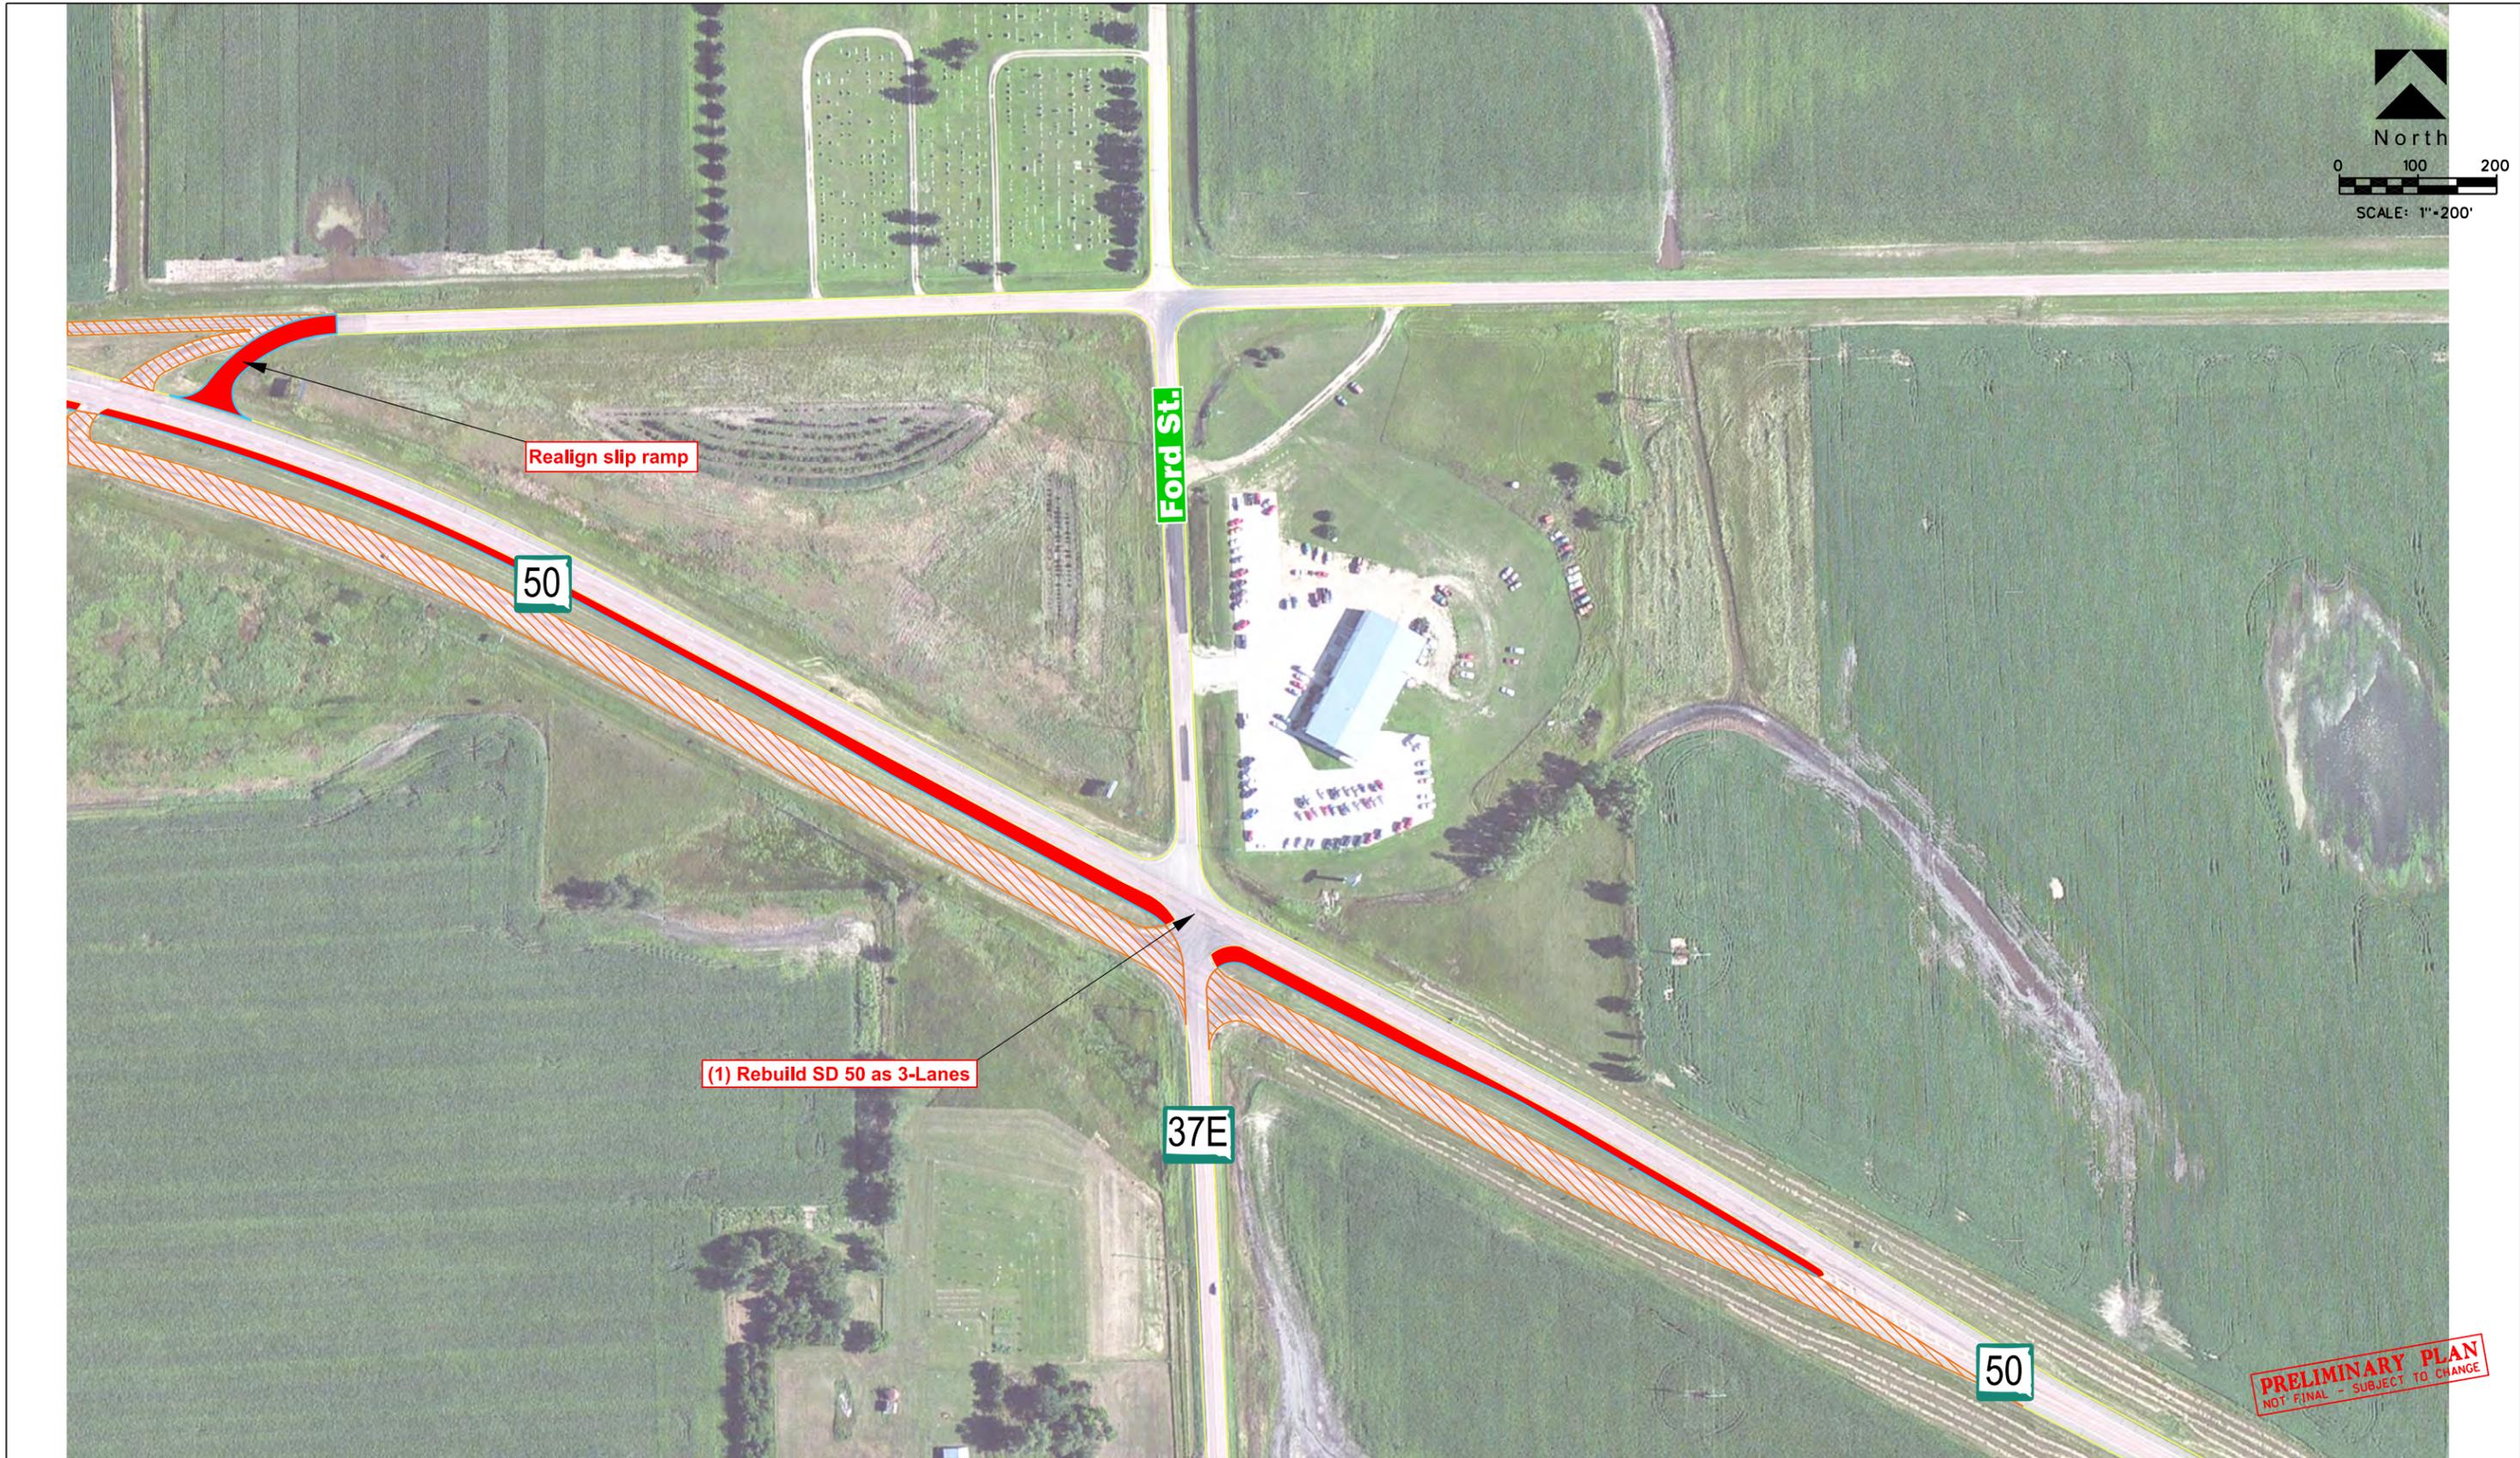
Figure 6.3
 Intersection #6
 Intersection Recommendations
 SD 50 / SD 37E

CONCEPTUAL DESIGN - OPTION 1

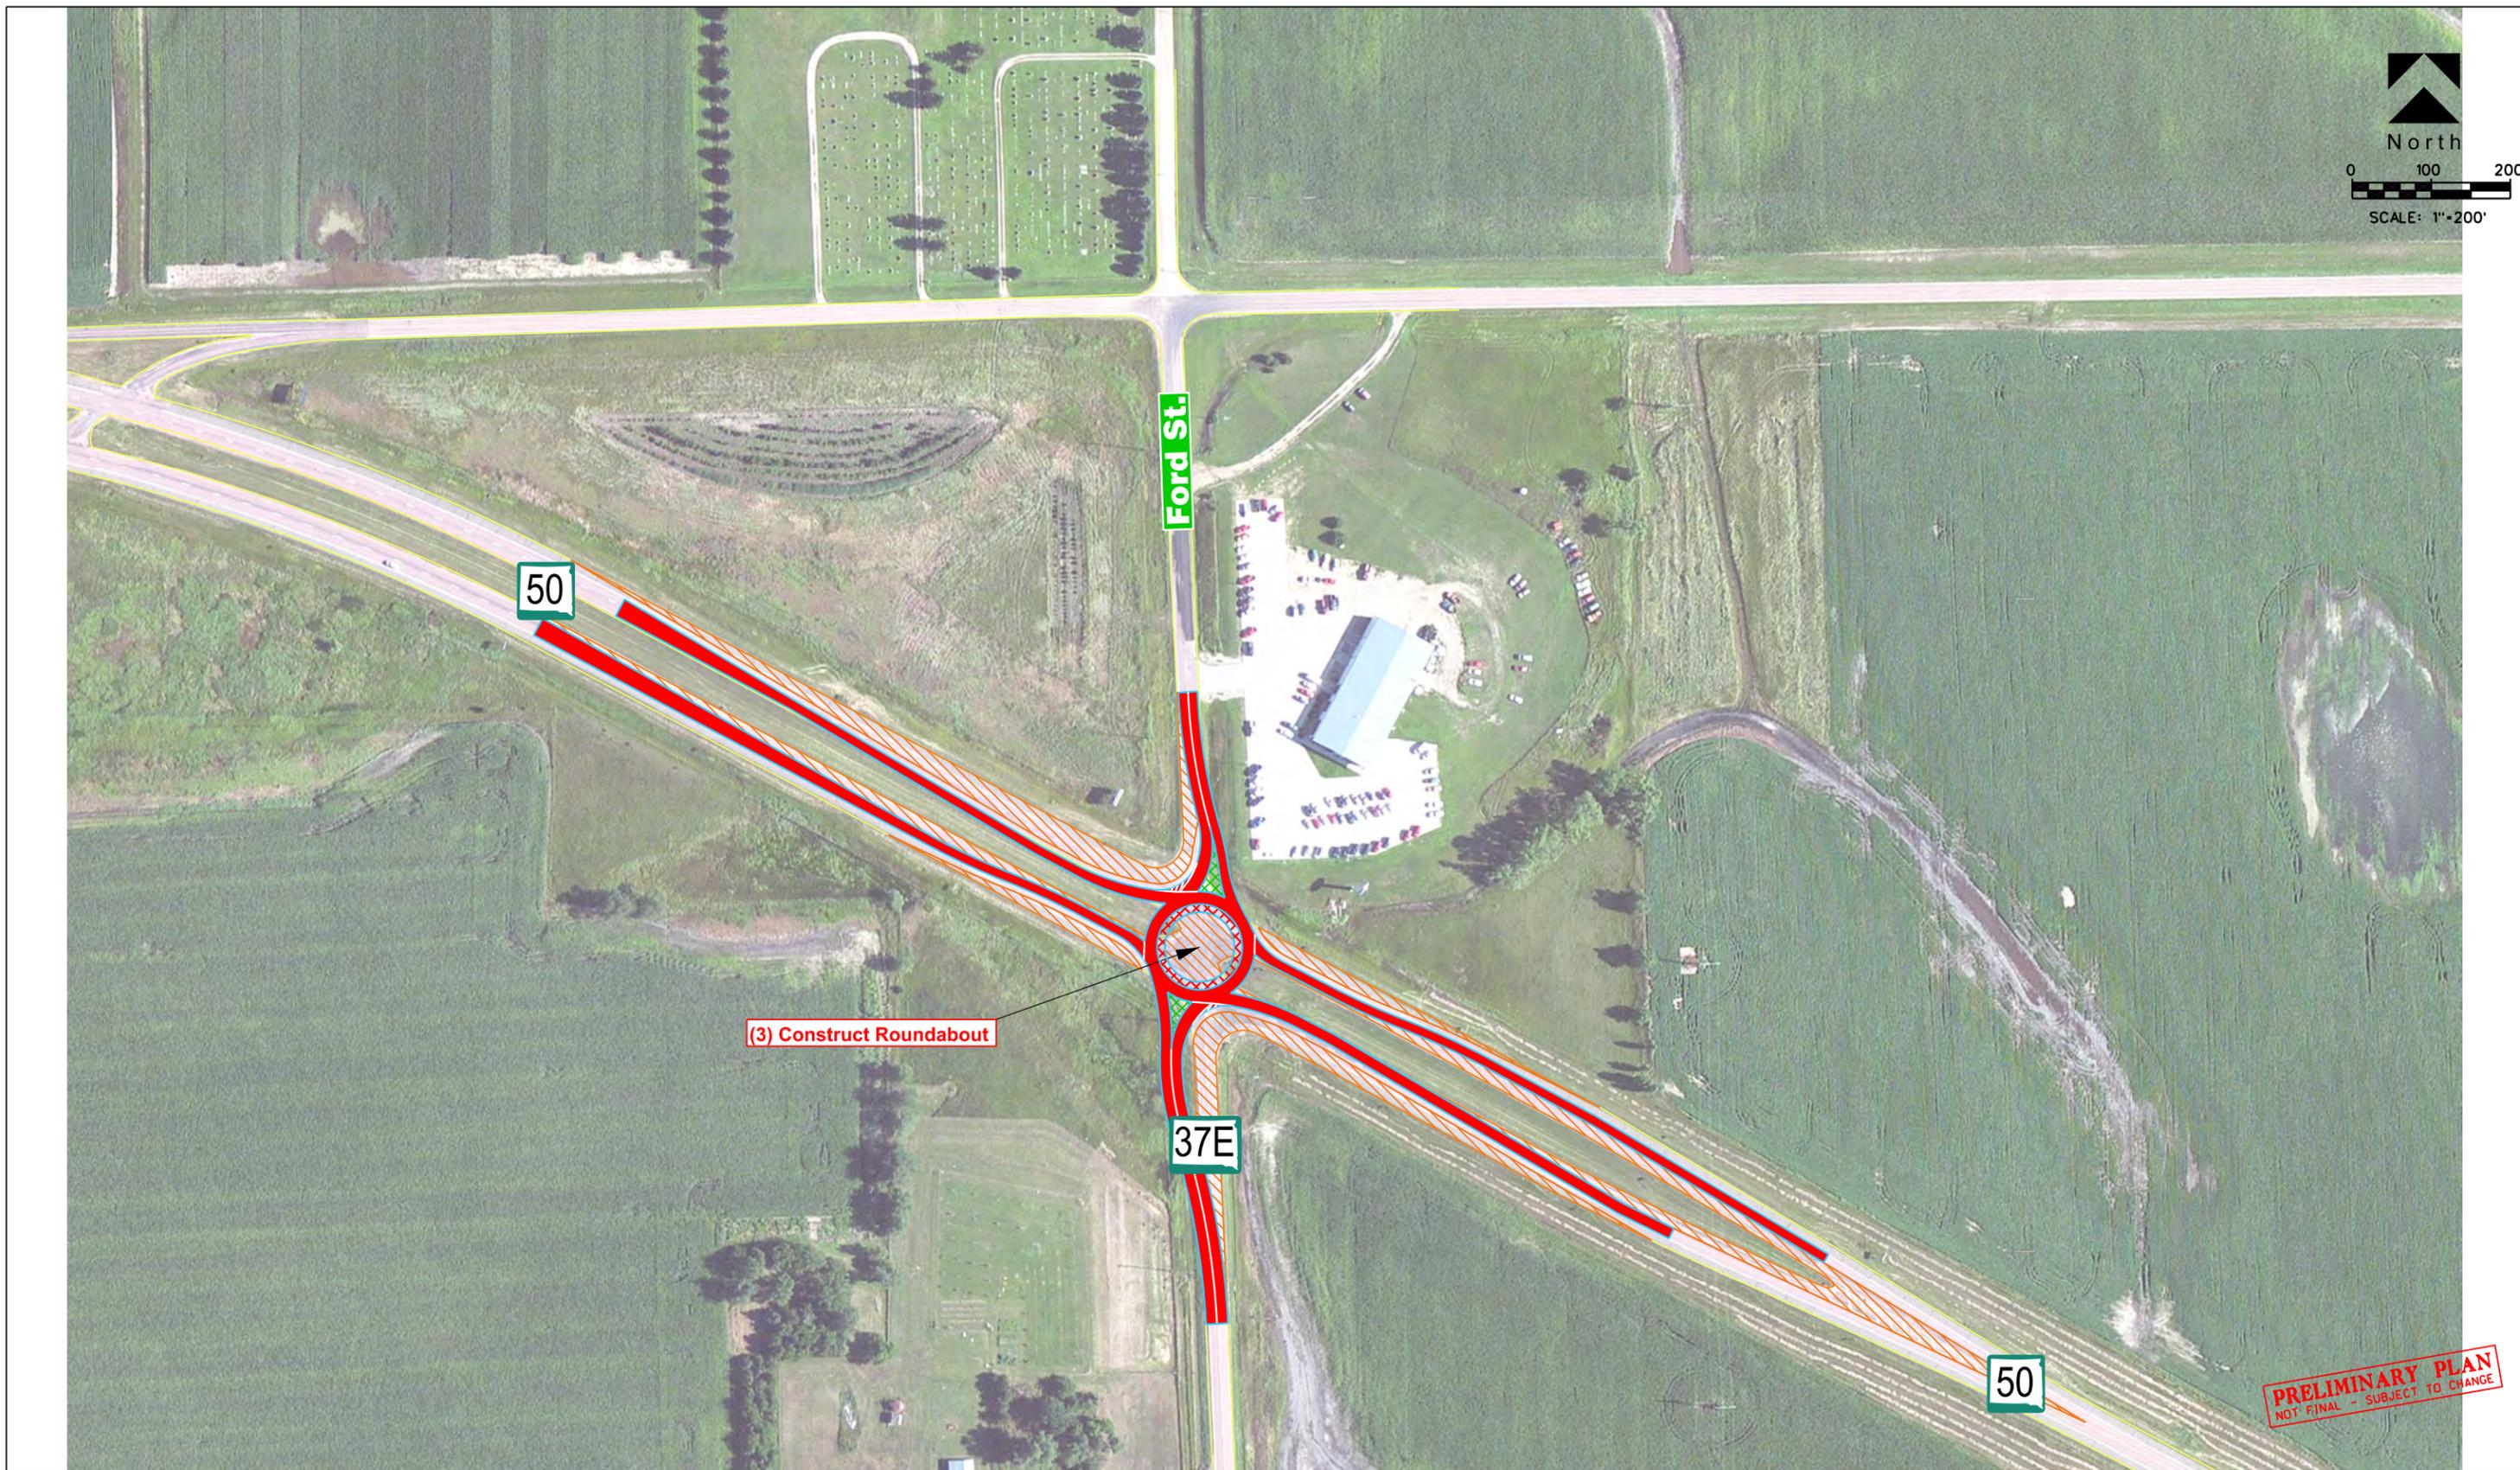
(3) Construct Roundabout

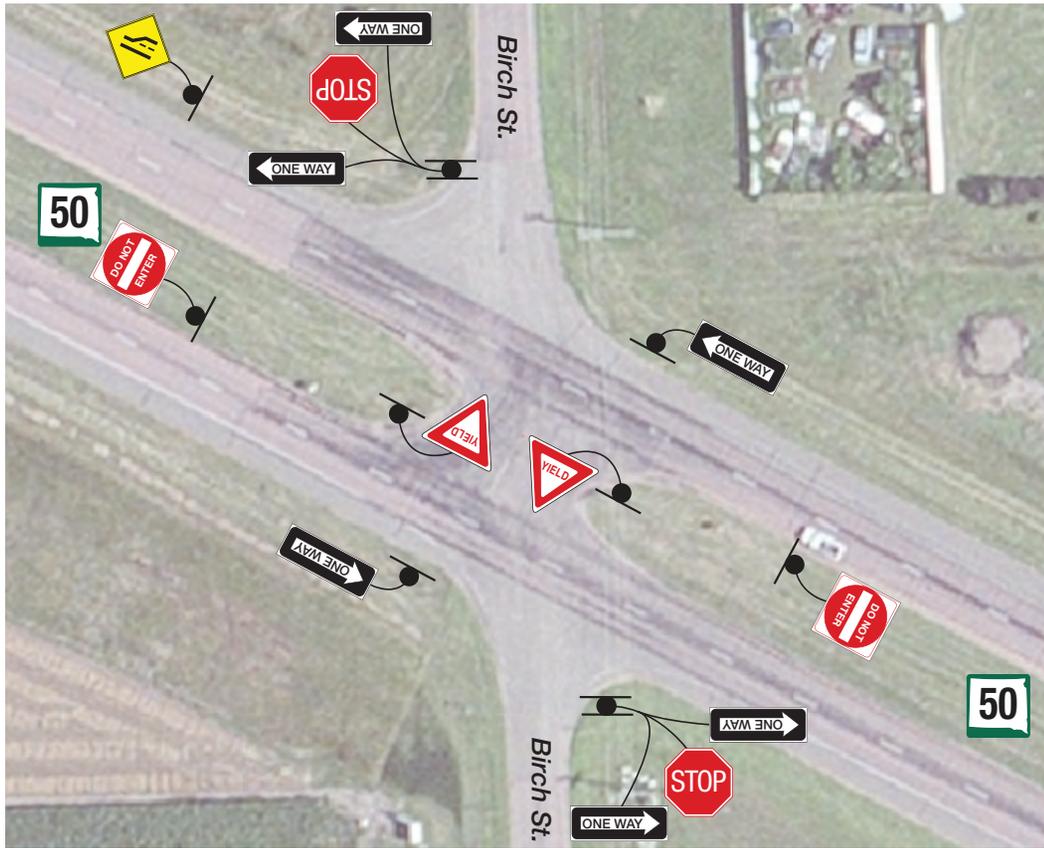
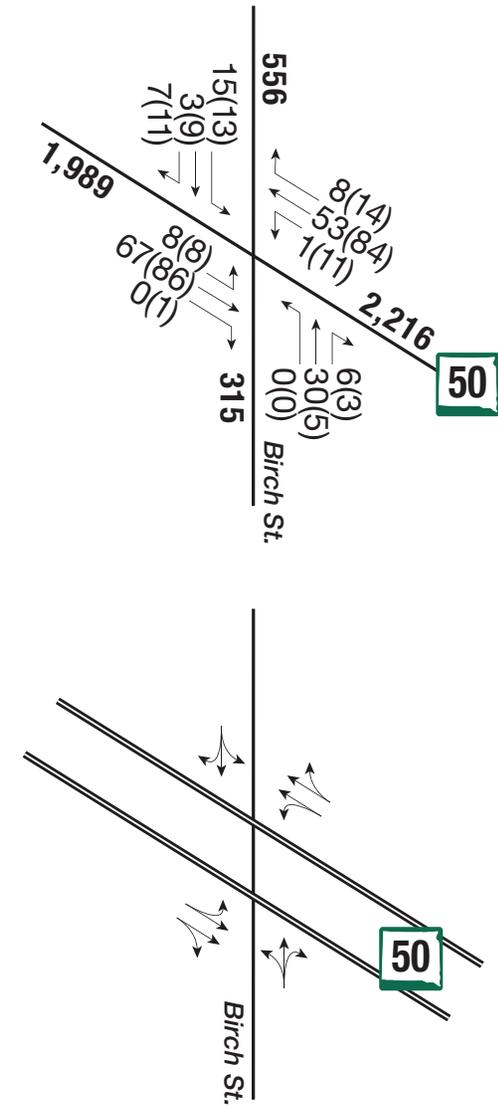
The intersection has a truck percentage of 17%. Also shown on **Figure 7.1** are the lane geometry, traffic control, and signage for existing traffic conditions at the intersection.

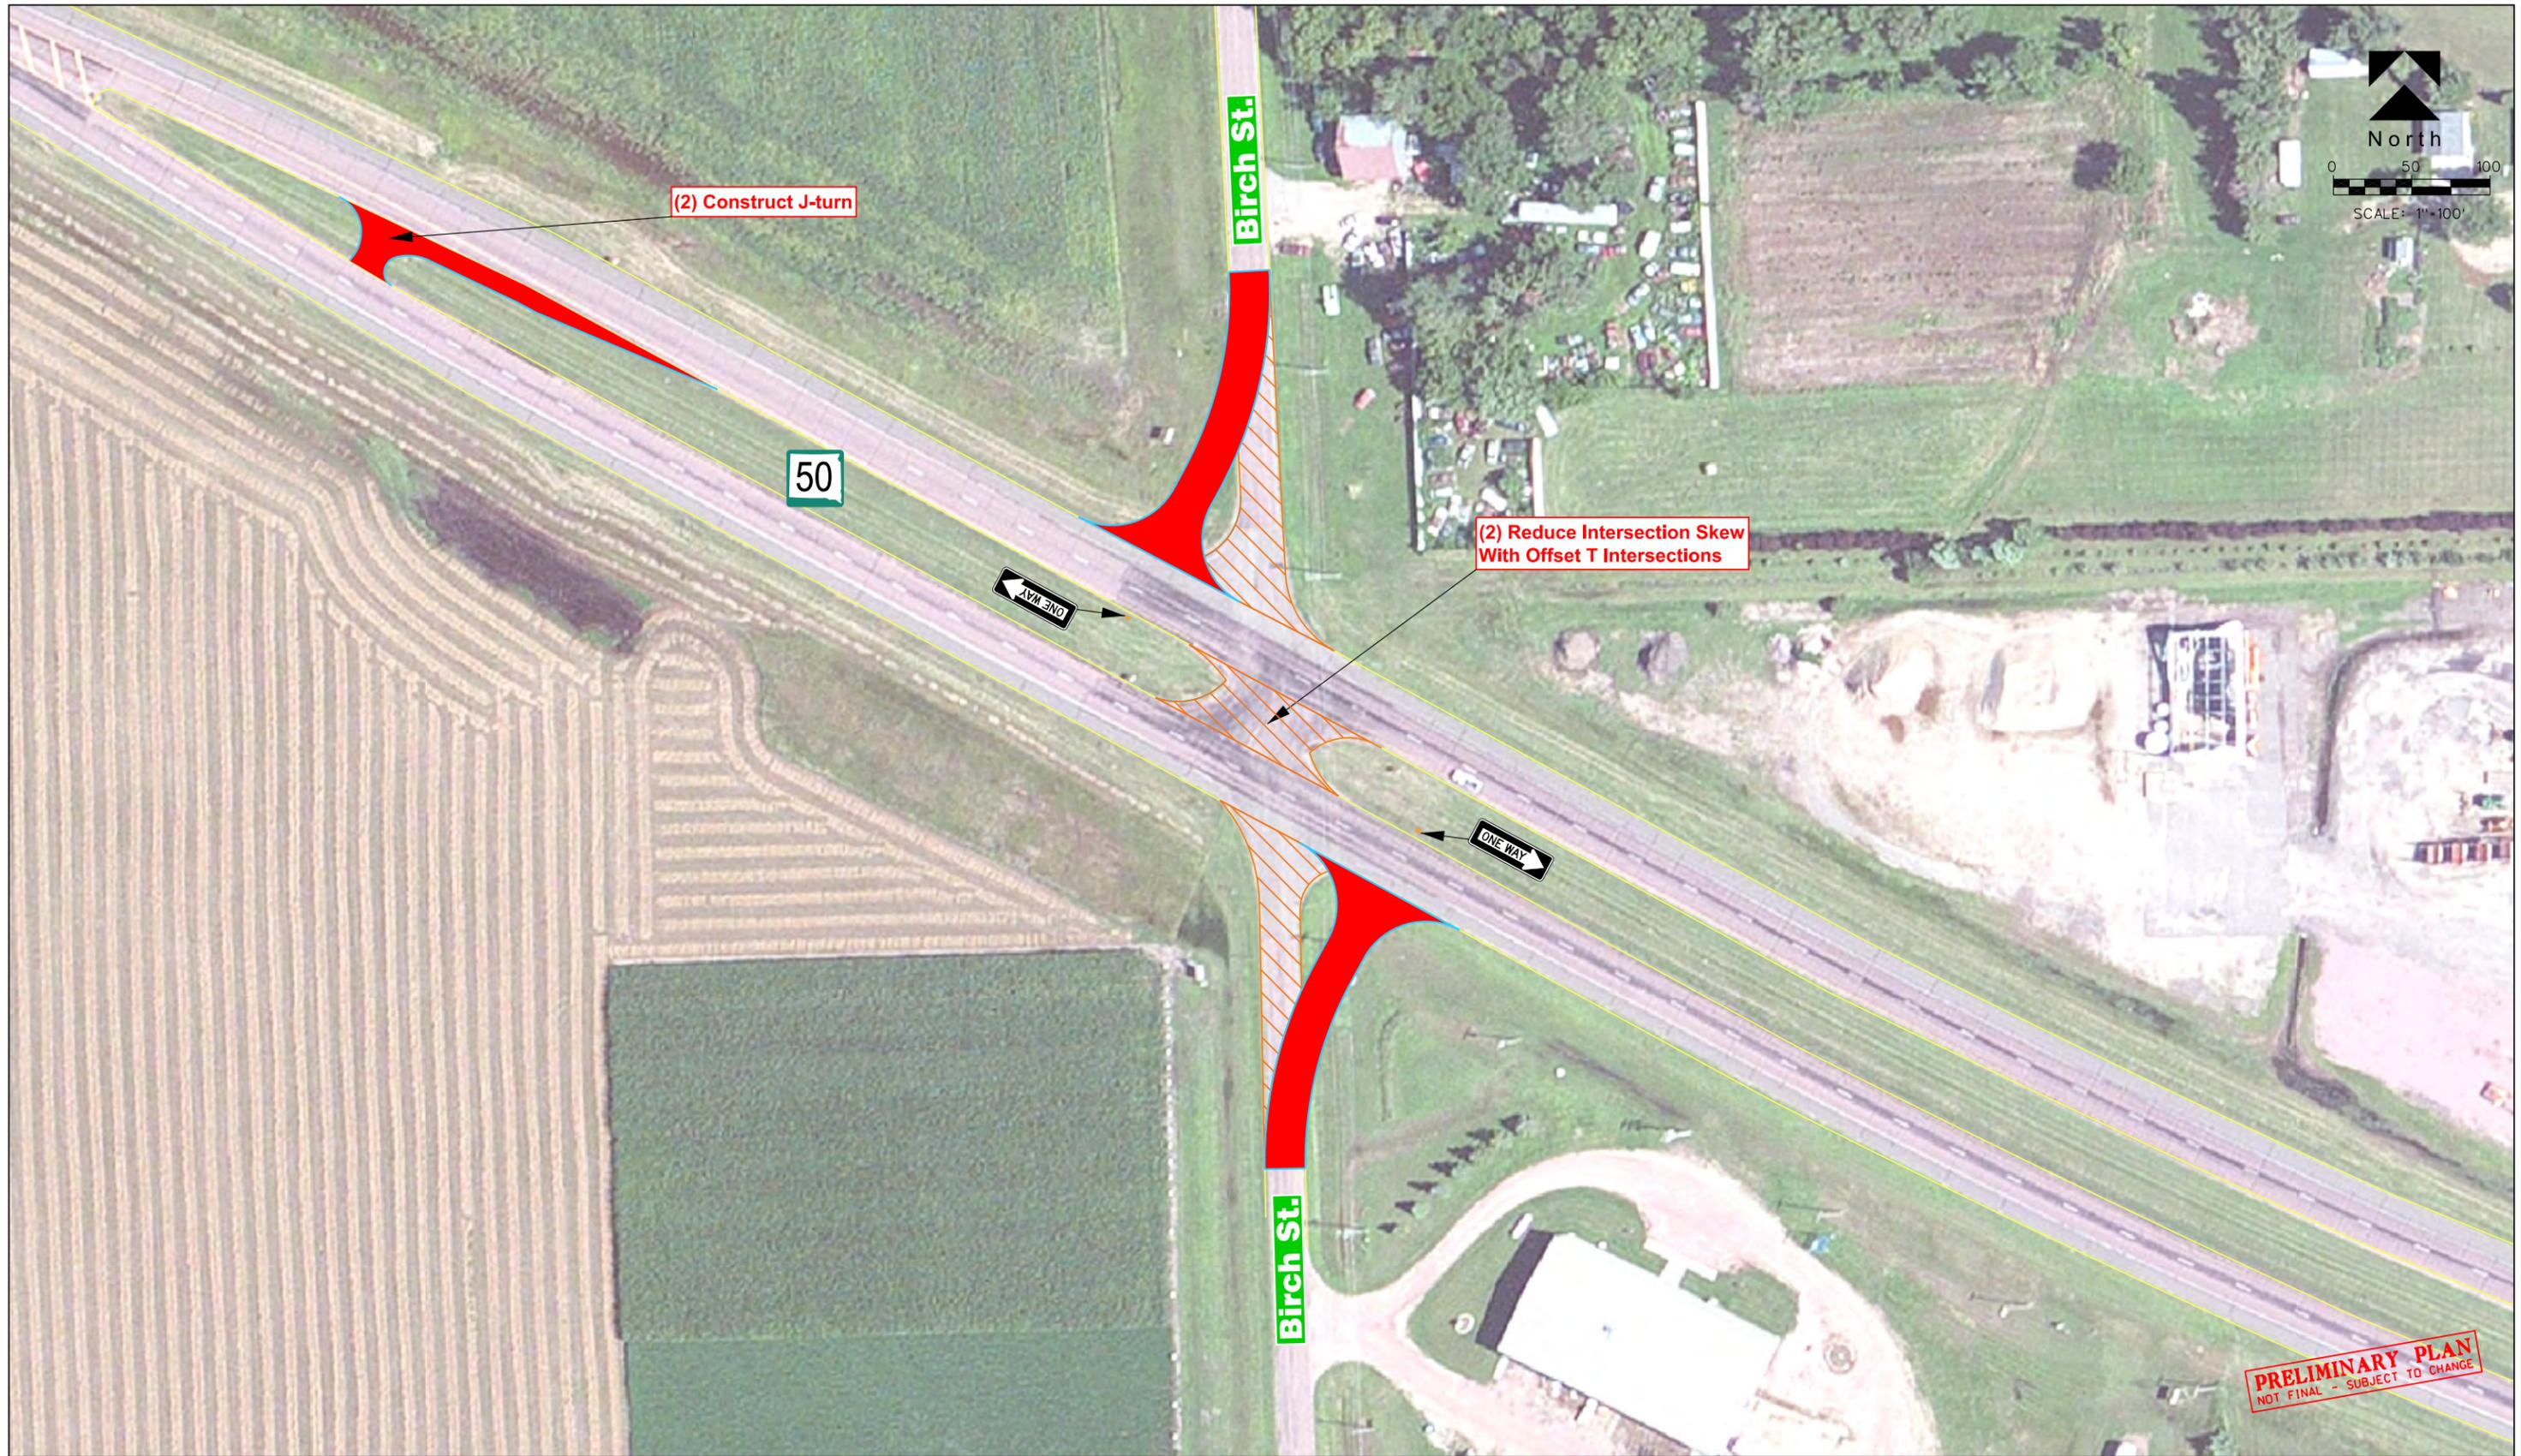
(2) Construct J-turn

(2) Reduce Intersection Skew
With Offset T Intersections

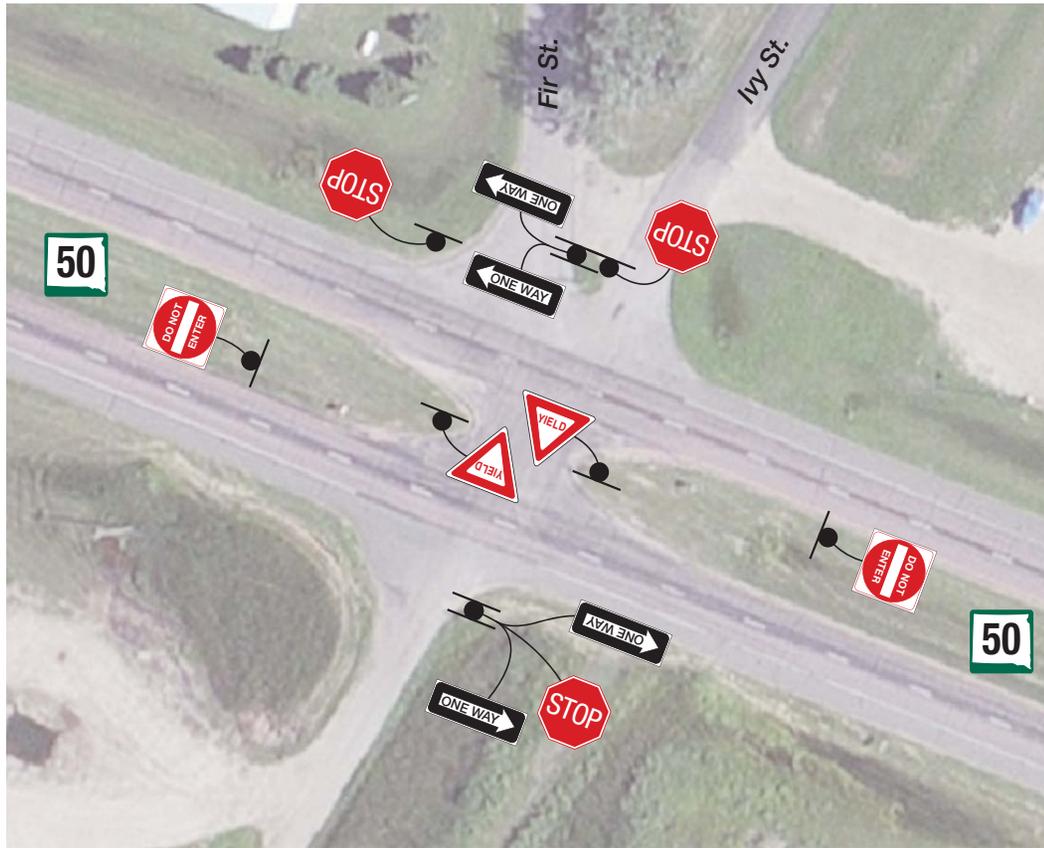
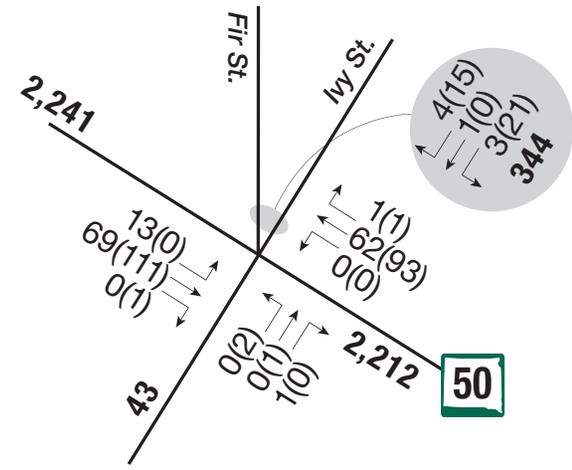
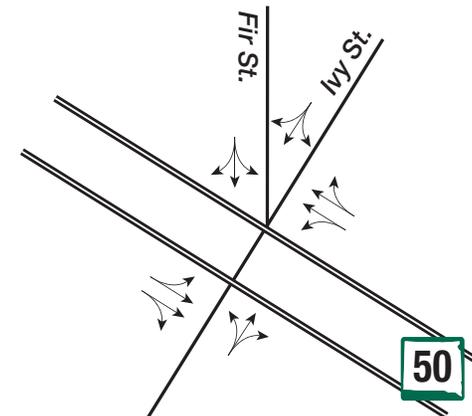
The intersection has a truck percentage of 16%. Also shown on **Figure 8.1** are the lane geometry, traffic control, and signage for existing traffic conditions at the intersection.

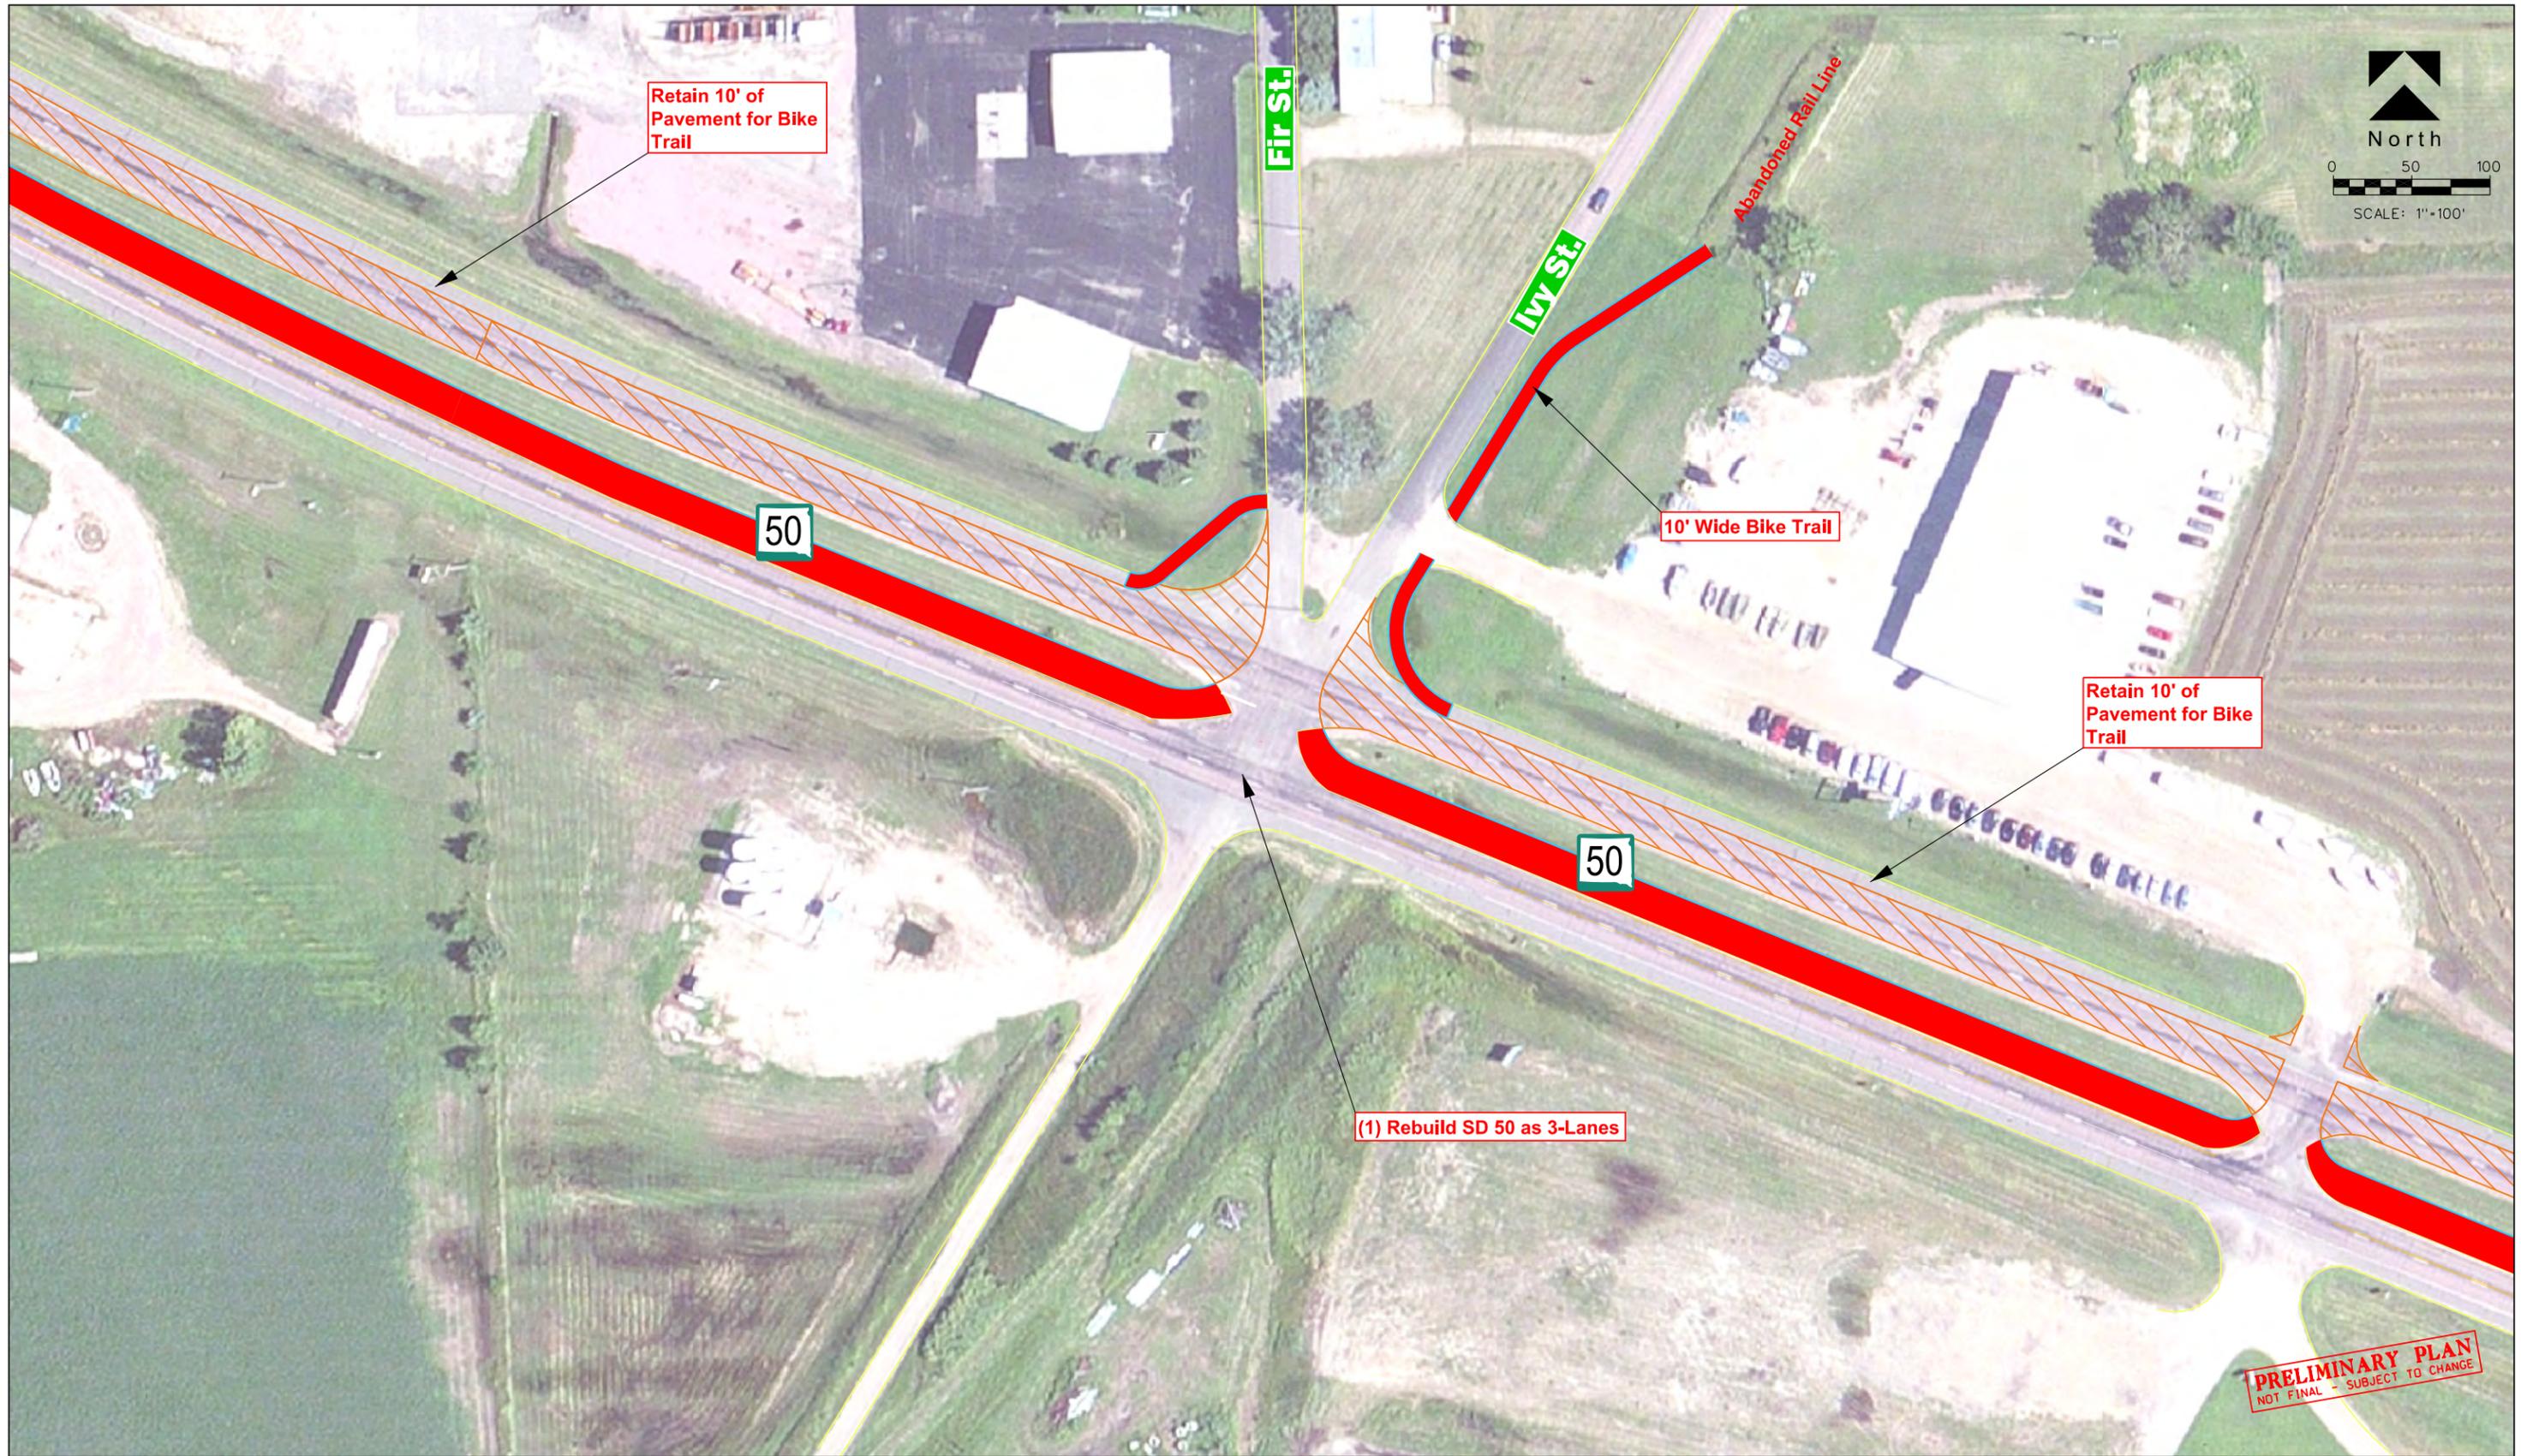
Figure 8.3
Intersection #8
Intersection Recommendations
SD 50 / Fir/Ivy Street

2 – It is recommended that SD 50 be reconstructed from a 4-lane to 3-lane roadway as part of a future rehabilitation project. The cost savings for resurfacing only part of the existing 4-lane roadway together with the reduced maintenance costs should be included in the analysis. This will increase the Benefit/Cost Ratio. (1)

Retain 10' of Pavement for Bike Trail

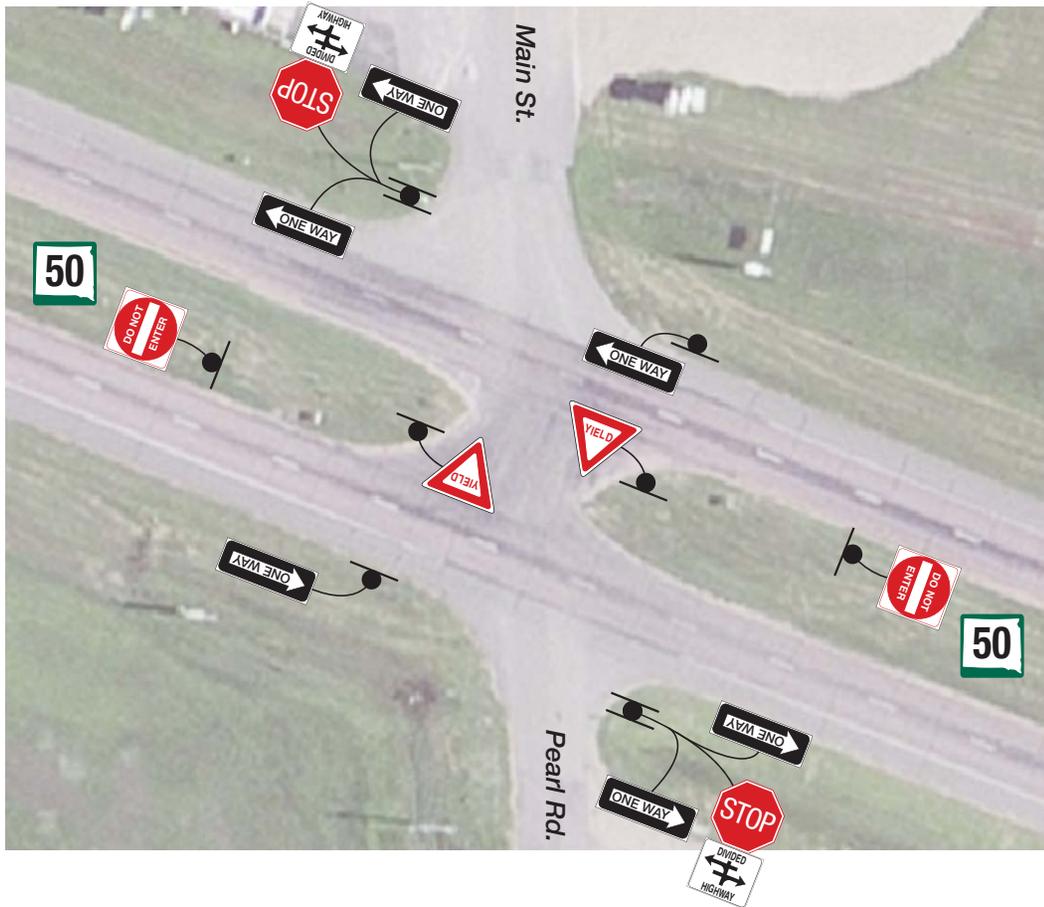
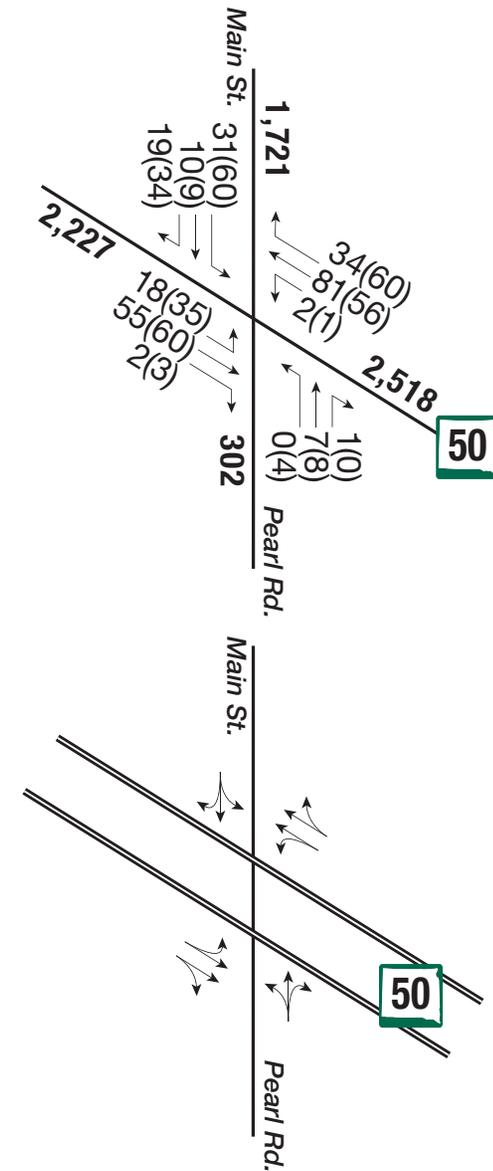
The intersection has a truck percentage of 13%. Also shown on **Figure 9.1** are the lane geometry, traffic control, and signage for existing traffic conditions at the intersection.

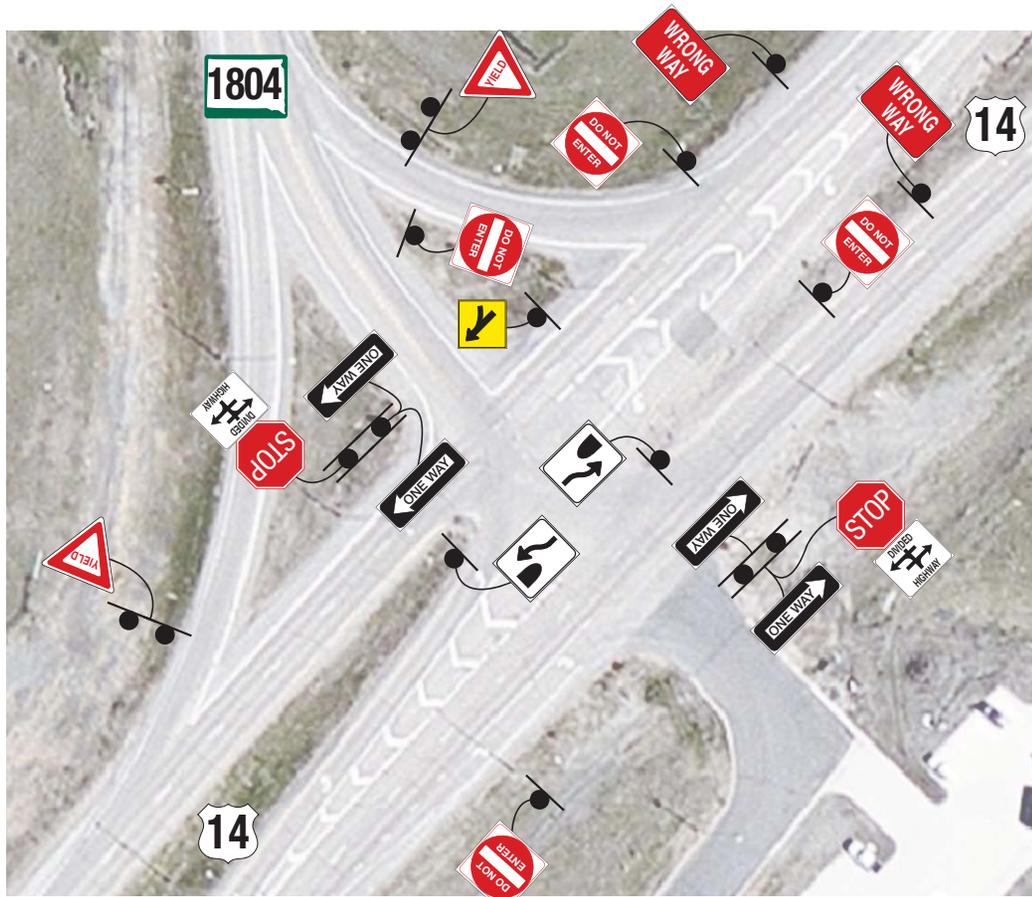
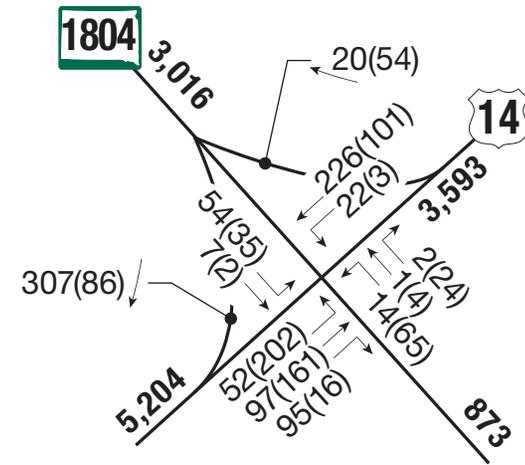
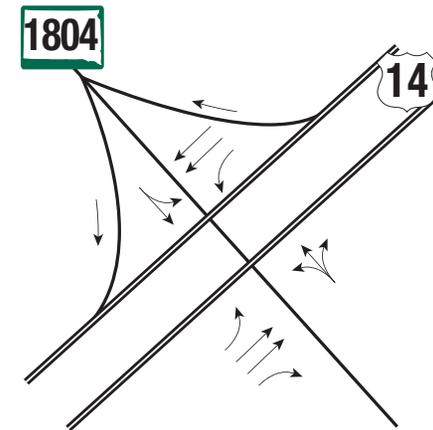
The heaviest peak hour turning movements were the southbound to westbound right turn in the AM (307) and the complimentary eastbound to northbound left turn in the PM (202). The intersection has a truck percentage of 3%. Also shown on **Figure 10.1** are the lane geometry, traffic control, and signage for existing traffic conditions at the intersection.
