SDDOT INTERSECTION SAFETY STUDY

South Dakota DOT
700 E. Broadway Ave.
Pierre, South Dakota 57501

Felsburg Holt & Ullevig
11422 Miracle Hills Drive, Suite 115
Omaha, Nebraska 68154
402-445-4405

FHU Reference No. 14-066
April 2015

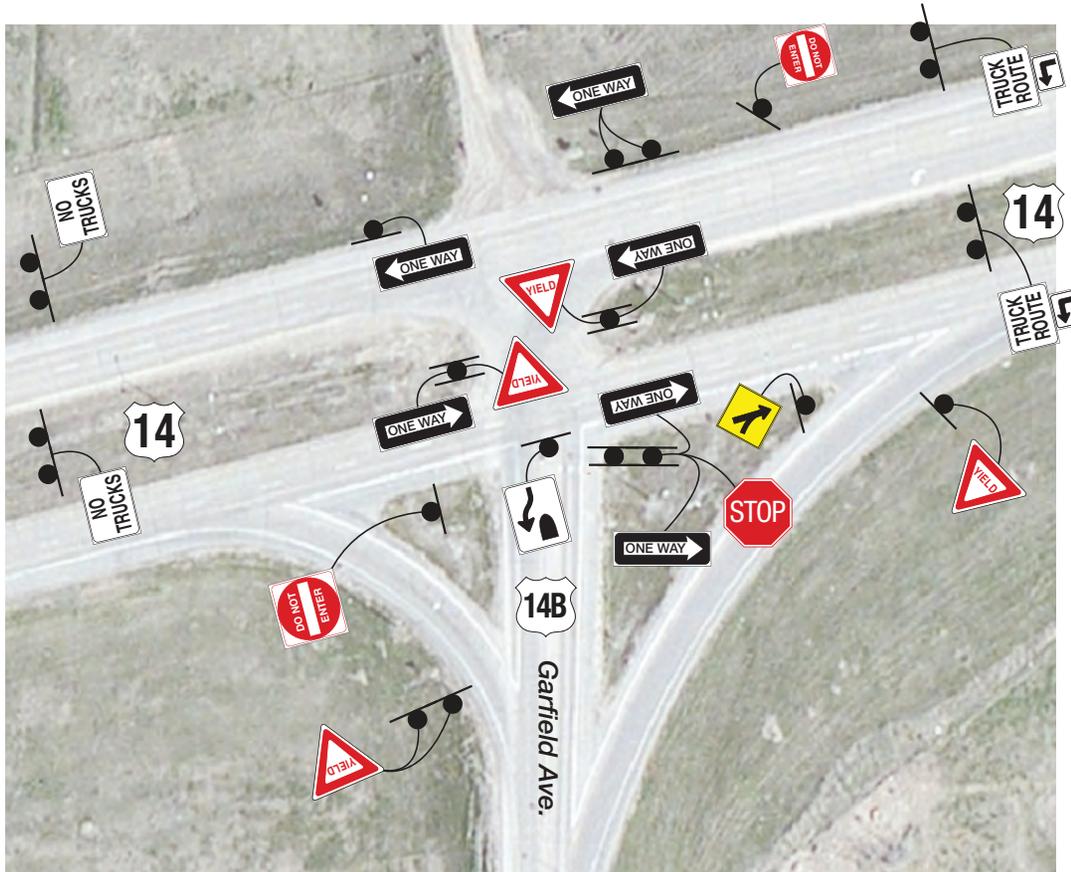
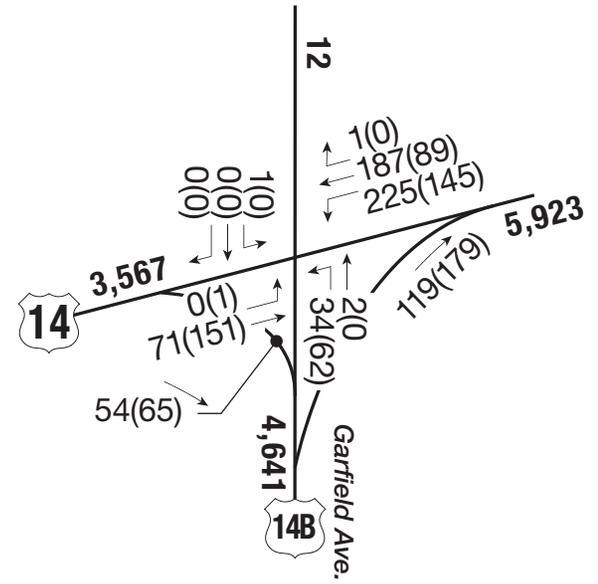
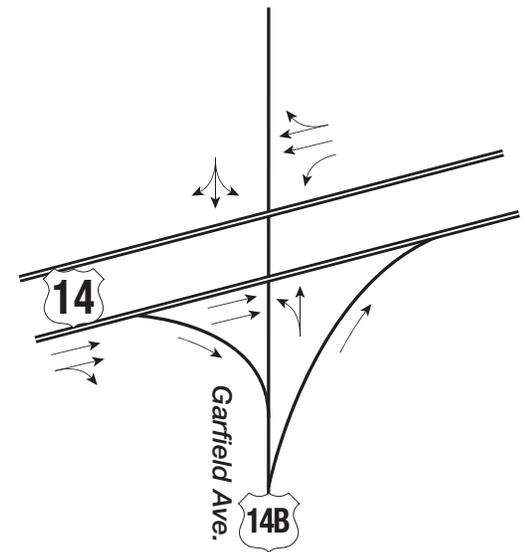
The intersection has an overall truck percentage of 15%. The westbound left turn movement and the northbound right turn have 12% and 19% truck turning percentages respectively. Also shown on **Figure 11W.1** are the lane geometry, traffic control, and signage for existing traffic conditions at the intersection.

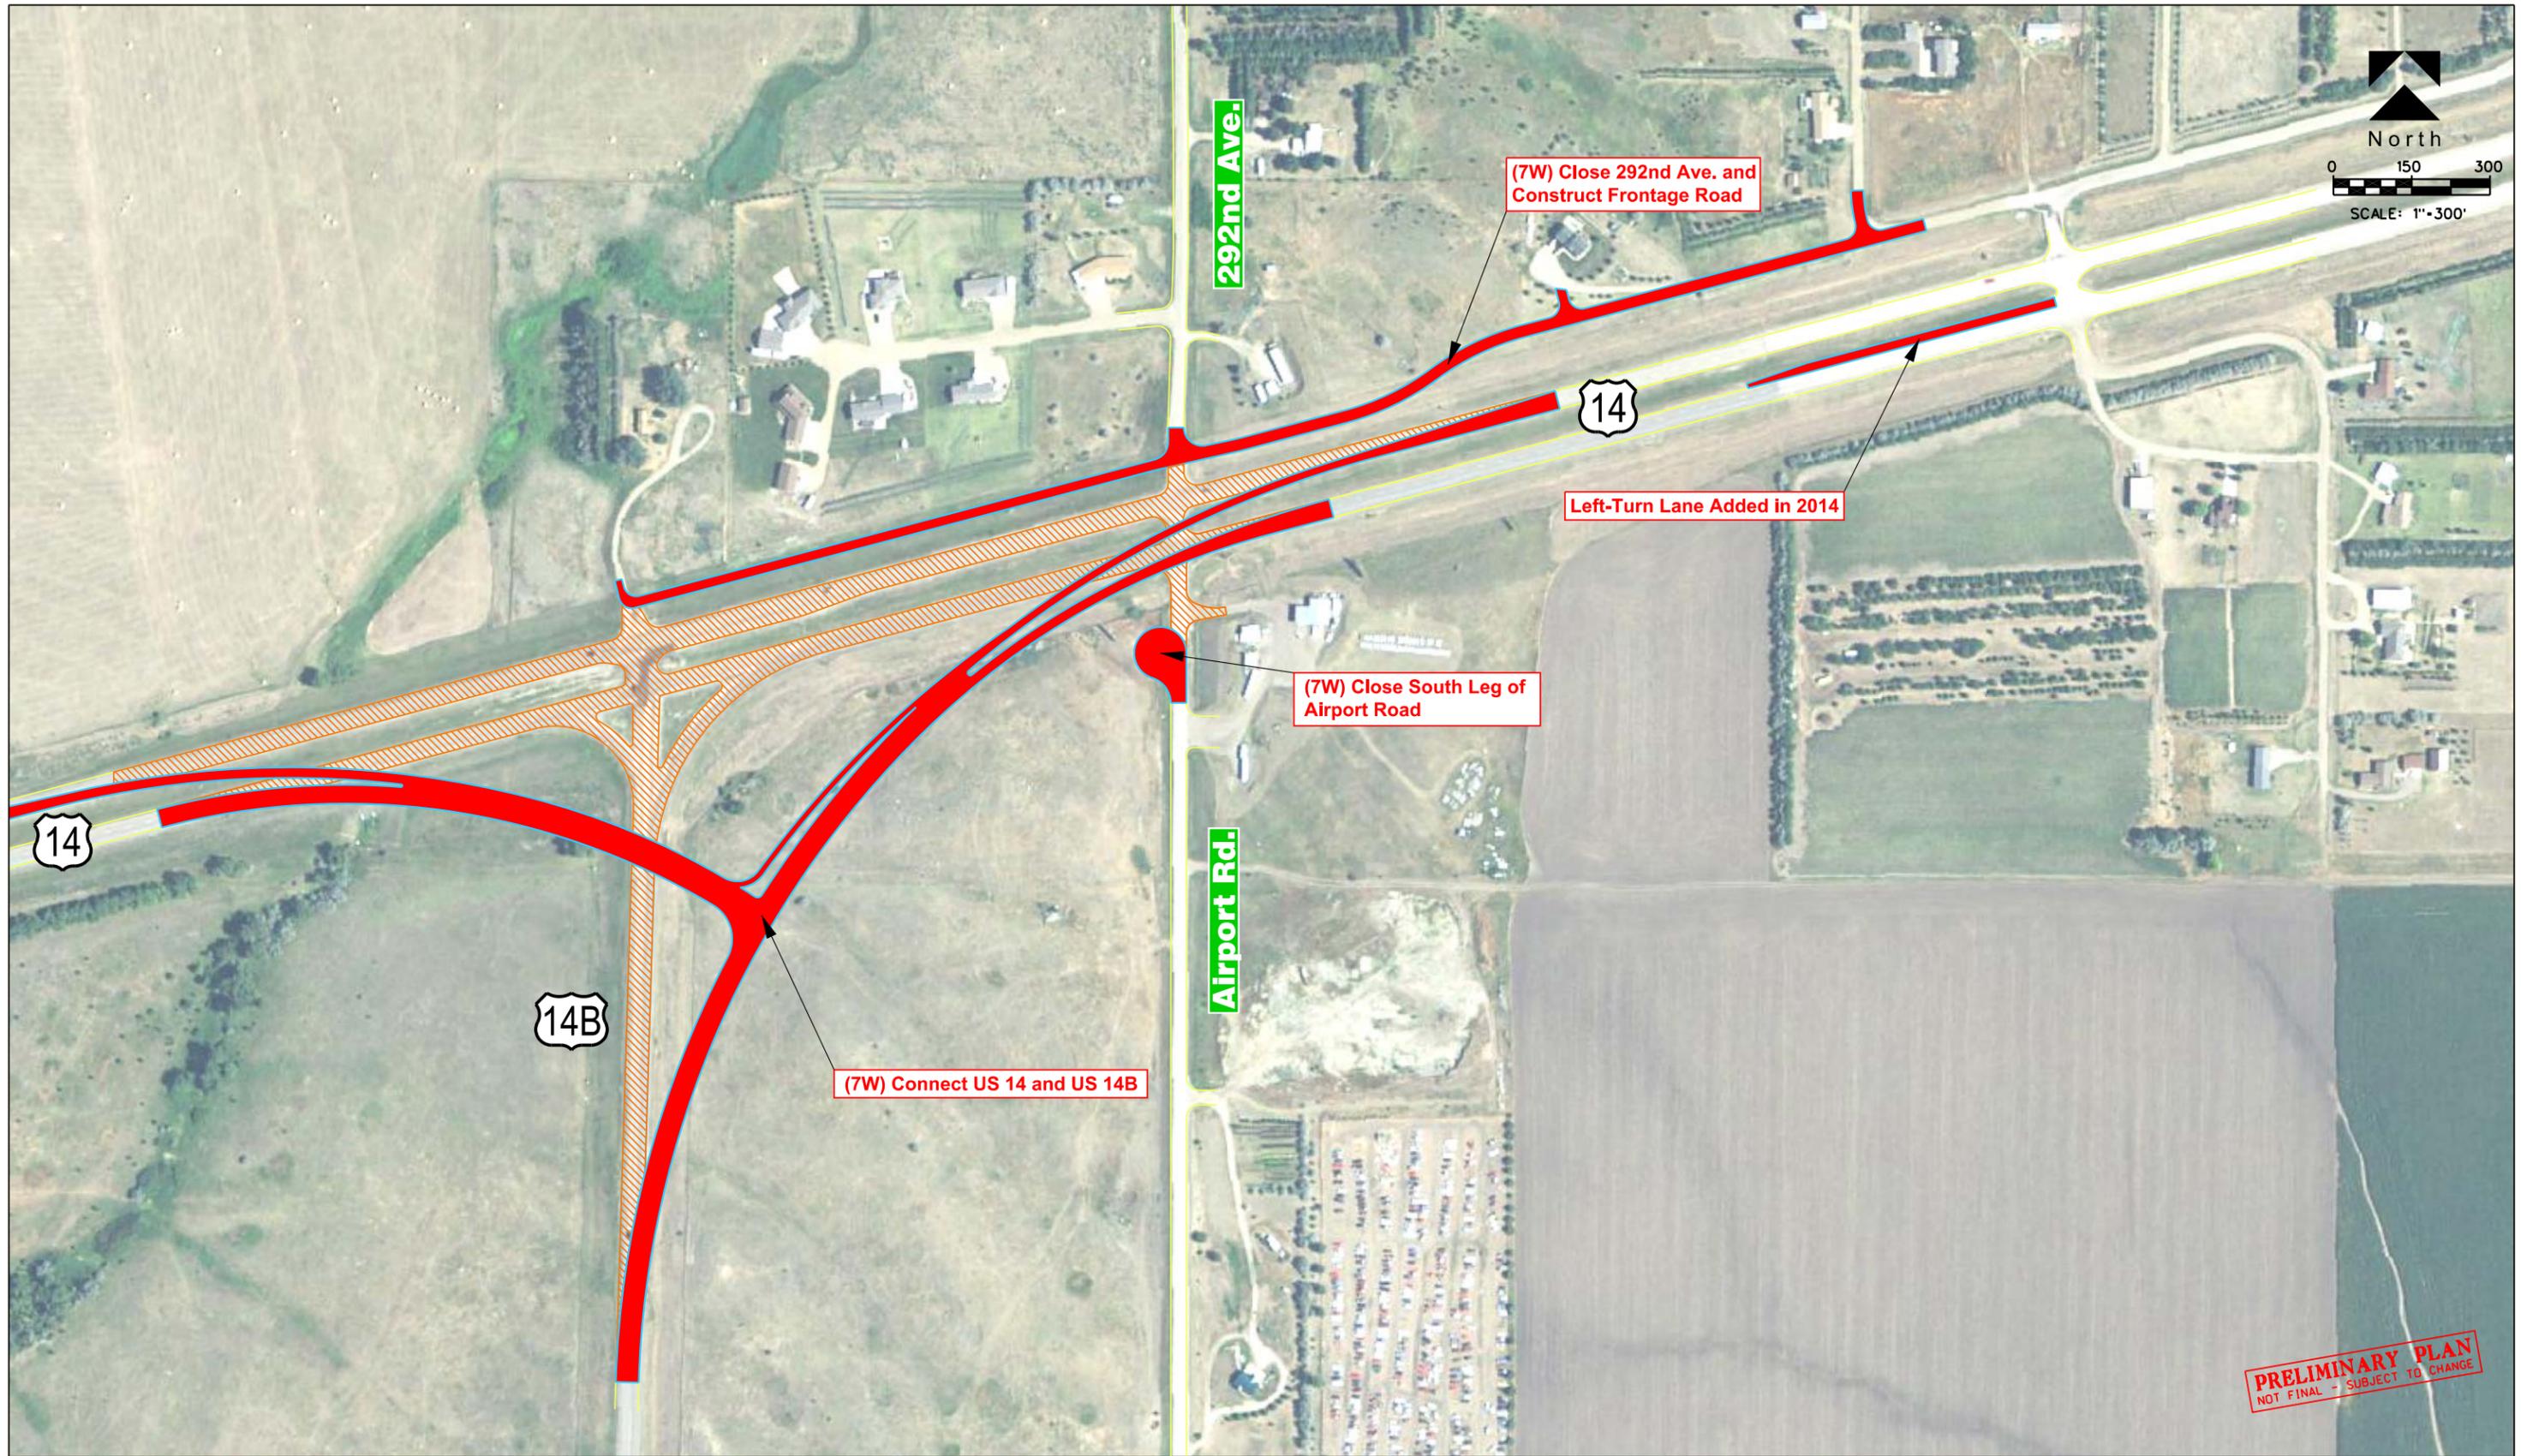
Figure 11.6
Intersection #11W & #11E
Intersection Recommendations
US14 / US14B / Airport Road

CONCEPTUAL DESIGN - OPTION 4

Figure 11.3 shows potential countermeasure (1W). **Figure 11.4** and **Figure 11.6** show countermeasures (2W), (3W), and (4W) for the intersection. **Figure 11.5** display potential countermeasures (2W), (5W), and (6W). **Figure 11.7** shows countermeasure (7W) and **Figure 11.8** shows countermeasure (8W).

Figure 11.3 shows potential improvements (1E), (2E), and (3E) for the intersection. **Figure 11.4** shows improvements (4E) and (5E). **Figure 11.5** and **Figure 11.6** both show potential countermeasure (6E).

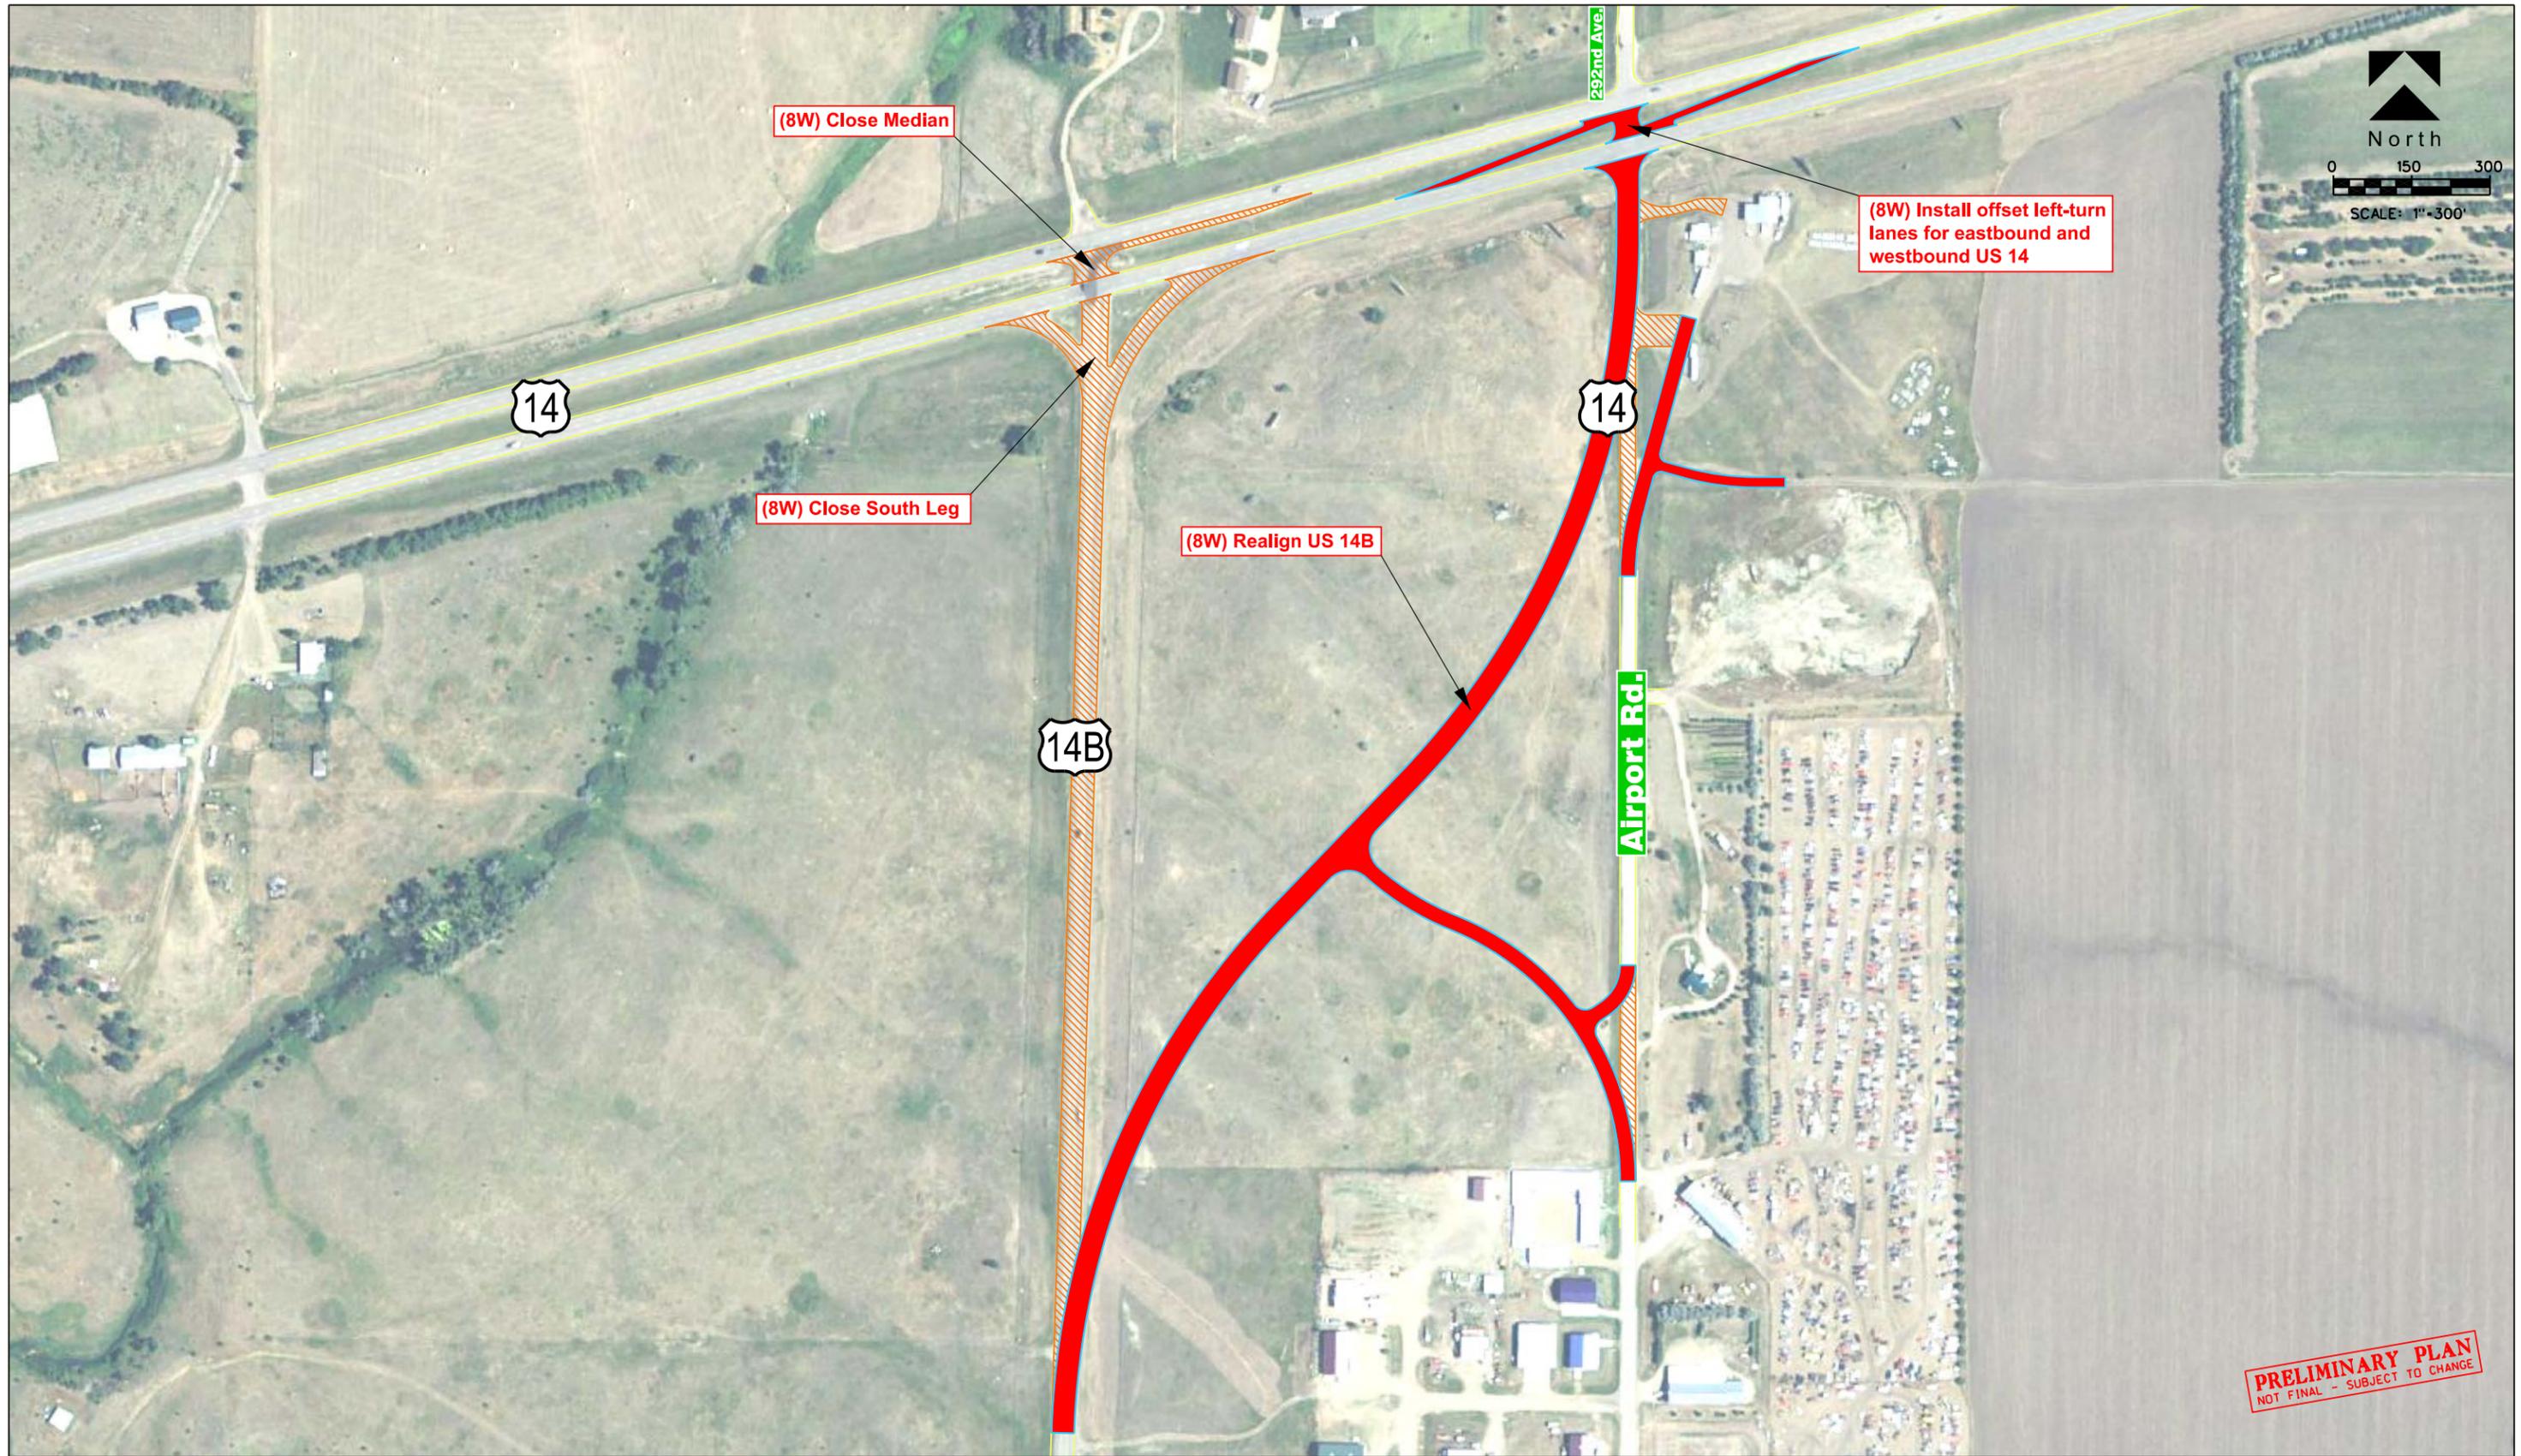
Figure 11.7
Intersection #11W & #11E
Intersection Recommendations
US14 / US14B / Airport Road

CONCEPTUAL DESIGN - OPTION 5

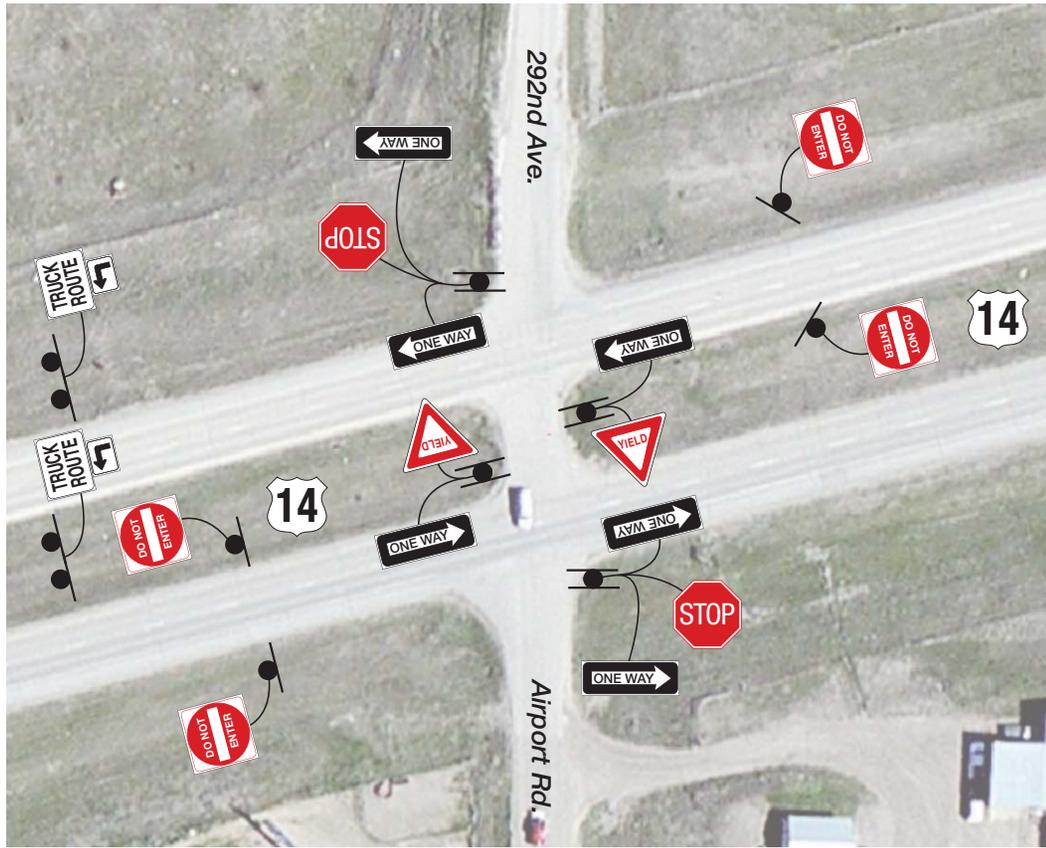
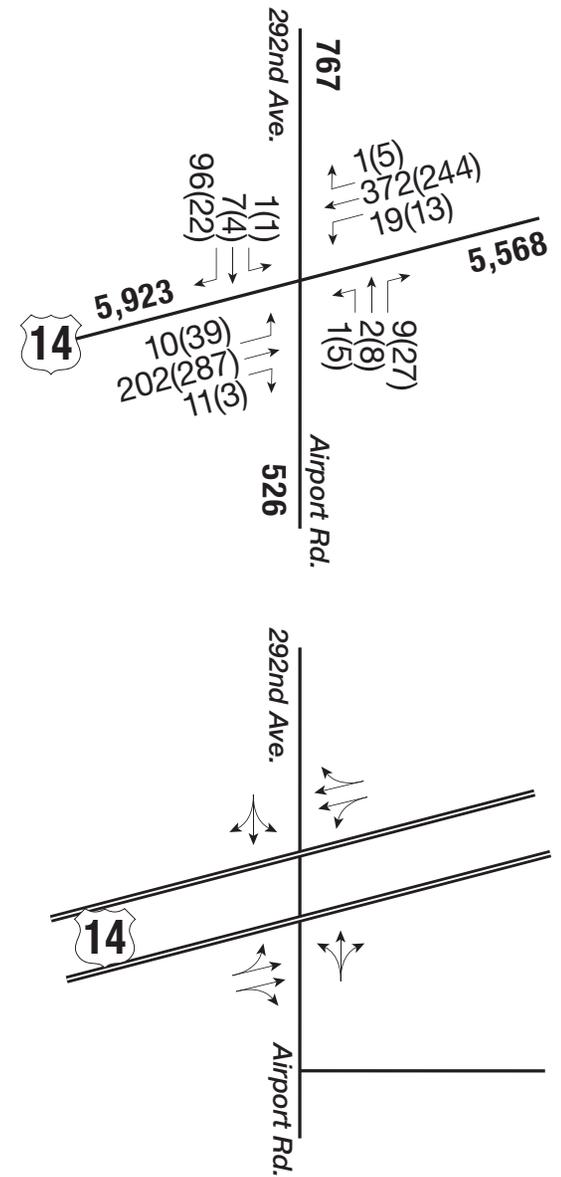
The intersection has a truck percentage of 10%. The north-south through movements are extremely low, totaling nine vehicles in the AM peak and twelve in the PM peak. Also shown on **Figure 11E.1** are the lane geometry, traffic control, and signage for existing traffic conditions at the intersection.

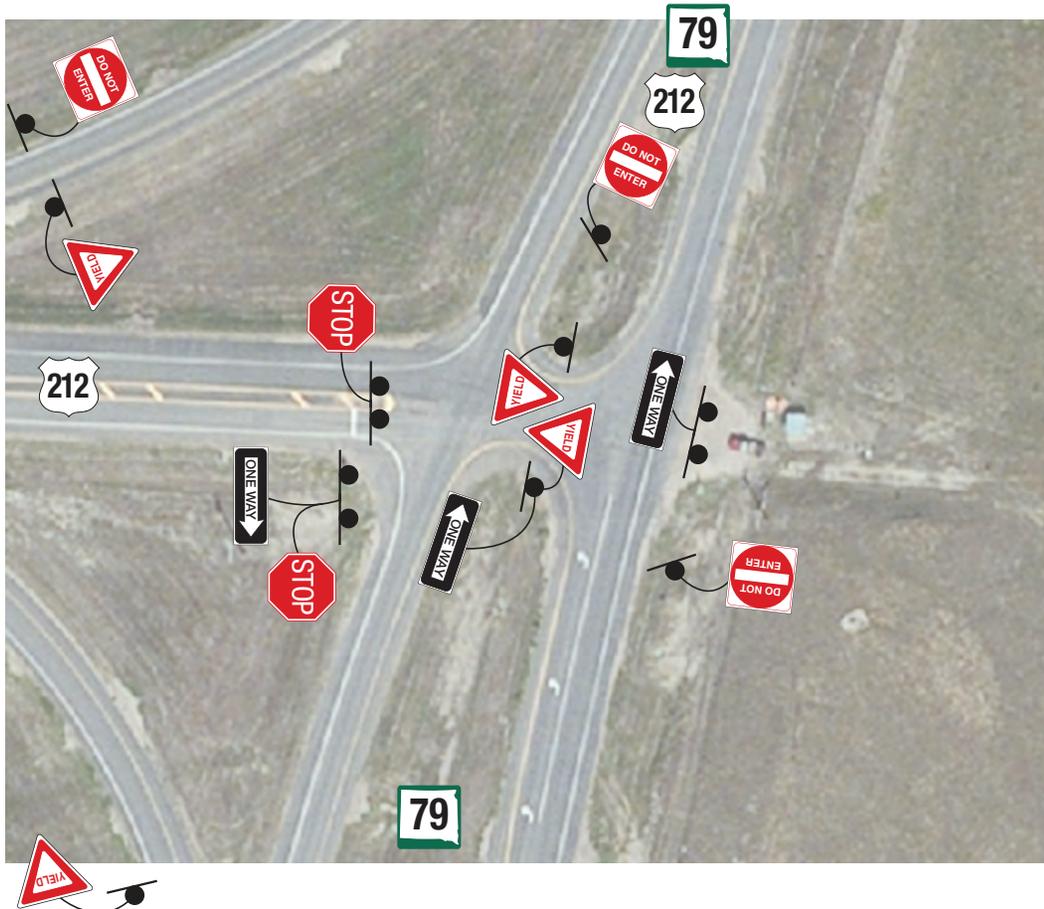
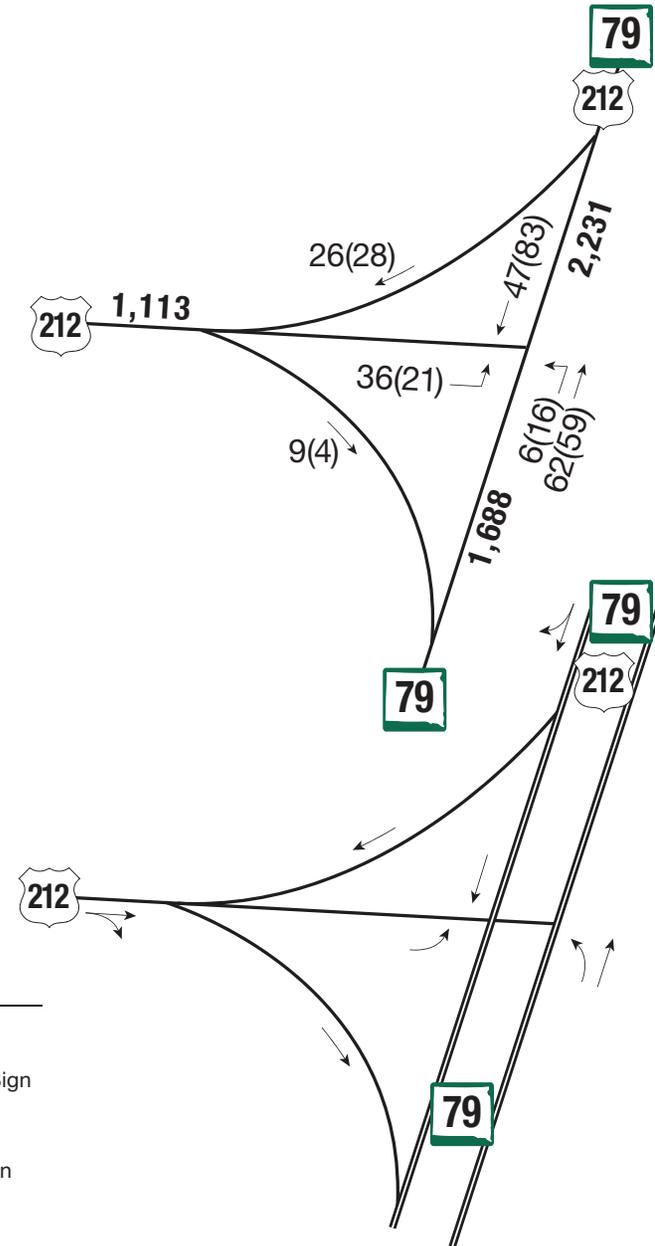
The intersection had an overall truck percentage of 10%. Looking at individual movements, the highest truck percentage was the northbound left-turn with 14%. Also shown on **Figure 12.1** are the lane geometry, traffic control, and signage for existing traffic conditions at the intersection.

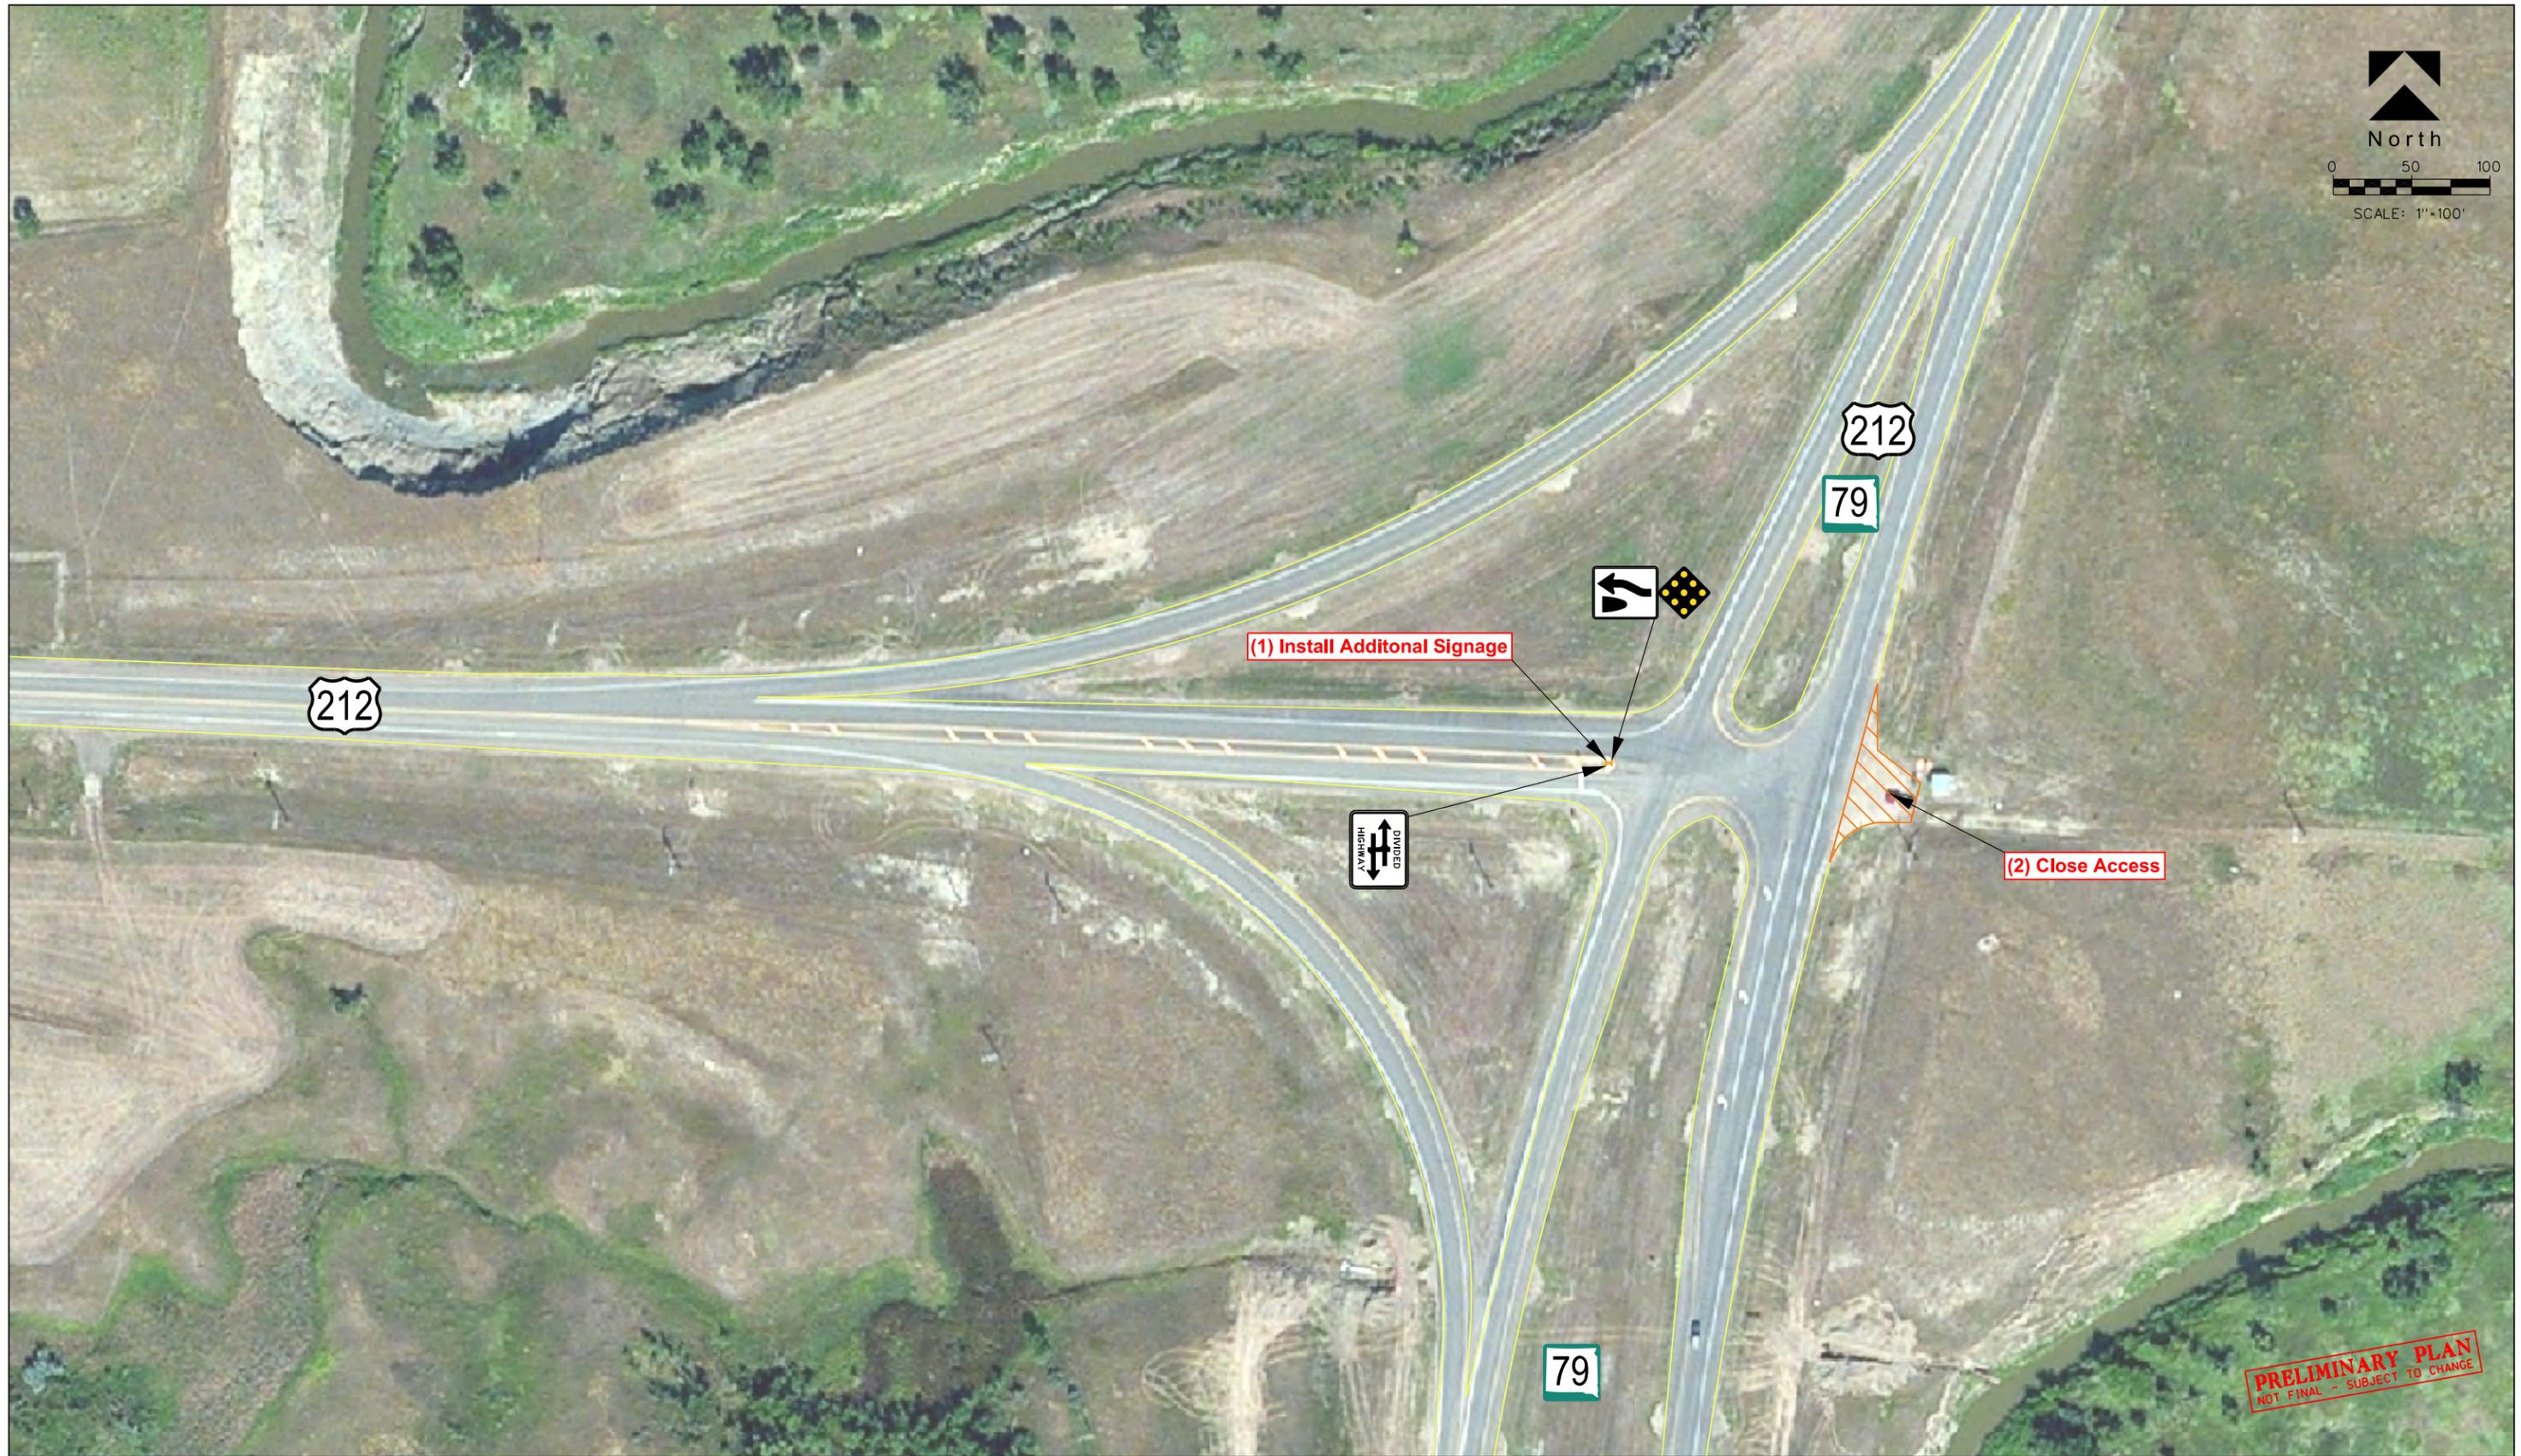
1 – It is recommended that access on the east side of SD 79 and opposite the intersection of US 212 be closed and the additional signing be installed as shown Figure 12.3. (1 & 2)
