ALTERNATIVES SCREENING EVALUATION - SUPPLEMENTAL INFORMATION

Subject: I-90 Exit 406 Interchange Concepts and SD 11/Splitrock Boulevard Concepts Screening Evaluation

Date: November 11, 2016 (modifies 11/8/16 version based on SAT comments)

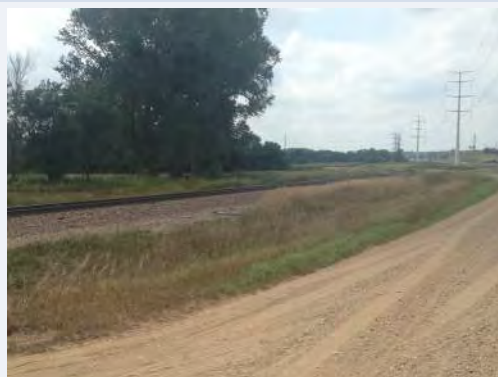
Two State Observation Wells observed near pilon in the central portion of site. Unique no. MA80EA and MA80FA.

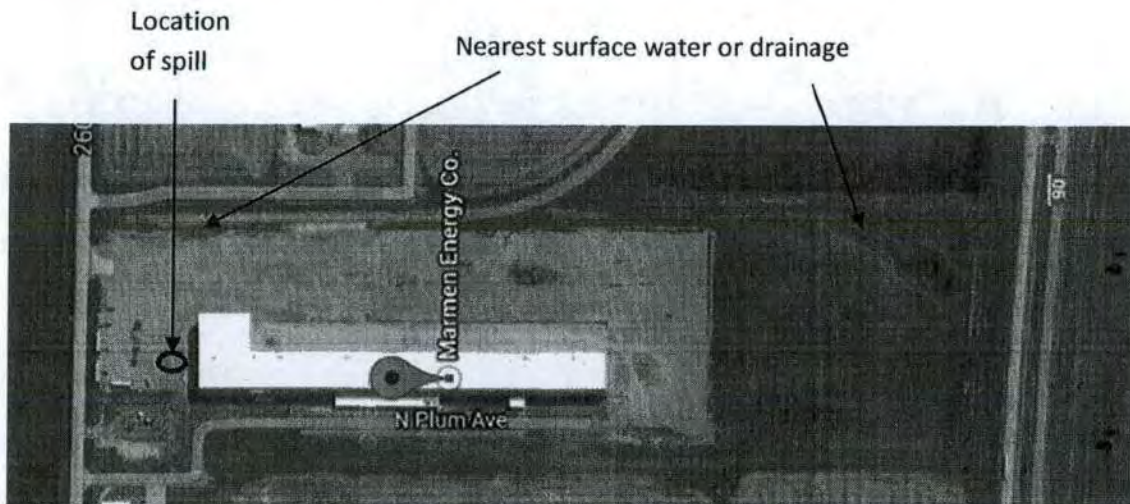
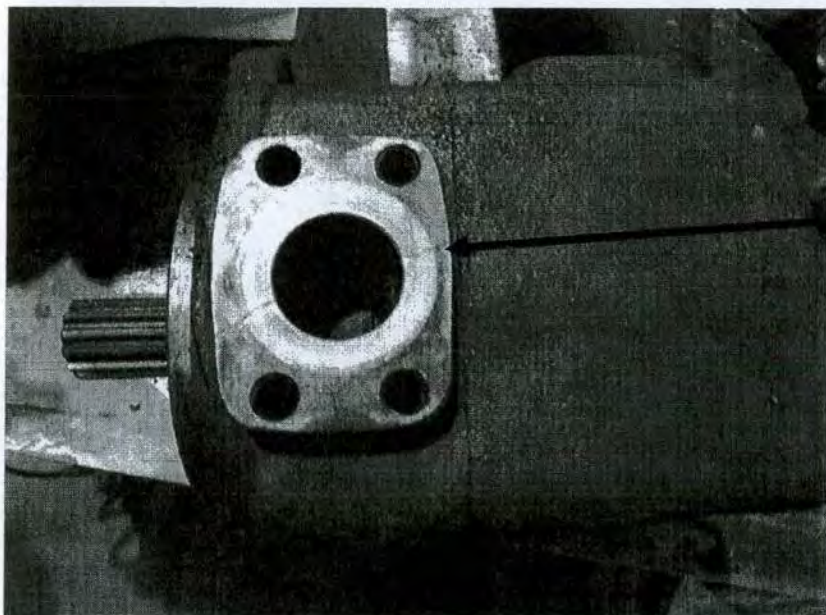
Cracked housing causing the leakage. The incident happened on Sunday, November 23.

The leak was reported immediately by the driver; however, because the temp was cold and the oil is viscous, the forklift appeared to have stopped leaking. Based on that, the supervisor allowed the truck to be parked outdoors overnight.

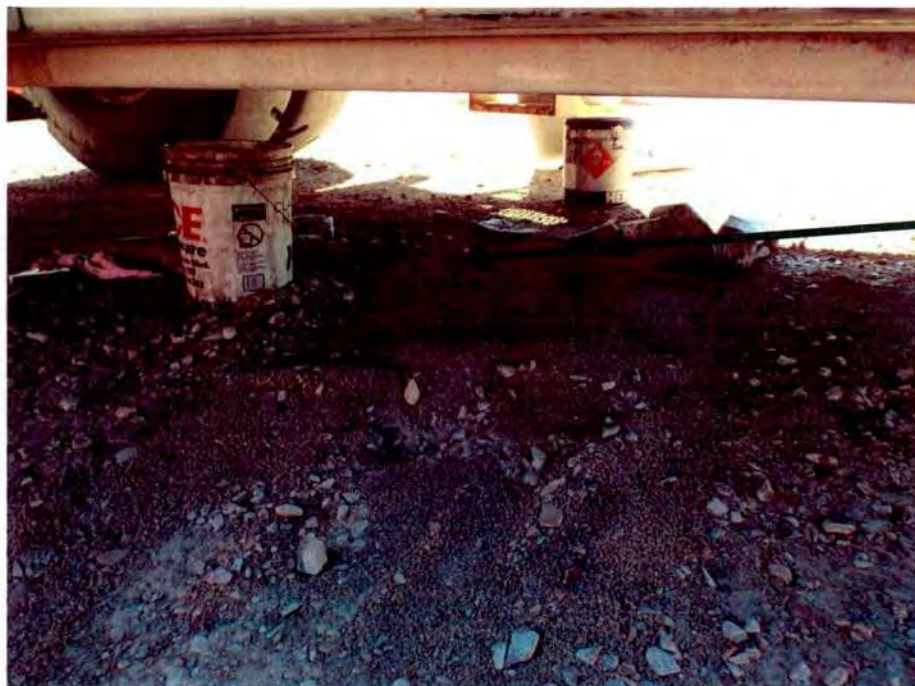
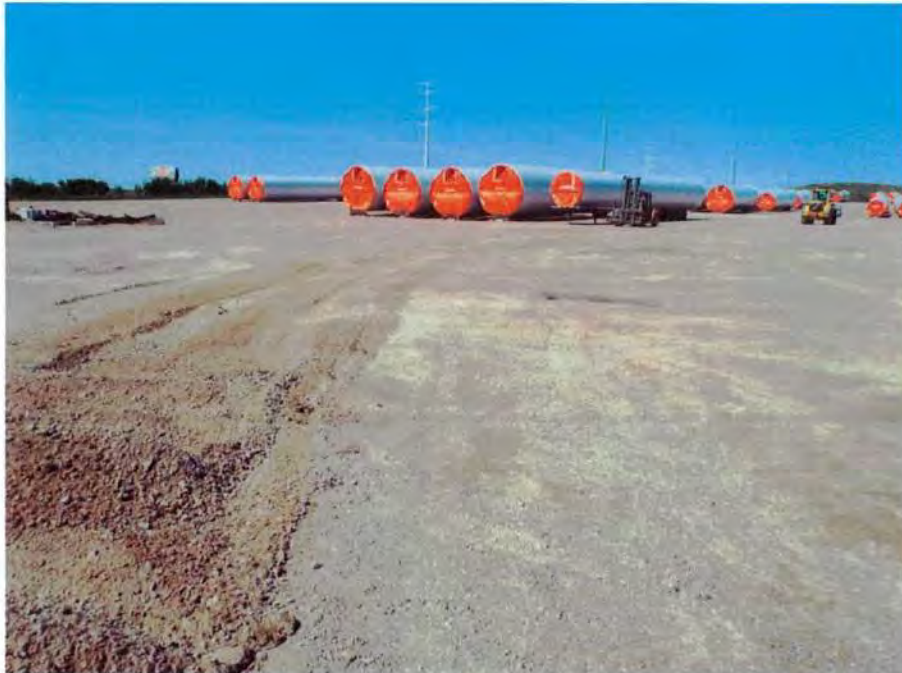
The cause of the leak was a blown oil line, which happened on May 21, 2015.

The leak was reported immediately by the driver; and clean up started at once.

A combination of granular sorbent and sorbent mats were used to collect any free oil. The pads were disposed of via an established waste stream.

Contractors already on site were able to scrape up the surface gravel along the path of travel.

When the forklift was repaired, the remaining gravel and granular sorbent was also collected.

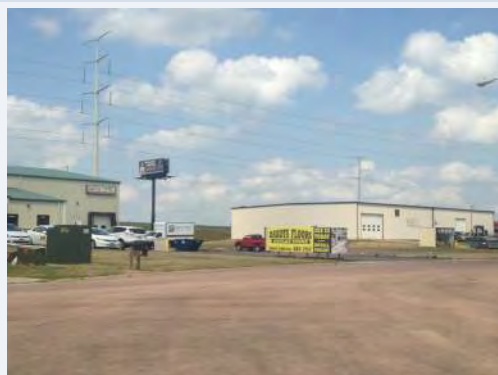
Sign reads "Production Machining." Several 55 gallon drums were observed in a storage area.

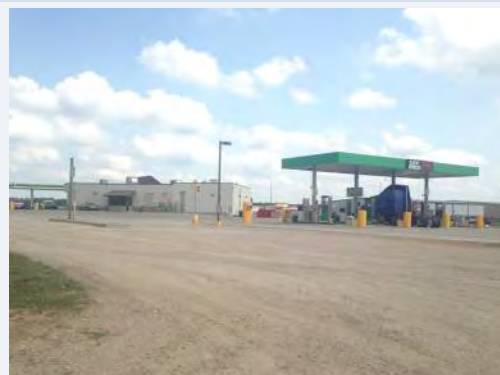
Typical staining at the pump islands. USTs.

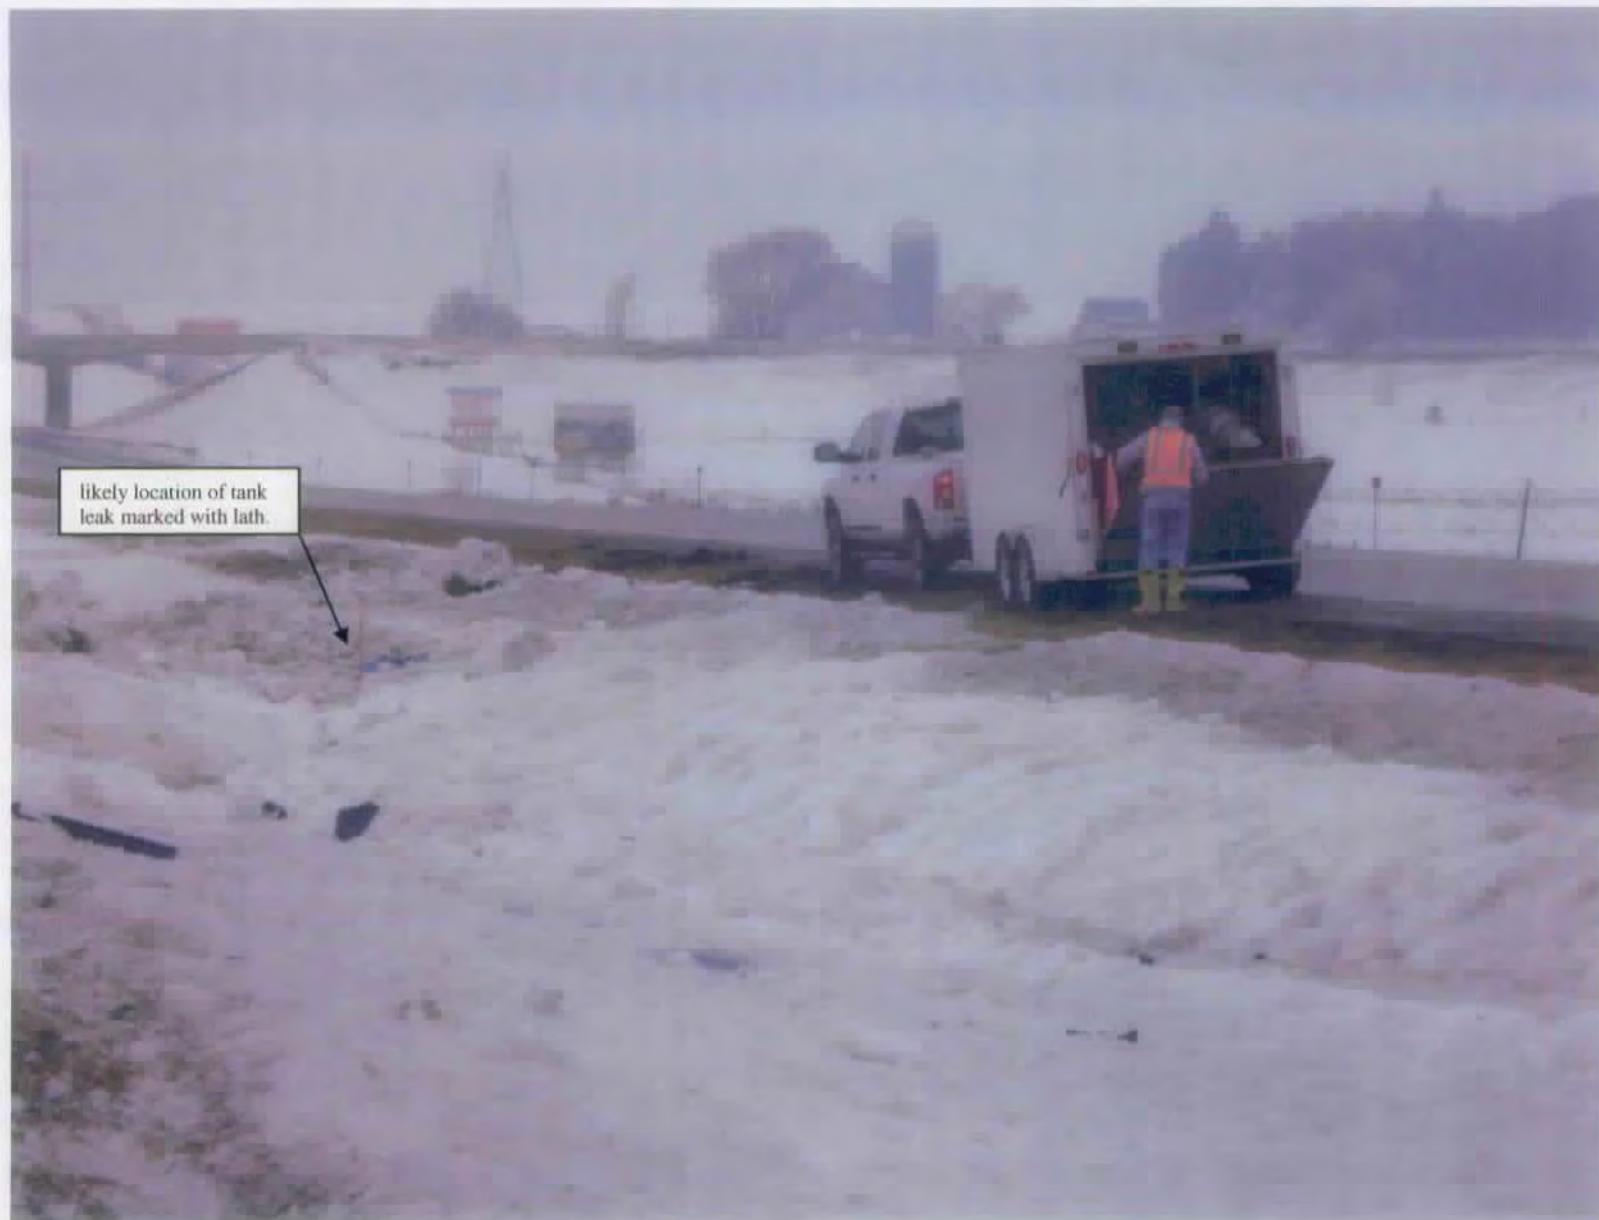
FIGURE 1
TOPOGRAPHIC SITE MAP
LANDSTAR TRUCK SPILL
I-90, MILE MARKER 409
NEAR BRANDON, SD
GEOTEK#: 10-196

likely location of tank
leak marked with lath.

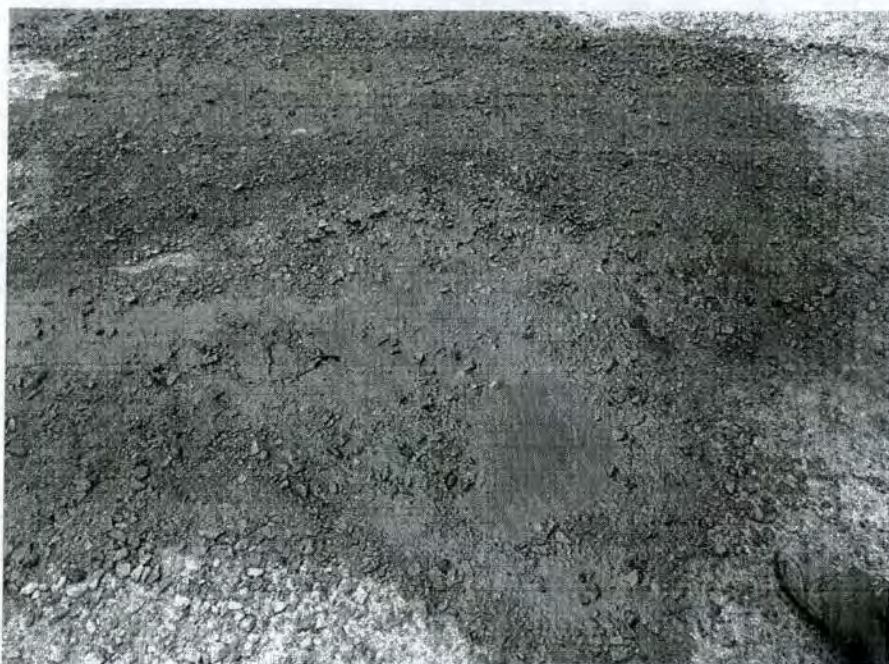
Cracked housing causing the leakage. The incident happened on Sunday, November 23.

The leak was reported immediately by the driver; however, because the temp was cold and the oil is viscous, the forklift appeared to have stopped leaking. Based on that, the supervisor allowed the truck to be parked outdoors overnight.

The following morning, the maintenance mechanic pulled the forklift indoors to begin repairs and reported the spill to EHS.

Frozen ground and time allowed the hydraulic fluid to move along the surface toward our plate inventory. The solid ground did not allow the oil to penetrate more than 6 – 8 inches at the point of release; far less elsewhere.

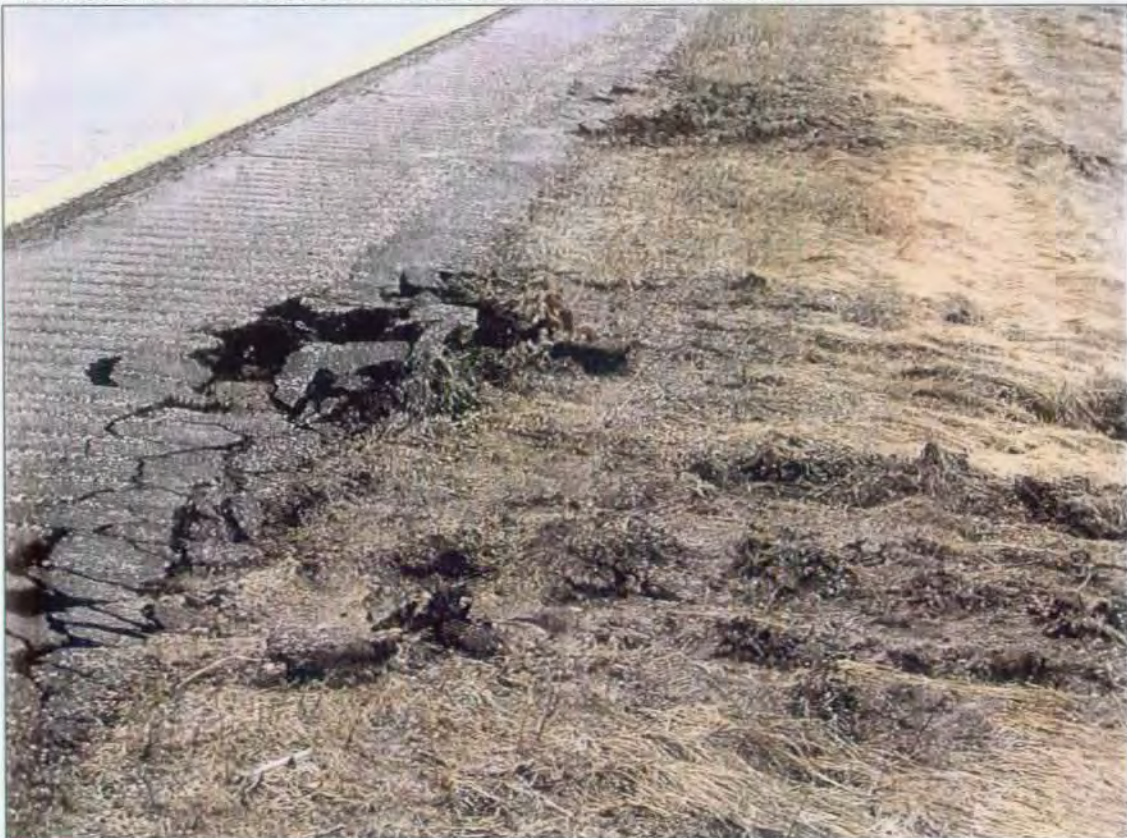
Photo 5: 3/15/10 - Debris left in the median after the accident.

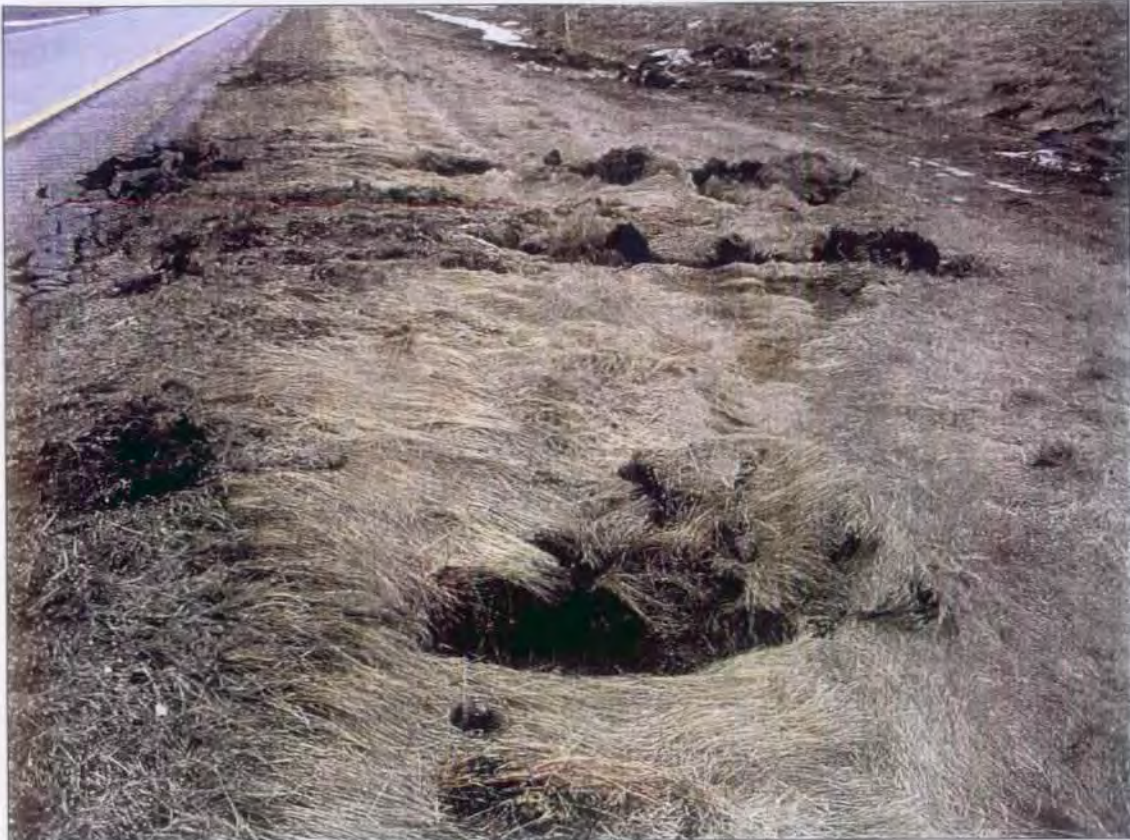
Photo 6: 3/15/10 - Damaged asphalt median shoulder.

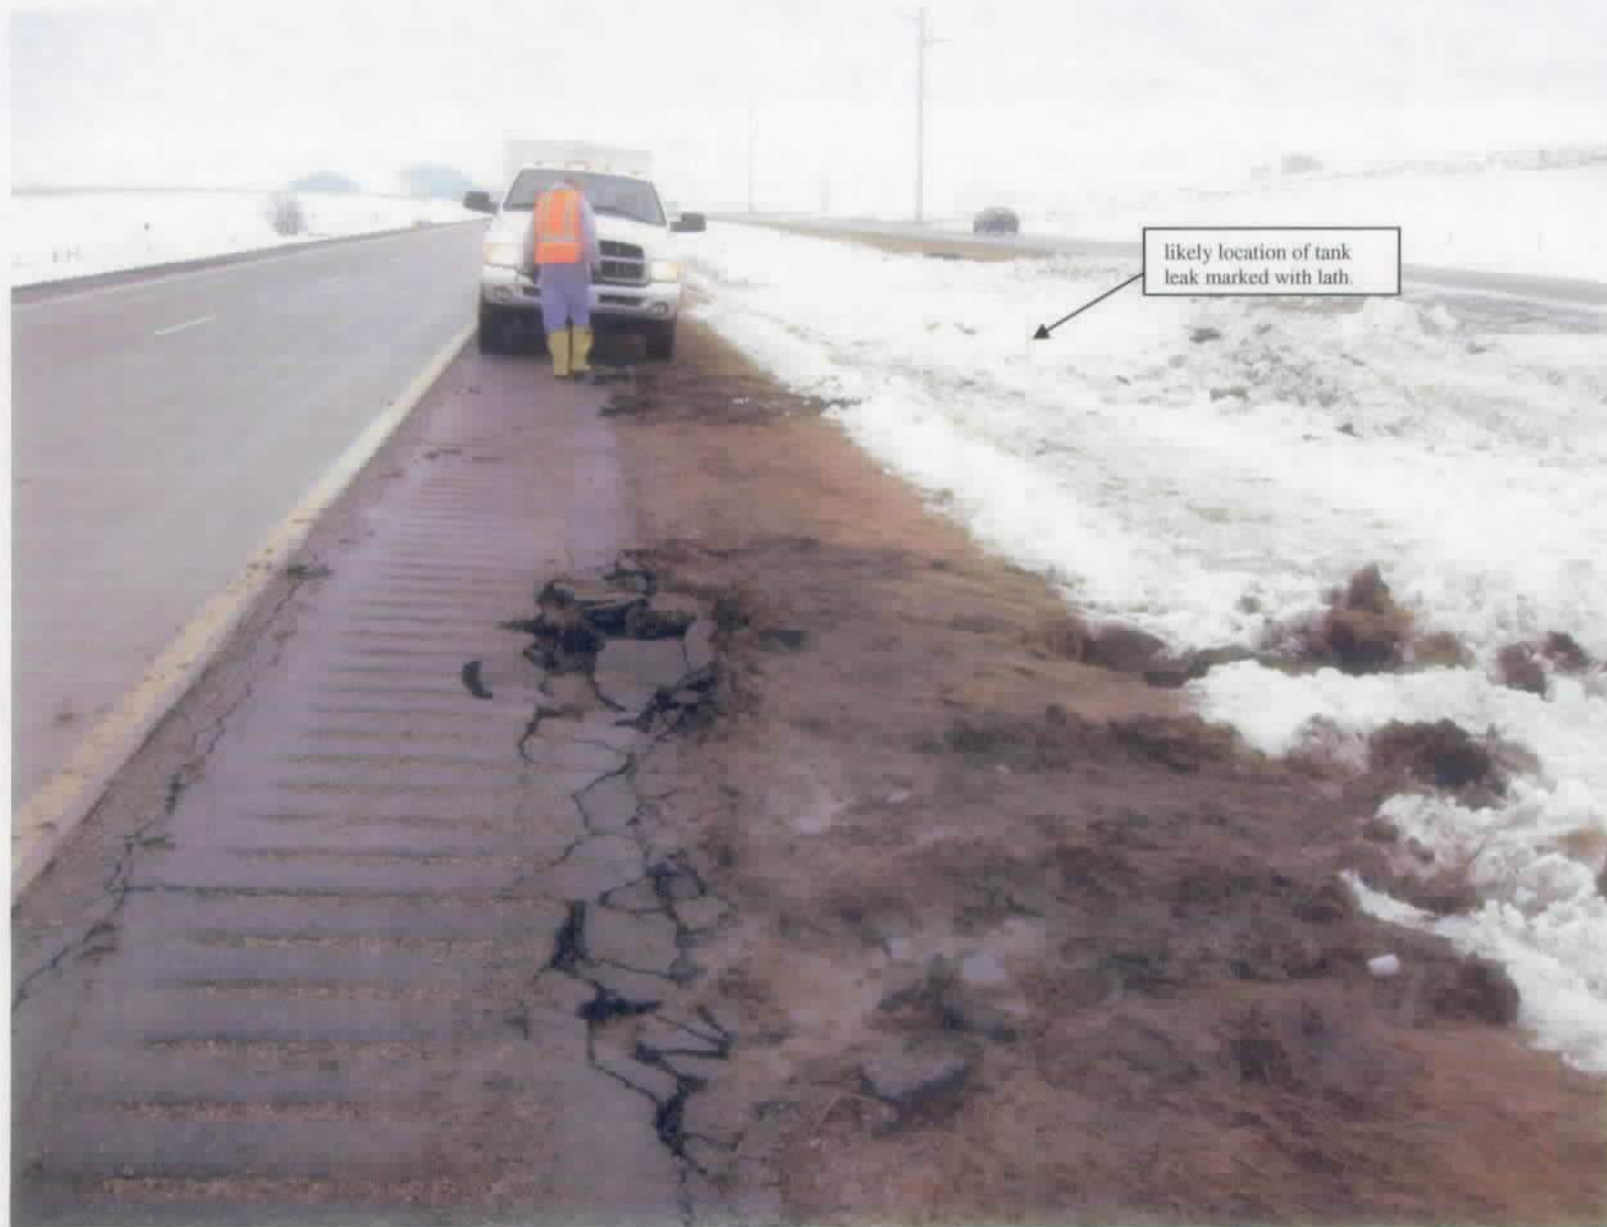
2' deep ruts in south shoulder.

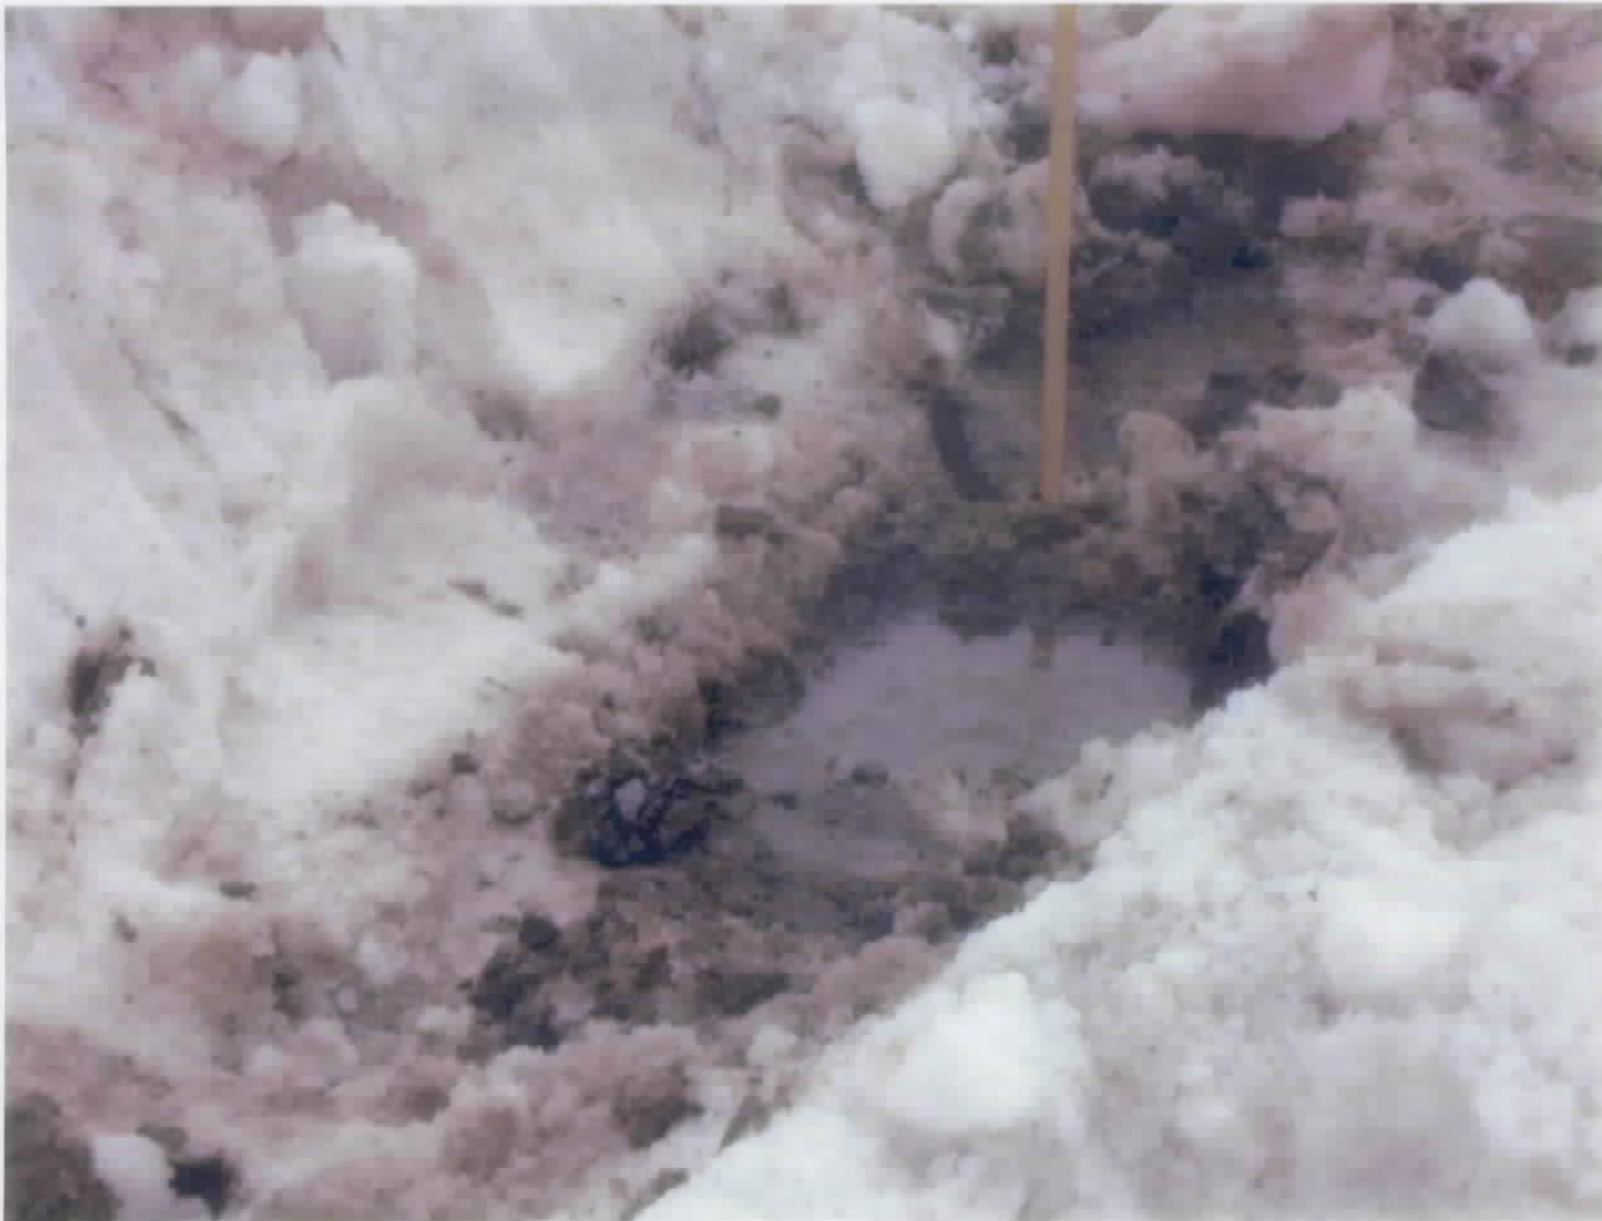
Lath marks likely location of leaking saddle tank.

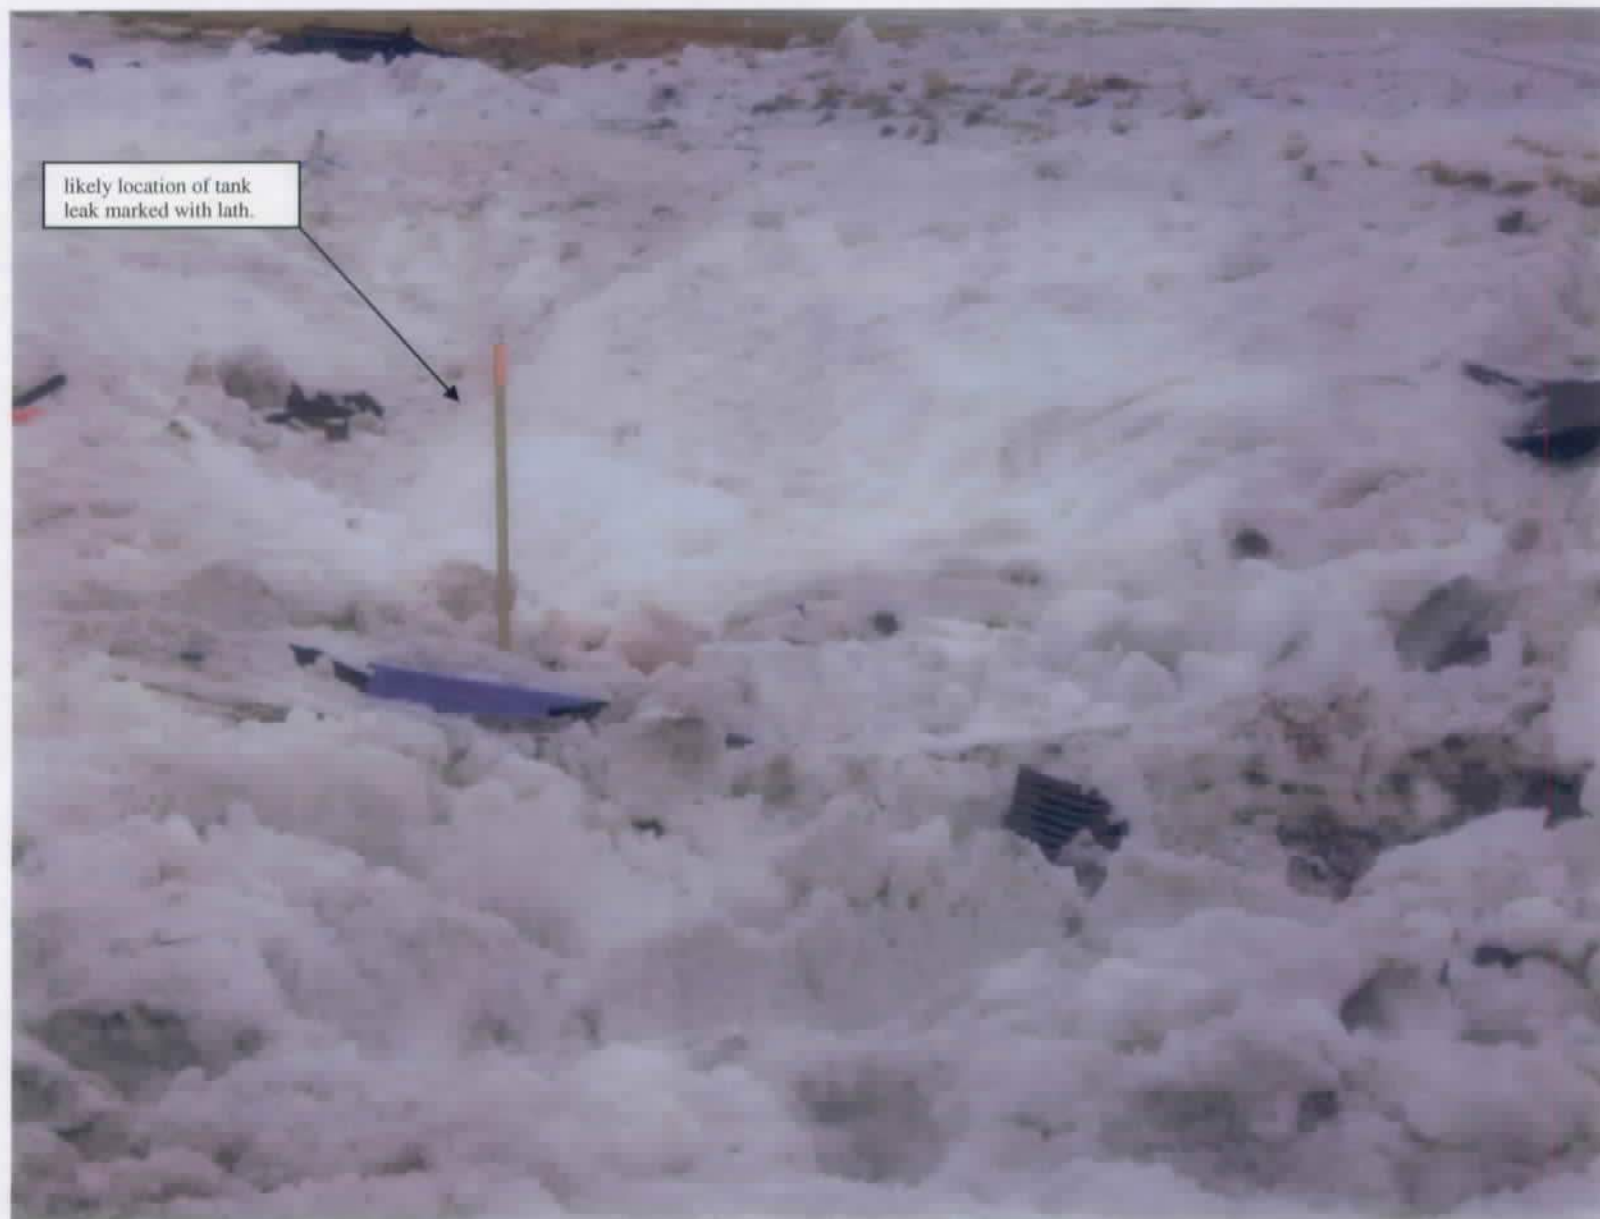
Some oil droplets were observed on water.
