# ABERDEEN RAIL / HIGHWAY GRADE CROSSING STUDY

SOUTH DAKOTA
DEPARTMENT OF TRANSPORTATION
DIVISION OF PLANNING
PIERRE, S. D. 57501

**NOVEMBER** 1984

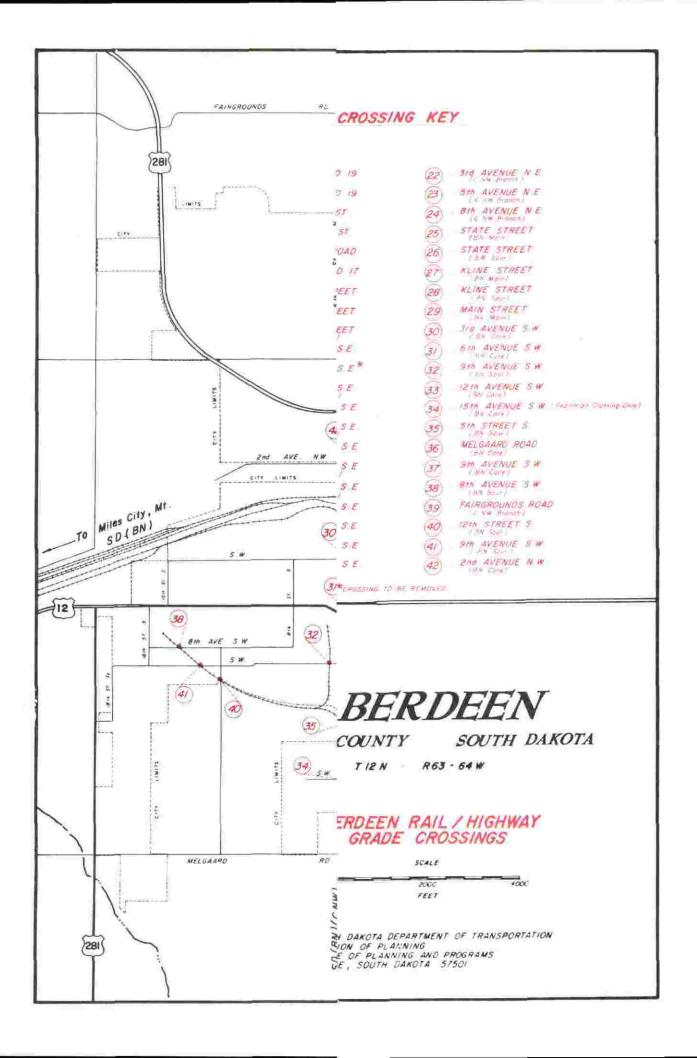
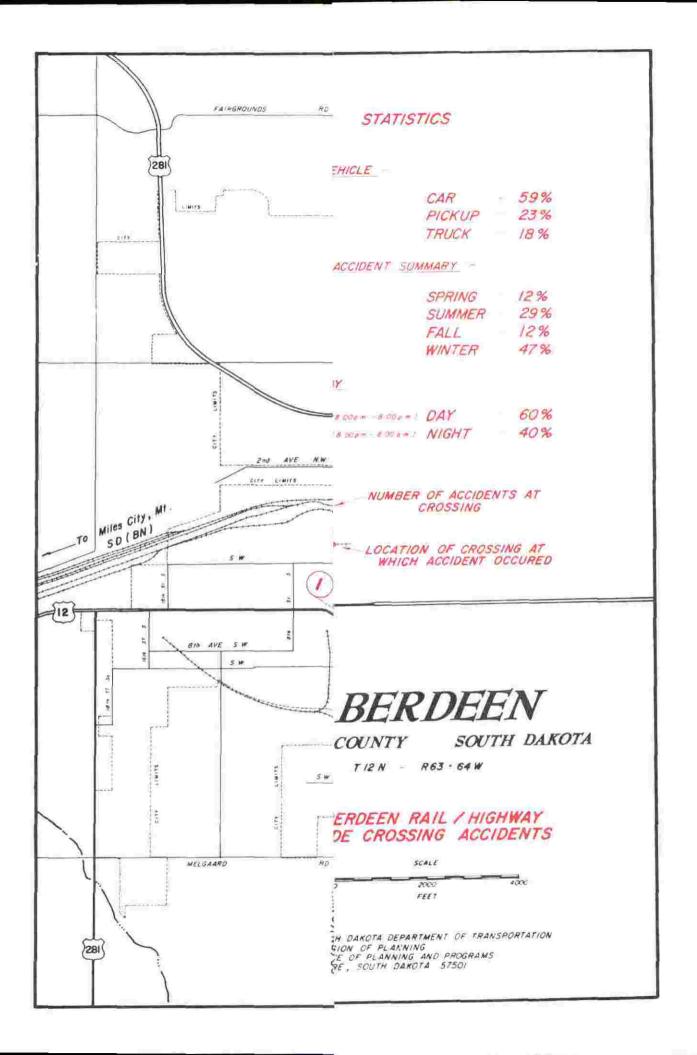
The second figure shows the actual location of crossing accidents in Aberdeen from 1973 to 1983. As this figure indicates, Aberdeen has had only 18 accidents during this time frame, or less than 5% of the statewide total. The crossings with more than one accident include Dakota Street (4), 1st Avenue SE (3), 6th Avenue SE (2), and 6th Avenue SW (2). Dakota Street maintains a high potential for accidents due to traffic increases from street improvements and a possible increase in train volume. While 6th Avenue will maintain a high traffic count since it is a main highway route, accidents should not increase because of the low train frequency. 1st Avenue SE should not experience a significant increase in accidents because of the relatively low and static traffic levels.

In Aberdeen, accidents have remained fairly constant, never rising above three accidents per year. An interesting fact is that during the Milwaukee Road reorganization and the resulting realignment of rail service in South Dakota (1980-1983), only two accidents occurred in Aberdeen. While this may not be directly related to the reduced train frequency during the period, greater hazards are now present because of the improved rail service and greater rail freight from the growing economy.

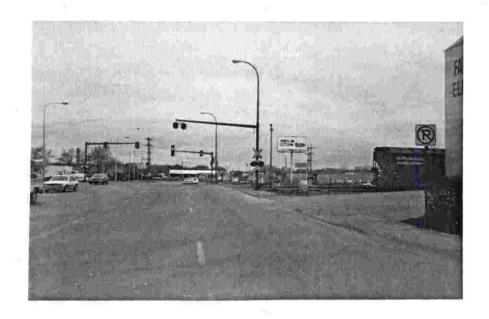
# 6TH AVENUE SW - Eastbound

Miscellaneous: View distance - Less than 500'

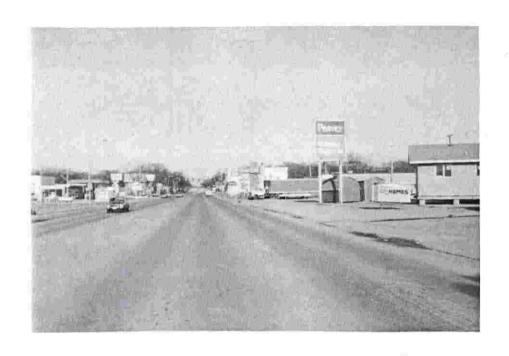
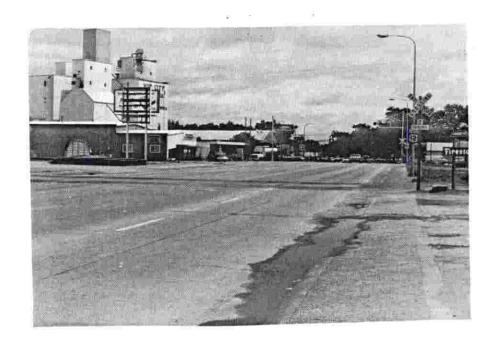
6TH AVENUE SE (BN SPUR) - Westbound

DATA INVENTORY				
Tracks	<u>2</u>	Traffic Lanes	<u>5</u>	
Trains/Day	0.5	Vehicles/Day	26,728	
Train Speed	<u>10</u>	Vehicle Speed	24	
Bus Crossings/Day (Passenge	rs) <u>320</u>	Warning Device	Crossbucks	
Hazardous Matls. Crossings/	Day <u>78</u>	Crossing Surface	Asphalt	
Driveways Within 200'	<u>5</u>	Crossing Angle	85 degrees	
Pavement Markings	No	Advance Warning Signs	No	
Accidents - Past Two Years	<u>0</u>	Land Use	Commercial	
Accidents - Past Ten Years	2	Approach	Straight, Level	
Local Priority	15	Ride	Moderate	
·				
	HAZARD RATING	1,339

Miscellaneous: View distance - Less than 500'

Alternative	Estimated Cost
<ol> <li>Advance warning signs</li> <li>Pavement markings</li> </ol>	\$40 \$1,500
Recommended Course of Action	Estimated Total Cost
Both alternatives. This crossing	\$1,540

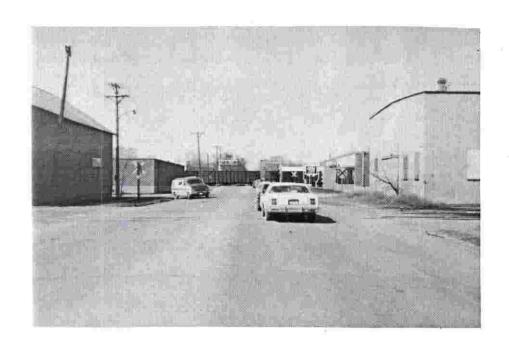
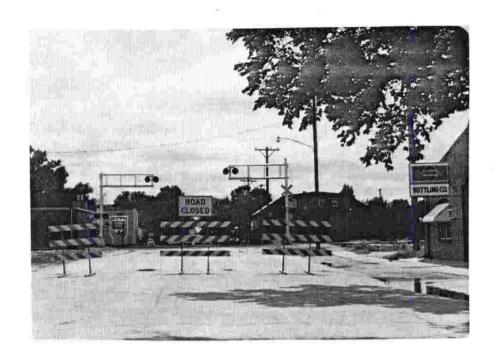
STATE STREET (MAIN LINE) - Northbound

#### DATA INVENTORY 5 Traffic Lanes Tracks 2 Vehicles/Day 6,930 12 Trains/Day Vehicle Speed 22 Train Speed 10 Cantilever Signals Bus Crossings/Day (Passengers) 89 Warning Device Crossing Surface Asphalt Hazardous Matls. Crossings/Day 1 90 degrees Driveways Within 200' Crossing Angle 4 Advance Warning Signs Yes Pavement Markings No Land Use Commercial Accidents - Past Two Years 1 Straight, Level Approach Accidents - Past Ten Years 1 Ride Poor 2 Local Priority

1,006

Alternative	Estimated Cost
1. 2. 3. 4.	Advance warning lights Pavement markings Rubber crossing Illumination Remove unnecessary trackage	\$2,500 \$1,500 \$70,000 \$250 Minor
A11	Recommended Course of Action alternatives.	Estimated Total Cost \$74,250

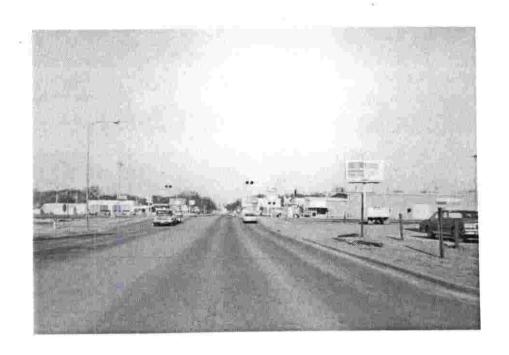
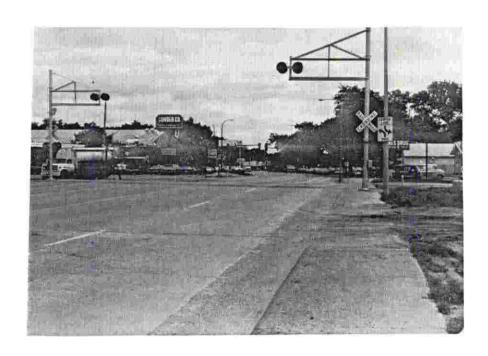
6TH AVENUE SE (CNW BRANCH) - Westbound

#### DATA INVENTORY Traffic Lanes Tracks 26,728 0.5 Vehicles/Day Trains/Day 24 Vehicle Speed 10 Train Speed Cantilever Signals 320 Warning Device Bus Crossings/Day (Passengers) Crossing Surface Asphalt Hazardous Matls. Crossings/Day 78 90 degrees Crossing Angle Driveways Within 200' 5 No Advance Warning Signs No Pavement Markings Commercial Land Use Accidents - Past Two Years 0 Curve on East Side, Level Accidents - Past Ten Years Approach Moderate Ride 15 Local Priority

HAZARD	RATING	954

Miscellaneous: View distance - Less than 500'

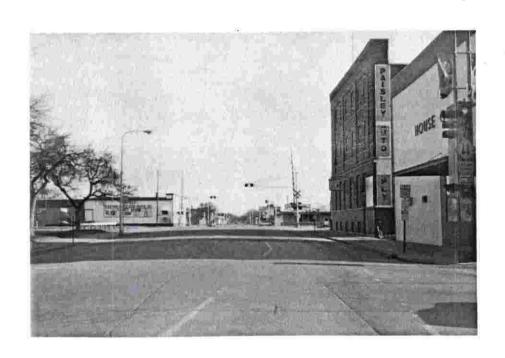
MAIN STREET - Northbound

HAZARD	RAT ING	816

#### Estimated Cost Alternative 1. Advance warning sign on north side \$40 \$2,500 Advance warning lights \$1,500 3. Pavement markings on north side \$50 4. Speed grooves/rumble strips \$500 5. Improved Illumination \$80,000 6. New rubber crossing surface Minor Remove unnecessary crossings Estimated Total Cost Recommended Course of Action \$82,040 All Alternatives except #2, which would interfere with existing traffic signals. Two of the crossings will

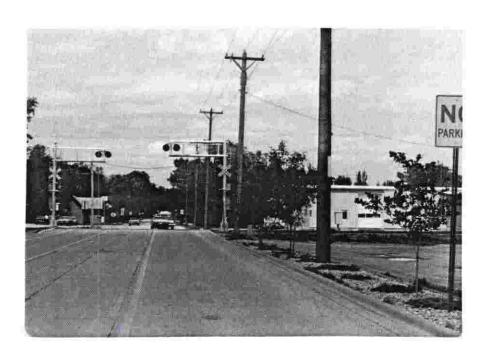
DAKOTA STREET (MAIN LINE) - Northbound

Tracks	1	Traffic Lanes	<u>3</u>
Trains/Day	12	Vehicles/Day	5,755
Train Speed	10	Vehicle Speed	<u>27</u>
Bus Crossings/Day (Passengers)	<u>10</u>	Warning Device	Cantilever Signals
Hazardous Matls. Crossings/Day	<u>0</u>	Crossing Surface	Rubber
Driveways Within 200'	<u>4</u>	Crossing Angle	90 degrees
Pavement Markings	No	Advance Warning Signs	<u>Yes</u> *
Accidents - Past Two Years	<u>o</u>	Land Use	Commercial
Accidents - Past Ten Years	<u>4</u>	Approach	Straight, Level
Local Priority	1	Ride	Good

HAZARD	RATING	789

Alternative	Estimated Cost
1.	Pavement markings	\$1,500
2.	Curb painting	\$50
3.	Illumination	\$250
4.	Gates	\$24,000
	Recommended Course of Action	Estimated Total Cost
A11	Alternatives.	\$25,800

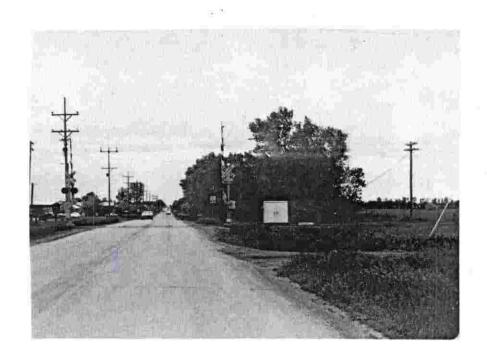
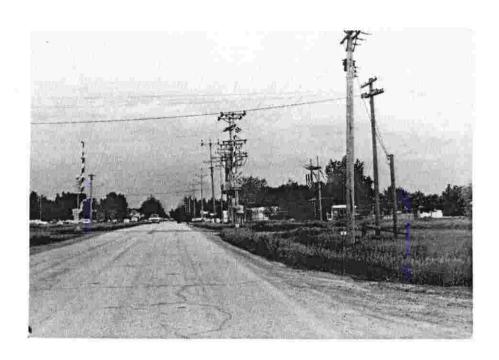
ROOSEVELT STREET (MAIN LINE) - Northbound

Tracks	1.	Traffic Lanes	<u>2</u> .
Trains/Day	12	Vehicles/Day	5,112
Train Speed	<u>10</u>	Vehicle Speed	<u>32</u>
Bus Crossings/Day (Passengers	) <u>70</u>	Warning Device	Gates/Mast Lights
Hazardous Matls. Crossings/Day	y <u>8</u>	Crossing Surface	Asphalt/Timber Headers
Driveways Within 200'	<u>4</u>	Crossing Angle	90 degrees
Pavement Markings	Poor Condition	Advance Warning S	igns <u>Yes</u>
Accidents - Past Two Years	0	Land Use	Residential/Industrial
Accidents - Past Ten Years	1	Approach	Straight, Level
Local Priority	Ţ	Ride	Moderate

HAZARD RATING 783

Miscellaneous: View distance - 1,500'

DESIGN OPTIONS	<u>s</u>
Alternative	Estimated Cost
<ol> <li>Pavement markings reconditioned</li> <li>Speed grooves/rumble strips</li> <li>Rubber crossing</li> <li>Grade separation</li> <li>Illumination</li> </ol>	\$1,500 \$250 \$70,000 \$450,000 \$250
Recommended Course of Action	Estimated Total Cost
#1, 2, 3, and 5 or #4. Alternative #3 is a project in the South Dakota Highway Construction Program. Alternative #4 should be implemented only if train traffic warrants the	\$72,000 (#4\$450,000)

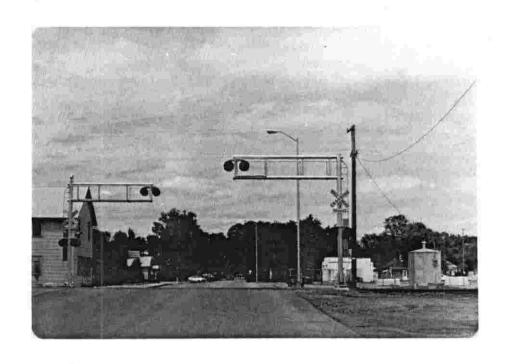
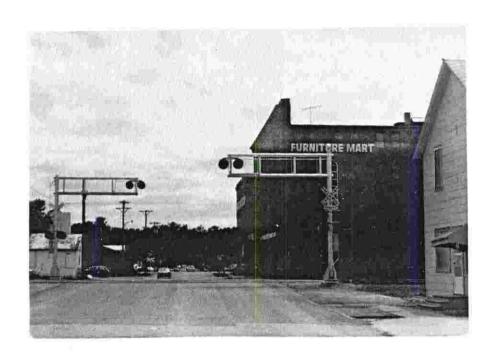
KLINE STREET (MAIN LINE) - Northbound

Tracks	<u>2</u>	Traffic Lanes	<u>2</u>
Trains/Day	12	Vehicles/Day	4,411
Train Speed	<u>10</u>	Vehicle Speed	<u>23</u>
Bus Crossings/Day (Passengers)	<u>80</u>	Warning Device	Cantilever Signals
Hazardous Matls. Crossings/Day	1	Crossing Surface	Rubber
Driveways Within 200'	1	Crossing Angle	90 degrees
Pavement Markings	No	Advance Warning Signs	Yes
Accidents - Past Two Years	<u>0</u>	Land Use	Commercial
Accidents - Past Ten Years	1	Approach	Straight, Level
Local Priority	<u>3</u>	Ride	Good

HAZARD RATING 639

Alternative	Estimated Cost
<ol> <li>Pavement marking</li> <li>Illumination</li> <li>Remove unnecessary trackage</li> </ol>	\$1,500 \$250 Minor
Recommended Course of Action	Estimated Total Cost
All Alternatives.	\$1,750

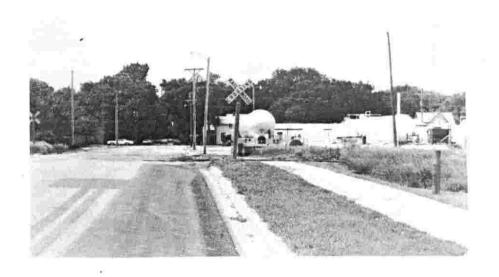
8TH AVENUE SE - Westbound

#### DATA INVENTORY Traffic Lanes Tracks 2 2 Vehicles/Day 690 Trains/Day 0.5 10 Vehicle Speed 17 Train Speed Warning Device Crossbucks Bus Crossings/Day (Passengers) 0 Sectional Timber Hazardous Matls. Crossings/Day 40 Crossing Surface Driveways Within 200' Crossing Angle 70 degrees 5 Pavement Markings No Advance Warning Signs No Residential/Commercial Land Use Accidents - Past Two Years 0 Straight, Level Approach Accidents - Past Ten Years 0 Rough Ride Local Priority 15

HAZARD RATING 458

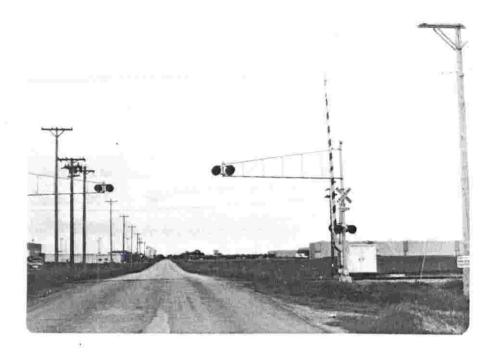
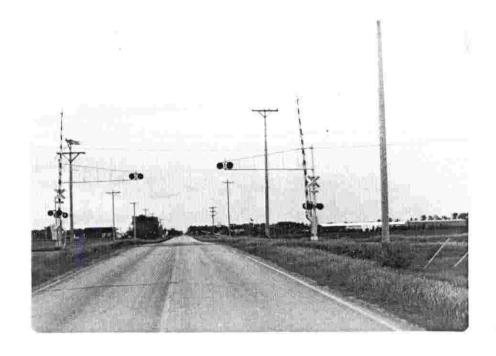
BROWN COUNTY #19 (MAIN LINE) - Northbound

Tracks	1	Traffic Lanes	<u>2</u>
Trains/Day	12	Vehicles/Day	2,287
Train Speed	<u>10</u>	Vehicle Speed	<u>37</u>
Bus Crossings/Day (Passengers)	20	Warning Device	Cantilever Lights
Hazardous Matls. Crossings/Day	<u>8</u>	Crossing Surface	Asphalt/Timber Headers
Driveways Within 200'	<u>o</u>	Crossing Angle	90 degrees
Pavement Markings	Poor Condition	Advance Warning S	igns <u>Yes</u>
Accidents - Past Two Years	<u>o</u>	Land Use	Agricultural
Accidents - Past Ten Years	<u>o</u>	Approach	Straight, Level
Local Priority	<u>14</u>	Ride	Rough

Miscellaneous: View distance - 2,000'

Crossing surface Sight distance Approach warning devices

Alternative	Estimated Cost
<ol> <li>Rubber crossing</li> <li>Illumination</li> <li>Pavement markings reconditioned</li> <li>Speed grooves/Rumble strips</li> </ol>	\$70,000 \$250 \$1,500 \$250
Recommended Course of Action	Estimated Total Cost
All alternatives. Alternative #1 is a project in the South Dakota Highway Construction Program.	\$72,000

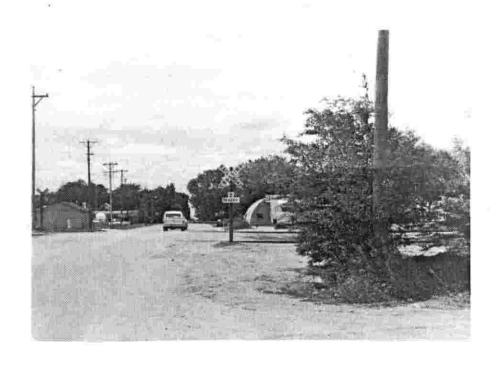
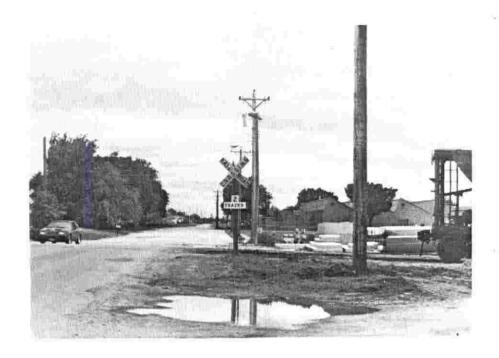
1ST AVENUE SE (CNW BRANCH) - Westbound

Tracks	1	Traffic Lanes	<u>2</u>
Trains/Day	0.5	Vehicles/Day	2,221
Train Speed	10	Vehicle Speed	20
Bus Crossings/Day (Passengers)	<u>.0</u>	Warning Device	Crossbucks
Hazardous Matls. Crossings/Day	0	Crossing Surface	Asphalt
Driveways Within 200'	2	Crossing Angle	70 degrees
Pavement Markings	<u>No</u>	Advance Warning Signs	No
Accidents - Past Two Years	<u>0</u>	Land Use	Industrial
Accidents - Past Ten Years	<u>3</u>	Approach	Straight, Level
Local Priority	_15	Ride	Moderate

Miscellaneous: View distance - 500'

Approach warning devices Traffic area interaction Sight distance Crossing surface

Alternative	Estimated Cost
1.	Advance warning signs	\$80
2.	Pavement markings	\$1,500
3.	Curb painting	\$50
4.	Illumination*	\$250
5.	Rubber crossing	\$70,000
	Recommended Course of Action	Estimated Total Cost
Alt	ernatives #1, #3, and #5.	\$70,130

Alternatives #1, #3, and #5.
Alternative #2 is not needed because of low rail traffic and uncertain future. Illumination (#4) previously recommended on Dakota Street should provide adequate lighting for both the crossing and the high traffic street intersection.
Alternative #5 is a scheduled project for 1985 in the 1985-1989 South Dakota DOT Construction Program.

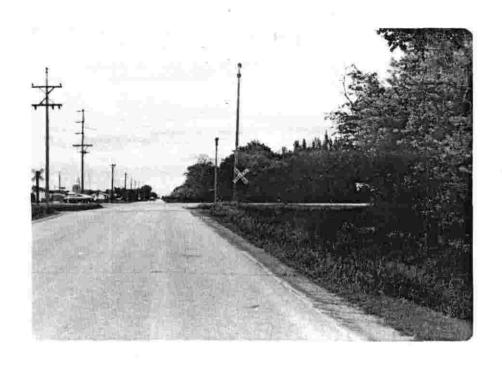
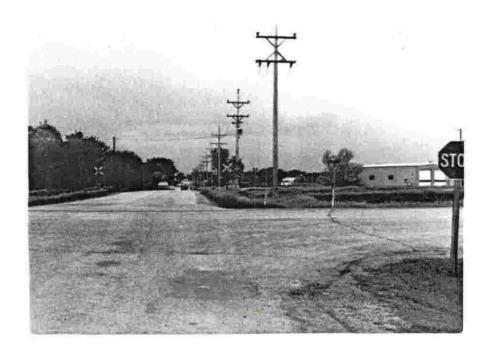
ROOSEVELT STREET (BN BRANCH) - Northbound

Tracks	1	Traffic Lanes	2
Trains/Day	<u>1</u>	Vehicles/Day	5,112
Train Speed	10	Vehicle Speed	<u>32</u>
Bus Crossings/Day (Passengers)	<u>70</u>	Warning Device	Crossbucks
Hazardous Matls. Crossings/Day	<u>8</u>	Crossing Surface	Asphalt
Driveways Within 200'	3	Crossing Angle	50 degrees
Pavement Markings Poo	or Condition	Advance Warning Signs	Yes
Accidents - Past Two Years	<u>o</u>	Land Use	Agricultural
Accidents - Past Ten Years	<u>o</u>	Approach	Straight, Level
Local Priority	_15	Ride	Good

Miscellaneous: View distance - 1,000'

Approach warning devices Crossing Surface

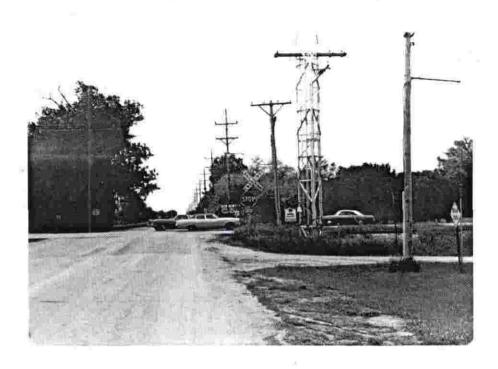
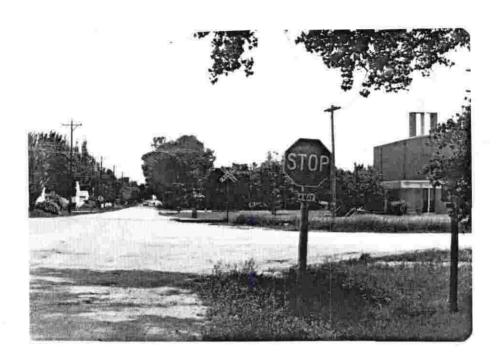
MELGAARD ROAD - Westbound

Tracks	<u>1</u>	Traffic Lanes	<u>2</u>
Trains/Day	1	Vehicles/Day	3,577
Train Speed	10	Vehicle Speed	<u>15</u>
Bus Crossings/Day (Passeng	ers) <u>0</u>	Warning Device	Crossbucks
Hazardous Matls. Crossings	/Day <u>0</u>	Crossing Surface	Asphalt/Timber Header
Driveways Within 200'	<u>0</u>	Crossing Angle	90 degrees
Pavement Markings	Incomplete, Faded	Advance Warning Si	gns <u>Yes</u>
Accidents - Past Two Years	<u>o</u>	Land Use	Residential
Accidents - Past Ten Years	<u>0</u>	Approach	Straight, Level
Local Priority	<u>13</u>	Ride	Good

Miscellaneous: View distance - 1,000'

# 1. Pavement markings \$1,500 2. Illumination \$250 Recommended Course of Action Estimated Total Cost

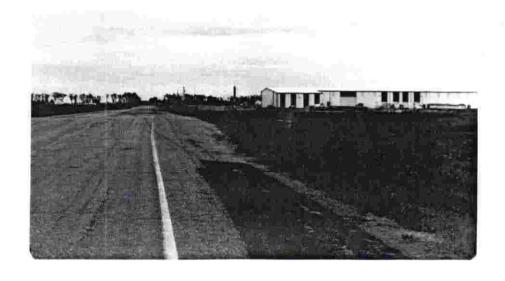
BROWN COUNTY #19 (BN BRANCH) - Northbound

A. Control of the con			
Tracks	1	Traffic Lanes	<u>2</u>
Trains/Day	1	Vehicles/Day	400
Train Speed	10	Vehicle Speed	<u>37</u>
Bus Crossings/Day (Passengers	) <u>50</u>	Warning Device	Crossbucks
Hazardous Matls. Crossings/Da	y <u>8</u>	Crossing Surface	Asphalt
Driveways Within 200'	<u>2</u>	Crossing Angle	70 degrees
Pavement Markings	Poor Condition	Advance Warning Signs	Yes
Accidents - Past Two Years	<u>0</u>	Land Use Agricult	ural, Recreational
Accidents - Past Ten Years	1	Approach	Straight, Level
Local Priority	<u>15</u>	Ride	Rough

HAZARD	RATING	187

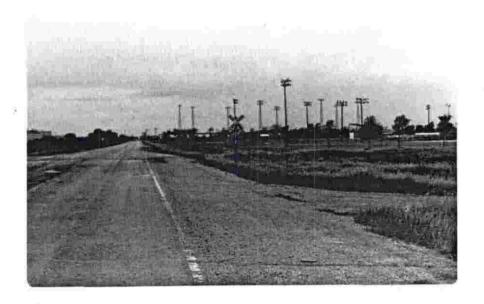
BROWN COUNTY #19 (BN BRANCH) - Southbound

Warning Device at Crossing Approach Warning Devices Crossing Surface

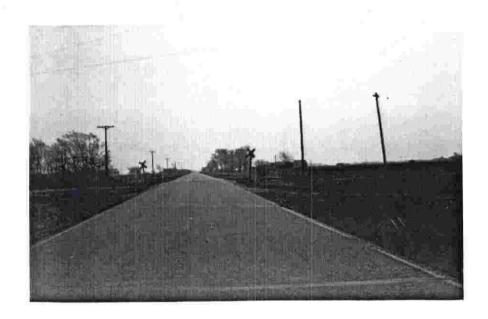
#### FAIRGROUNDS ROAD - Eastbound

Miscellaneous: View distance - 500'

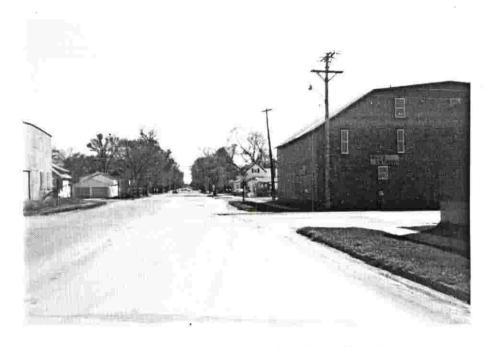
STATE STREET (BN SPUR) - Southbound

Approach warning devices Crossing elimination

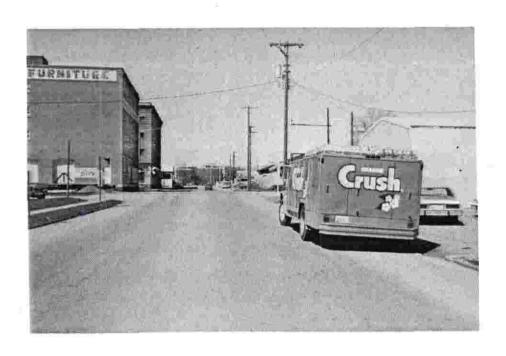
KLINE STREET (BN SPUR) - Northbound

Tracks	1	Traffic Lanes	2
Trains/Day	0.5	Vehicles/Day	4,411
Train Speed	10	Vehicle Speed	<u>23</u>
Bus Crossings/Day (Passengers)	<u>80</u>	Warning Device	Crossbucks
Hazardous Matls. Crossings/Day	1	Crossing Surface	Asphalt
Driveways Within 200'	<u>3</u>	Crossing Angle	90 degrees
Pavement Markings	No	Advance Warning Signs	Yes
Accidents - Past Two Years	<u>0</u>	Land Use	Commercial
Accidents - Past Ten Years	<u>o</u>	Approach	Straight, Level
Local Priority	11	Ride	Moderate

HAZARD RATING 162

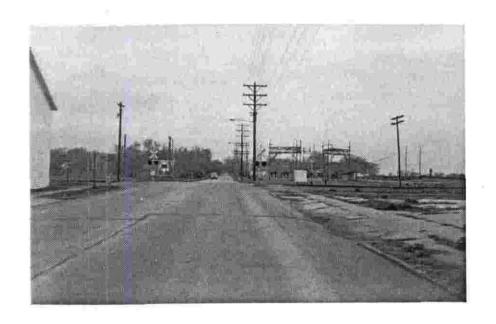
3RD AVENUE SW - Westbound

#### DATA INVENTORY Traffic Lanes 2 Tracks 1 3,652 Vehicles/Day Trains/Day 1 26 10 Vehicle Speed Train Speed Warning Device Crossbucks 45 Bus Crossings/Day (Passengers) Asphalt Crossing Surface 0 Hazardous Matls. Crossings/Day 90 degrees Driveways Within 200' 1 Crossing Angle No Advance Warning Signs No Pavement Markings Open Space Accidents - Past Two Years 0 Land Use Straight, Level Accidents - Past Ten Years Approach Good Ride Local Priority

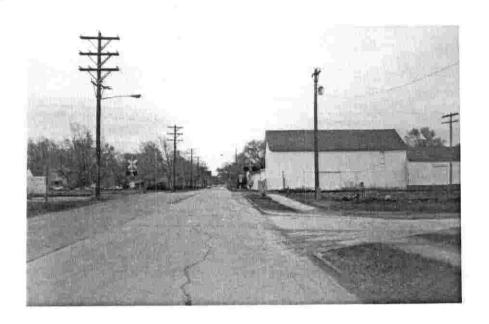
3RD AVENUE SW - Eastbound

Warning device at crossing Approach warning devices Sight distance

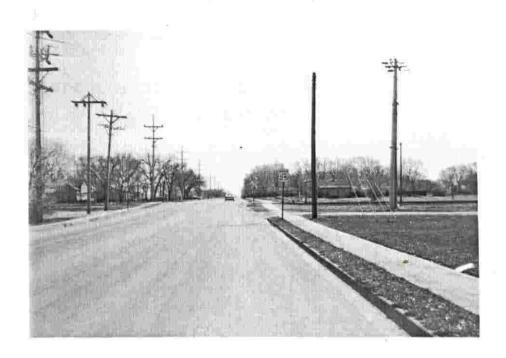
8TH AVENUE NE - Eastbound

Approach warning devices Traffic area interaction Sight distance

Alternative	Estimated Cost
1. Advance warning signs	\$80
<ol><li>Pavement markings</li></ol>	\$1,500
3. Curb painting	\$50
4. Illumination	\$250
Recommended Course of Action	Estimated Total Cost
All alternatives. Despite the low rail traffic and questionable future of this line, a new rubber	\$1,880
crossing is currently being installed.

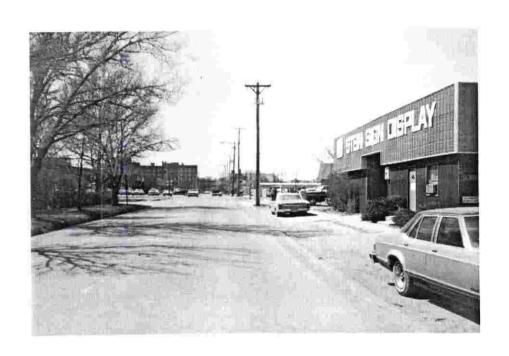
3RD AVENUE SE (CNW BRANCH) - Westbound

DATA INVENTORY				
Tracks	<u>2</u>	Traffic Lanes	, <u>2</u> ,	
Trains/Day	0.5	Vehicles/Day	8.556	
Train Speed	<u>10</u>	Vehicle Speed	<u>15</u>	
Bus Crossings/Day (Passengers)	25	Warning Device	Crossbucks	
Hazardous Matls. Crossings/Day	<u>o</u>	Crossing Surface	Asphalt	
Driveways Within 200'	2	Crossing Angle	70 degrees	
Pavement Markings	No	Advance Warning Signs	<u>No</u>	
Accidents - Past Two Years	<u>o</u>	Land Use	Industrial	
Accidents - Past Ten Years	<u>o</u>	Approach	Straight, Level	
Local Priority	_15	Ride	Good

HAZARD RATING 103

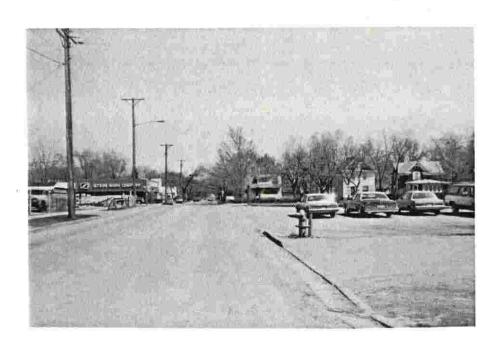
3RD AVENUE SE (CNW BRANCH) - Eastbound

Approach warning devices Traffic Area Interaction Sight Distance

<u>Alternative</u>	Estimated Cost
1.	Advance warning signs westbound	\$40
2.	Pavement markings westbound	\$750
3.	Crossing/street intersection engineering design study	Minor
	Recommended Course of Action	Estimated Total Cost

All alternatives. Advance warning devices should be shared between all 3rd Avenue crossings. Since Dakota Street is a new, high traffic route, an engineering design study for preemptive signals may be necessary to avoid potential conflicts at the Dakota/3rd Avenue intersection caused by train movements.

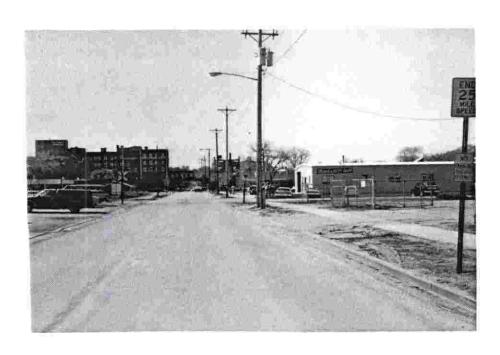
3RD AVENUE SE (CNW SPUR) - Westbound

Tracks	1	Traffic Lanes	<u>2</u>
Trains/Day	0.5	Vehicles/Day	8,556
Train Speed	10	Vehicle Speed	<u>15</u>
Bus Crossings/Day (Passengers)	0	Warning Device	Crossbucks
Hazardous Matls. Crossings/Day	0	Crossing Surface	Asphalt
Driveways Within 200'	<u>4</u>	Crossing Angle	80 degrees
Pavement Markings	<u>No</u>	Advance Warning Signs	No
Accidents - Past Two Years	<u>0</u>	Land Use	Commercial
Accidents - Past Ten Years	0	Approach	Straight, Level
Local Priority	15	Ride	Moderate

HAZARD	RATING	98

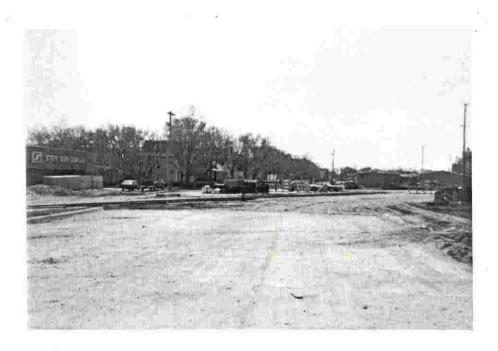
DAKOTA STREET (CNW BRANCH) - Southbound

Miscellaneous: View distance - Less than 500'
\*This crossing is under construction.
Signals are to be installed.

Warning devices at crossings Approach warning devices Traffic area interaction Sight distance

Alternative	Estimated Cost
1. Crossbucks	\$80
2. Advance warning signs	\$80
3. Pavement markings	\$1,500
4. Curb painting	\$50
5. Illumination	\$250
Recommended Course of Action	Estimated Total Cost
All Alternatives except #3 because of nearby BN crossings, low train traffic, and uncertain future of	\$460
the rail line.

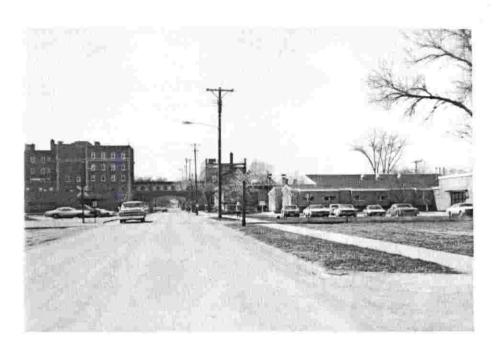
3RD AVENUE SE (BN SPUR) - Westbound

Tracks	1	Traffic Lanes	2
Trains/Day	0.5	Vehicles/Day	8,556
Train Speed	10	Vehicle Speed	<u>15</u>
Bus Crossings/Day (Passengers)	<u>25</u>	Warning Device	Crossbucks
Hazardous Matls. Crossings/Day	0	Crossing Surface	Asphalt
Driveways Within 200'	<u>3</u>	Crossing Angle	70 degrees
Pavement Markings	<u>No</u>	Advance Warning Signs	No
Accidents - Past Two Years	<u>0</u>	Land Use	Commercial
Accidents - Past Ten Years	<u>0</u>	Approach	Straight, Level
Local Priority	_15	Ride	Good

HAZARD	RATING	88

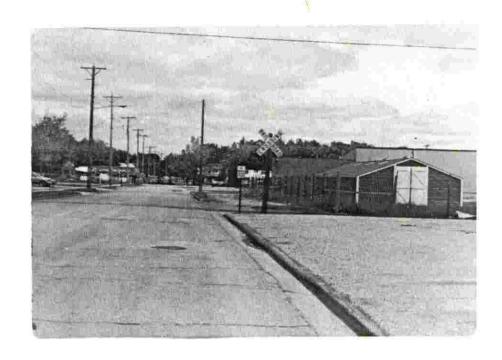
3RD AVENUE SE (BN SPUR) - Eastbound

Approach warning devices Traffic area interaction Crossing surface

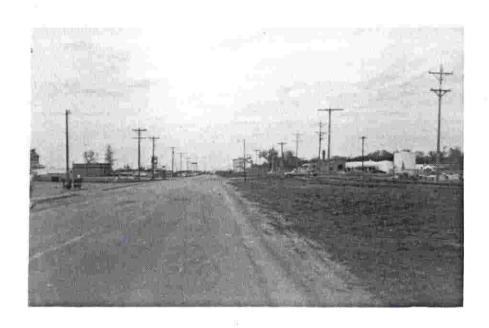
FIFTH STREET S. - Northbound

#### Traffic Lanes Tracks 1 2,500 0 Vehicles/Day Trains/Day Vehicle Speed 25 0 Train Speed Crossbucks Warning Device 0 Bus Crossings/Day (Passengers) Crossing Surface Asphalt 0 Hazardous Matls. Crossings/Day Crossing Angle 35 degrees 2 Driveways Within 200' Advance Warning Signs No No Pavement Markings Land Use Industrial Accidents - Past Two Years 0 Approach Straight, Level Accidents - Past Ten Years 0 Ride 6 Rough Local Priority

HAZARD	RATING	80

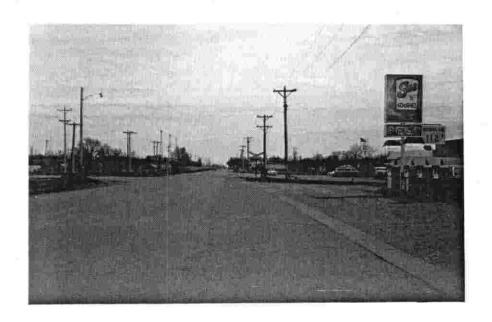
FIFTH STREET S. - Southbound

Advance warning devices

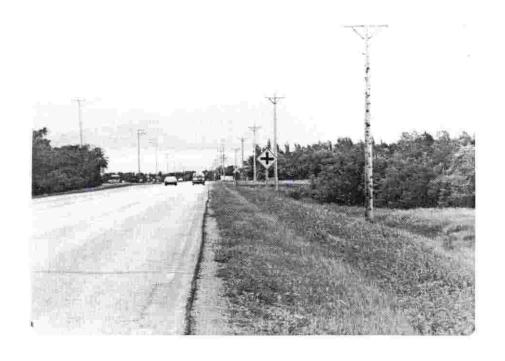
BROWN COUNTY #17 - Westbound

Tracks	1	Traffic Lanes	4
Trains/Day	1	Vehicles/Day	5,554
Train Speed	10	Vehicle Speed	<u>43</u>
Bus Crossings/Day (Passengers)	<u>0</u>	Warning Device	Crossbucks
Hazardous Matls. Crossings/Day	<u>o</u>	Crossing Surface	Asphalt
Driveways Within 200'	0	Crossing Angle	40 degrees
Pavement Markings <u>Poor Condition/Wes</u>	t Side	Advance Warning Signs	Yes
Accidents - Past Two Years	<u>o</u>	Land Use	Agricultural
Accidents - Past Ten Years	0	Approach	Straight, Level
Local Priority	15	Ride	Good

HAZARD RATING 66

Miscellaneous: View distance - 2,000'

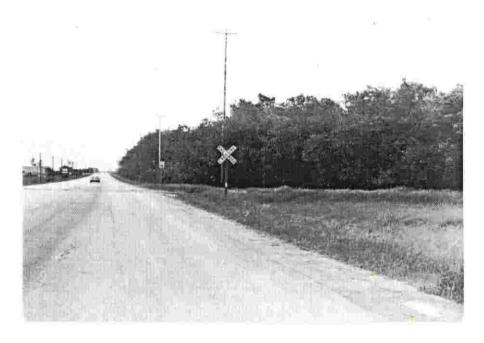
BROWN COUNTY #17 - Eastbound

Advance warning device Sight distance Crossing surface

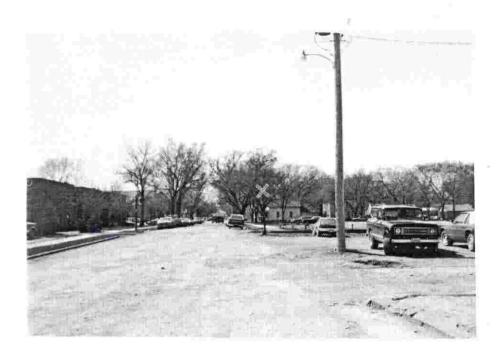
2ND AVENUE SE (BN SPUR) - Westbound

Tracks	<u>2</u>	Traffic Lanes	2_
Trains/Day	0.5	Vehicles/Day	1,800
Train Speed	<u>10</u>	Vehicle Speed	<u>18</u>
Bus Crossings/Day (Passengers)	<u>0</u>	Warning Device	Crossbucks
Hazardous Matls, Crossings/Day	<u>0</u>	Crossing Surface	Asphalt
Driveways Within 200'	<u>3</u>	Crossing Angle	80 degrees
Pavement Markings	<u>No</u>	Advance Warning Signs	No
Accidents - Past Two Years	<u>0</u>	Land Use	Industrial
Accidents - Past Ten Years	<u>0</u>	Approach	Straight, Level
Local Priority	_15	Ride	Rough

HAZARD RATING 64

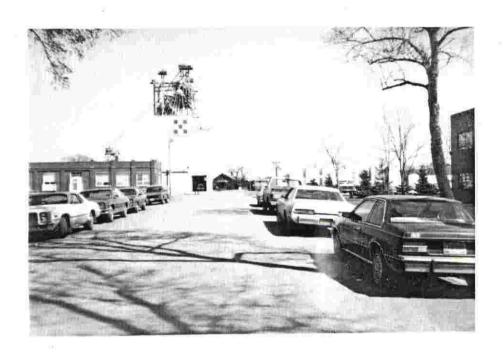
## 2ND AVENUE SE (BN SPUR) - Eastbound

needed at this low traffic location for both modes.

Alternative	Estimated Cost
<ol> <li>Advance warning signs</li> <li>Pavement markings</li> <li>Curb painting</li> <li>Rubber crossing</li> </ol>	\$80 \$1,500 \$80 \$40,000
Recommended Course of Action	Estimated Total Cost
Alternatives #1 and #3. Alternatives #2 and 4 are not	\$160

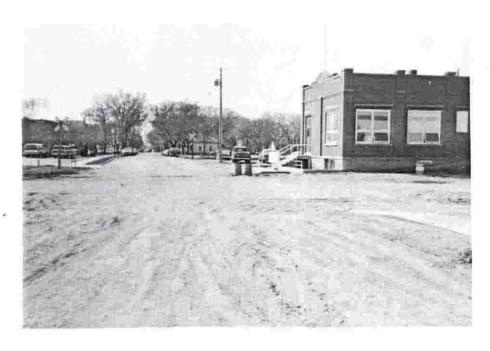
2ND AVENUE SE (CNW SPUR) - Westbound

Tracks	<u>2</u>	Traffic Lanes 2
Trains/Day	0.5	Vehicles/Day 1.800
Train Speed	<u>10</u>	Vehicle Speed <u>18</u>
Bus Crossings/Day (Passengers)	<u>0</u>	Warning Device <u>Crossbucks</u>
Hazardous Matls. Crossings/Day	<u>o</u>	Crossing Surface <u>Timber Section</u> , <u>Gravel</u>
Driveways Within 200'	<u>0</u>	Crossing Angle <u>85 degrees</u>
Pavement Markings	No	Advance Warning Signs <u>No</u>
Accidents - Past Two Years	<u>o</u>	Land Use <u>Industrial</u>
Accidents - Past Ten Years	<u>o</u>	Approach Straight, Level
Local Priority	_15	Ride <u>Rough</u>

HAZARD RATING 64

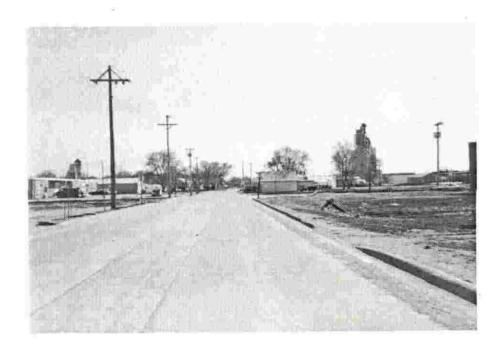
DAKOTA STREET (BN BRANCH) - Southbound

Miscellaneous: View distance - 1,000'
\*This crossing shares advance warning signs with the
Main Line/Dakota Street Crossing.

Warning devices at crossing Approach warning devices Traffic area interaction

Alternative	Estimated Cost
1.	Move crossbuck for southbound lane back to crossing	Minor
2.	Pavement markings*	
3.	Curb painting	\$50
fi.	Recommended Course of Action	Estimated Total Cost
	3 Alternatives	\$50
	ement markings should be shared with Main Line/Dakota Street crossing.

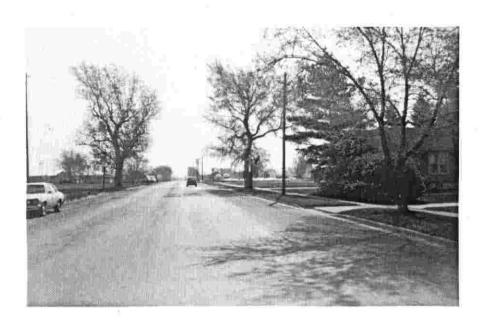
1ST AVENUE SE (BN SPUR) - Eastbound

Warning devices at crossing Approach warning devices Traffic area interaction Crossing surface

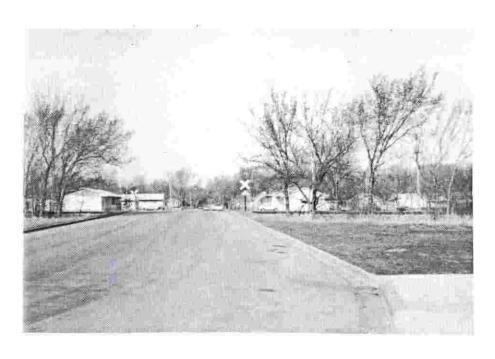
5TH AVENUE NE - Westbound

Tracks	<u>2</u>	Traffic Lanes	<u>2</u>
Trains/Day	0.5	Vehicles/Day	500
Train Speed	<u>10</u>	Vehicle Speed	<u>16</u>
Bus Crossings/Day (Passengers)	<u>0</u>	Warning Device	Crossbucks
Hazardous Matls. Crossings/Day	<u>0</u>	Crossing Surface	Asphalt
Driveways Within 200'	4	Crossing Angle	70 degrees
Pavement Markings	No	Advance Warning Signs	No
Accidents - Past Two Years	<u>0</u>	Land Use	Residential
Accidents - Past Ten Years	<u>o</u>	Approach	Straight, Level
Local Priority	_15	Ride	Rough

HAZARD RATING 46

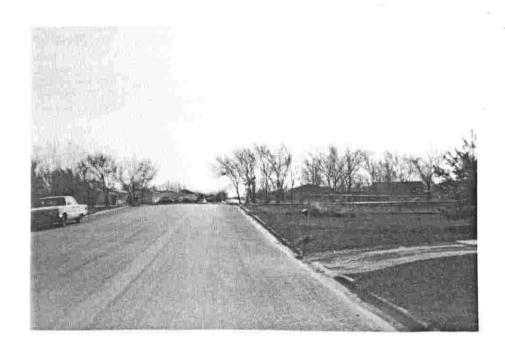
5TH AVENUE NE - Eastbound

Approach warning devices Traffic area interaction

<u>Alternative</u>	Estimated Cost
<ol> <li>Advance warning signs</li> <li>Pavement markings</li> <li>Curb painting</li> </ol>	\$80 \$1,500 \$50
Recommended Course of Action	Estimated Total Cost
Alternatives #1 and #3. Pavement markings are not needed at this	\$130

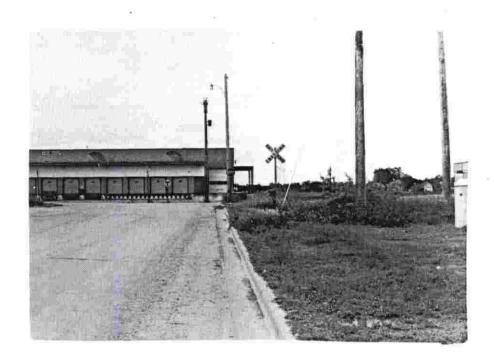
12TH AVENUE SW - Westbound

DATA INVENTORY					
Tracks	<u>2</u>	Traffic Lanes	<u>2</u>		
Trains/Day	1	Vehicles/Day	1,289		
Train Speed	10	Vehicle Speed	<u>15</u>		
Bus Crossings/Day (Passengers)	0	Warning Device	Crossbucks		
Hazardous Matls. Crossings/Day	0	Crossing Surface	Asphalt		
Driveways Within 200'	2	Crossing Angle	90 degrees		
Pavement Markings	No	Advance Warning Signs	<u>East</u> Side		
Accidents - Past Two Years	<u>0</u>	Land Use	Industrial		
Accidents - Past Ten Years	<u>o</u>	Approach	Straight, Level		
Local Priority	_15	Ride	Good

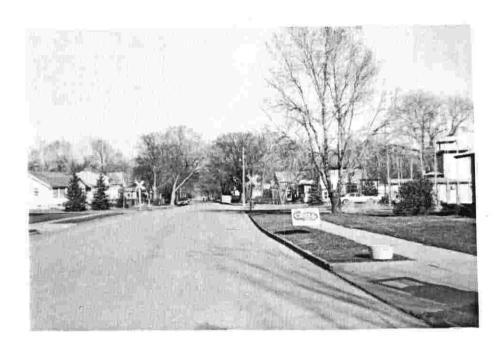
9TH AVENUE SE - Eastbound

Approach warning devices Crossing surface

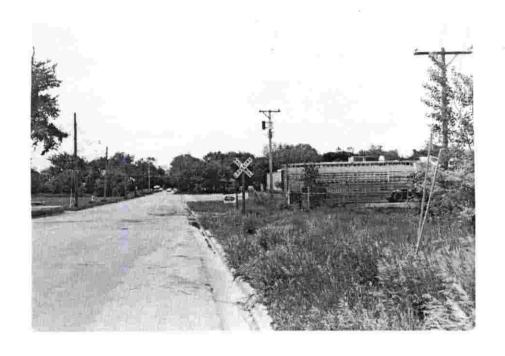
9TH AVENUE SW (AT GAGE BROS.) - Westbound

#### DATA INVENTORY Traffic Lanes 2 1 Tracks 550 Vehicles/Day 0 Trains/Day Vehicle Speed 13 0 Train Speed Crossbucks Warning Device 12 Bus Crossings/Day (Passengers) Crossing Surface Asphalt 0 Hazardous Matls. Crossings/Day 90 degrees Crossing Angle 3 Driveways Within 200' Advance Warning Signs No No Pavement Markings Land Use Industrial Accidents - Past Two Years 0 Straight, Level Approach Accidents - Past Ten Years 0 Rough 15 Ride Local Priority

HAZARD RATING 42

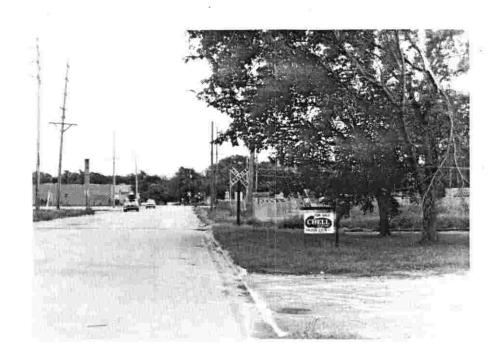
9TH AVENUE SW (AT GAGE BROS.) - Eastbound

Sight distance Advance warning devices

# Alternative Estimated Cost 1. Illumination \$250 2. Pavement markings to the east \$750 Recommended Course of Action Estimated Total Cost Both alternatives. However, if a rail user does not locate in the warehouse formerly operated

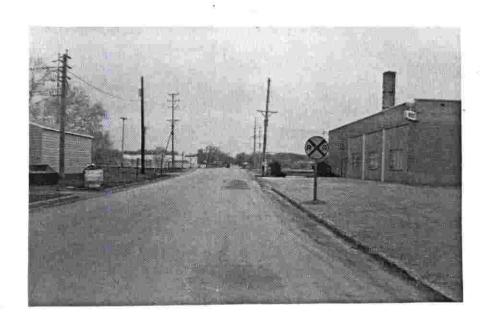
9TH AVENUE SW (SD CORE) - Westbound

Tracks	1	Traffic Lanes	<u>2</u>
Trains/Day	1	Vehicles/Day	550
Train Speed	10	Vehicle Speed	<u>18</u>
Bus Crossings/Day (Passengers)	<u>12</u>	Warning Device	Crossbucks
Hazardous Matls. Crossings/Day	<u>0</u>	Crossing Surface	Asphalt
Driveways Within 200'	<u>3</u>	Crossing Angle	90 degrees
Pavement Markings	No	Advance Warning Signs	<u>No</u>
Accidents - Past Two Years	<u>0</u>	Land Use	Industrial
Accidents - Past Ten Years	<u>0</u>	Approach	Straight, Level
Local Priority	_15	Ride	Rough

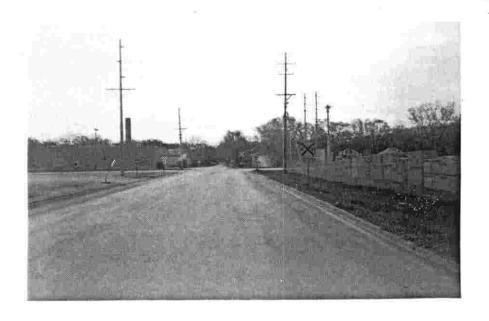
9TH AVENUE SW (SD CORE) - Eastbound

HAZARD RATING 36

Sight distance Advance warning devices

Alternative	Estimated Cost
1.	Illumination	\$250
2.	Pavement markings to the east	\$750
	Advance Warning Sign to the east	\$40
	Recommended Course of Action	Estimated Total Cost
- A11	alternatives.	\$1,040

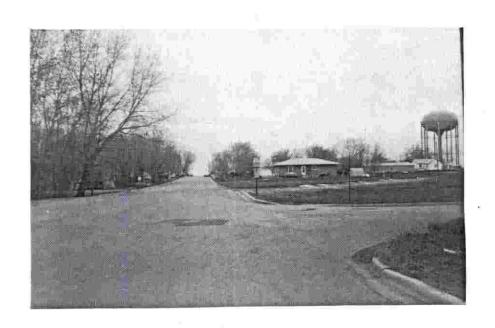
9TH AVENUE SW (WEST END) - Westbound

DATA INVENTORY					
Tracks	<u>2</u>	Traffic Lanes	<u>2</u> .		
Trains/Day	0	Vehicles/Day	200		
Train Speed	0	Vehicle Speed	<u>18</u>		
Bus Crossings/Day (Passengers)	0	Warning Device 1	Crossbuck on west side		
Hazardous Matls. Crossings/Day	<u>o</u>	Crossing Surface	Asphalt		
Driveways Within 200'	2	Crossing Angle	45 degrees		
Pavement Markings	No	Advance Warning S	Signs <u>No</u>		
Accidents - Past Two Years	<u>0</u>	Land Use	Residential		
Accidents - Past Ten Years	<u>o</u>	Approach	Straight, Level		
Local Priority	15	Ride	Rough

HAZARD RATING 35

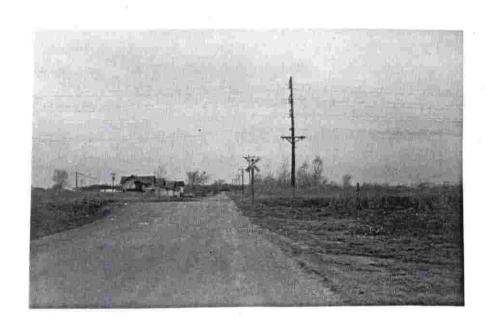
2ND AVENUE NW - Westbound

DATA INVENTORY				
Tracks	1	Traffic Lanes	<u>2</u>	
Trains/Day	0	Vehicles/Day	<u>50</u>	
Train Speed	0	Vehicle Speed	<u>15</u>	
Bus Crossings/Day (Passengers)	<u>0</u>	Warning Device	Crossbuck on east side	
Hazardous Matls. Crossings/Day	<u>0</u>	Crossing Surface	Asphalt on Wood Plank	
Driveways Within 200'	<u>3</u>	Crossing Angle	80 degrees	
Pavement Markings	No	Advance Warning Si	gns <u>No</u>	
Accidents - Past Two Years	<u>o</u>	Land Use	Open Space	
Accidents - Past Ten Years	<u>o</u>	Approach	Straight, Level	
Local Priority	15	Ride	Rough

HAZARD RATING	
	31

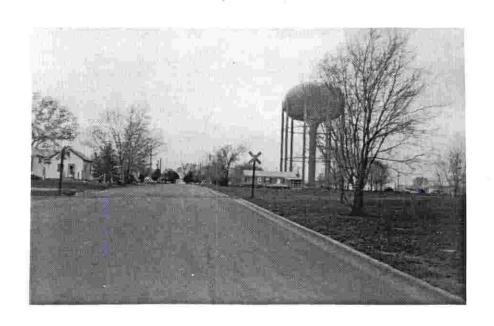
8TH AVENUE SW - Westbound

DATA INVENTORY				
Tracks	1	Traffic Lanes	<u>2</u>	
Trains/Day	<u>o</u>	Vehicles/Day	500	
Train Speed	<u>o</u>	Vehicle Speed	18	
Bus Crossings/Day (Passengers)	<u>o</u>	Warning Device	Crossbucks	
Hazardous Matls. Crossings/Day	<u>o</u>	Crossing Surface	Asphalt	
Driveways Within 200'	<u>2</u>	Crossing Angle	45 degrees	
Pavement Markings	No	Advance Warning Signs	No	
Accidents - Past Two Years	<u>0</u>	Land Use	Residential	
Accidents - Past Ten Years	<u>0</u>	Approach	Straight, Level	
Local Priority	<u>15</u>	Ride	Rough

HAZARD RATING 30

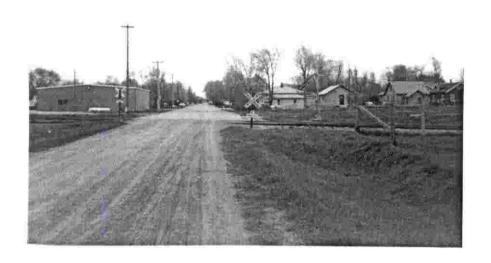
12TH STREET S. - Northbound

Tracks	<u>1</u>	Traffic Lanes	<u>2</u>
Trains/Day	<u>0</u>	Vehicles/Day	50
Train Speed	0	Vehicle Speed	12
Bus Crossings/Day (Passengers)	<u>0</u>	Warning Device	Crossbucks
Hazardous Matls. Crossings/Day	<u>o</u>	Crossing Surface	Gravel
Driveways Within 200'	<u>4</u>	Crossing Angle	60 degrees
Pavement Markings	No	Advance Warning Signs	<u>No</u>
Accidents - Past Two Years	<u>0</u>	Land Use	Agricultural
Accidents - Past Ten Years	<u>o</u> .	Approach	Straight, Level
Local Priority	_15	Ride	Rough

HAZARD RATING 29

Miscellaneous: View distance - 500'

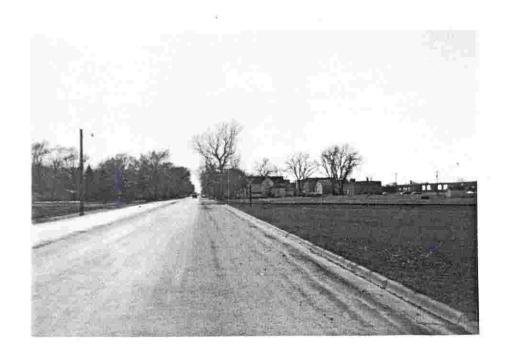
1ST AVENUE SE (BN BRANCH) - Westbound

Tracks	<u>1</u>	Traffic Lanes	<u>2</u>
Trains/Day	<u>0</u>	Vehicles/Day	2,221
Train Speed	<u>0</u>	Vehicle Speed	20
Bus Crossings/Day (Passengers)	<u>0</u>	Warning Device	Crossbucks
Hazardous Matls. Crossings/Day	<u>0</u>	Crossing Surface	Asphalt
Driveways Within 200'	1	Crossing Angle	70 degrees
Pavement Markings	No	Advance Warning Signs	No
Accidents - Past Two Years	<u>o</u>	Land Use	Open Space
Accidents - Past Ten Years	<u>o</u>	Approach	Straight, Level
Local Priority	_15	Ride	Moderate

HAZARD RATING 27

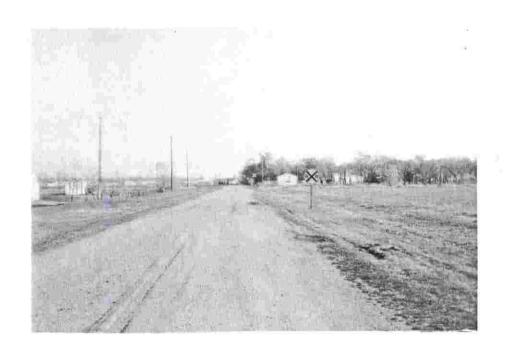
PRIVATE CEMETARY ROAD - Northbound

Tracks	1	Traffic Lanes	1_
Trains/Day	12	Vehicles/Day	10
Train Speed	10	Vehicle Speed	<u>10</u>
Bus Crossings/Day (Passengers)	<u>6</u>	Warning Device	Crossbucks
Hazardous Matls. Crossings/Day	<u>o</u>	Crossing Surface	Wood Plank
Driveways Within 200'	1	Crossing Angle	90 degrees
Pavement Markings	No	Advance Warning Signs	South Side Only
Accidents - Past Two Years	0	Land Use	Institutional

HAZARD	RATING	7

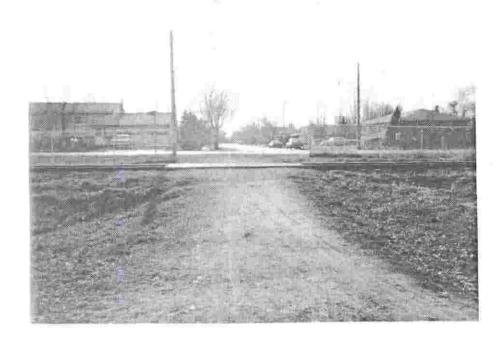
15TH AVENUE SW - Westbound

DATA INVENTORY							
Tracks	1	Traffic Lanes	;=				
Trains/Day	1	Vehicles/Day	_				
Train Speed	10	Vehicle Speed					
Bus Crossings/Day (Passengers)	:	Warning Device	_				
Hazardous Matls. Crossings/Day	-	Crossing Surface	_				
Driveways Within 200'	-	Crossing Angle	_				
Pavement Markings	=	Advance Warning Signs	_				
Accidents - Past Two Years	=	Land Use	-				
Accidents - Past Ten Years	-	Approach					
Local Priority	<u>15</u>	Ride					
The state of the s
