## Appendix J – Phase I Environmental Site Assessment

RE: Modified Phase I Environmental Site Assessment  
I-229 Exits 3 and 4  
Sioux Falls, South Dakota  
State Project No. IM 2292(84)3 and IM  
2292(101)4  
SEH No. SDDOT 147016

Short Elliott Hendrickson (SEH) has completed the Modified Phase I Environmental Site Assessment (ESA) for the I-229 Exits 3 and 4 Project located in Sioux Falls, South Dakota. The project area was assigned South Dakota Department of Transportation (SDDOT) Project Numbers IM 2292(84)3 and IM 2292(101)4. Select features are depicted on **Figures 1 and 2**.

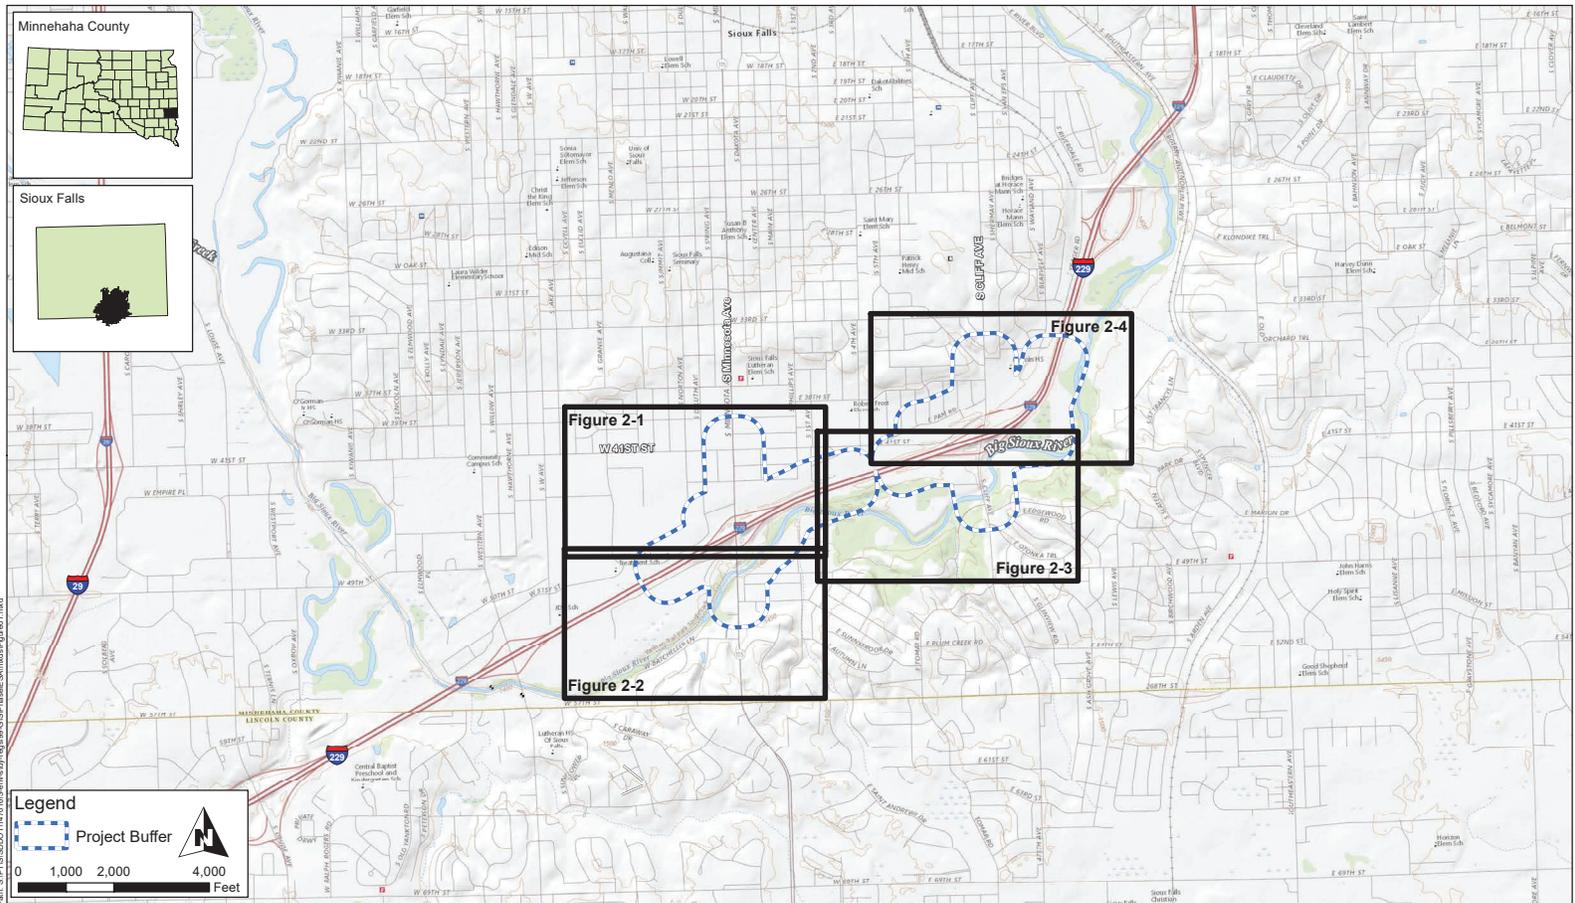
Figure 1 – Project Corridor Location

The topography of the project corridor and surrounding area is generally flat, with elevations ranging from approximately 1,400 to 1,500 feet amsl. The Big Sioux River runs east-west near the project corridor. It intersects South Minnesota Avenue and South Cliff Avenue on the southern portion of the project corridor. Low-lying floodplain associated with the Big Sioux River is adjacent to I-229 to the south. (USGS, 2019) Topography is depicted on **Figure 1**.

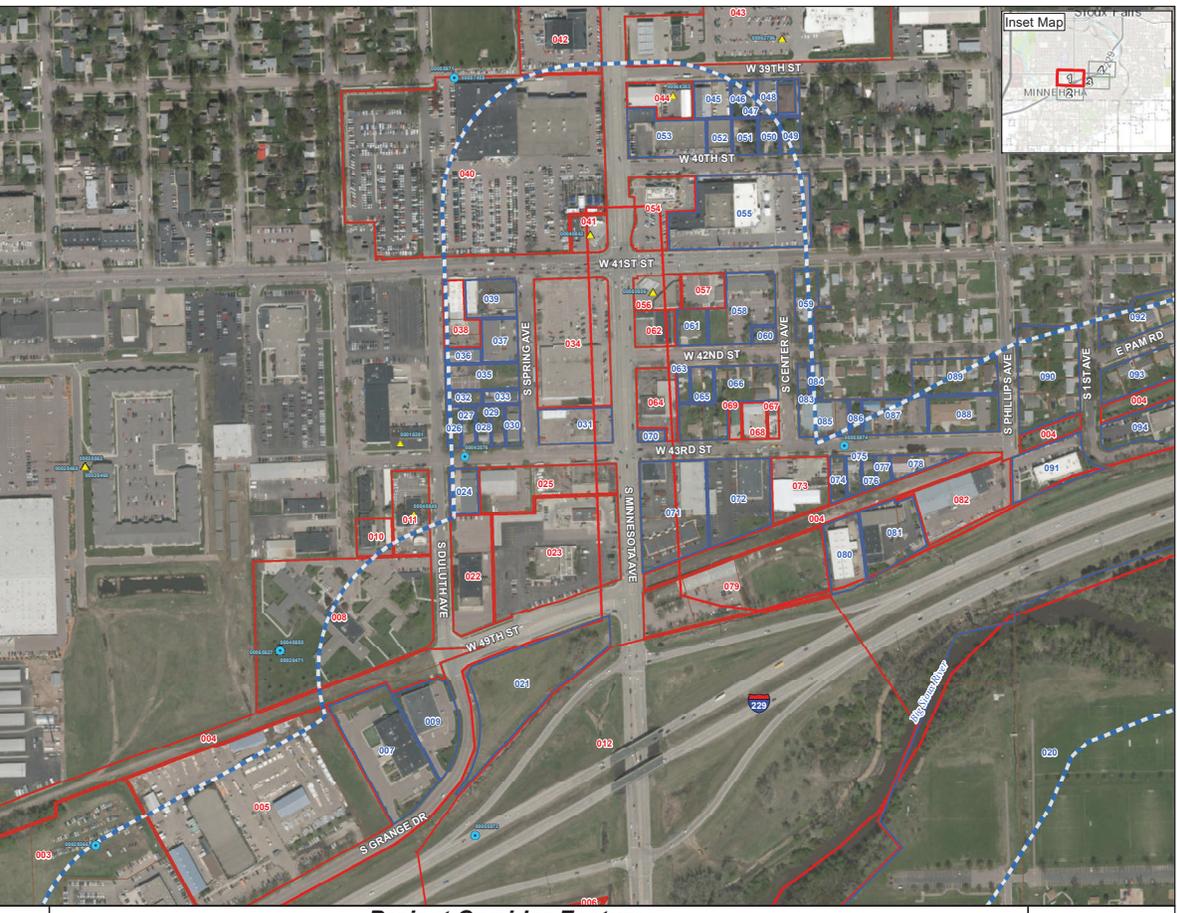
**Figure 2-1**

SEH ID	Current Use	Status	Site Summary
000	Vern Edge Acura Car Dealership	De minimis	Car dealership, auto repair, drums.
004	Vacant Land	De minimis	Former railroad corridor.
005	Scott's Lumber, Lampert Lumber Companies	De minimis	Lumber yard, RCRA SQG, former UST.
006	Fashion Trail Park	REC	Spills, dumps, sealed monitoring wells.
008	Southbridge Healthcare Rehabilitation Center	De minimis	Spill, former UST.
010	Apartment Building	De minimis	Transformer oil leak.
011	Midcontinent Communications	REC	Former auto repair, spill.
012	729 and South Minnesota Avenue Interchange	REC	Spills.
022	Former DakoAbilities Social Services Organization	De minimis	Phase I and II, Brownfield file.
023	VMW Post-202 Non-Profit Organization, Arby's Restaurant	HREC	Spill.
025	ABC Rentals Party Equipment Rental Service, Bartlett Basketball Academy Sports School	REC	Long history of auto repair and outdoor storage.
034	Multi-tenant Department Store	REC	Long history of auto fueling, former ASTs.

038	Unknown	REC	Tank Removal.
040	Simon Auto Car Dealership	REC	Potential former junk yard, car dealership.
041	Little Caesars Restaurant, The Big BBA Restaurant	REC	Long history of auto fueling, Leaks, Spills, USTs, sealed monitoring wells.
042	Simon Auto Car Dealership	De minimis	Auto dealer, Spill, Leak, removed UST, RCRA SQG.
043	Ry-Vee Grocery Store and Gas Station	REC	Former USTs, active fuel.
044	Best Brands Inc Window Treatment Store, Neighborhood Automotive Auto Repair Shop	REC	Former Brownfield, Spills, institutional controls, sealed monitoring wells, auto repair shop.
054	McDonald's Restaurant	REC	Former fuel station, undocumented tanks.
056	Simcar Fuel Station and Liquor Store	REC	Long history of auto fueling, Leaks, Spills, USTs, sealed monitoring wells.
057	Enterprise Rent-A-Car Car Rental Agency	De minimis	Former auto repair.
062	Rainbow Comics, Cars & Collectibles Center Book Store, H&B Block Tax Preparation Service	REC	Spill, long history of auto sales/service/fueling, plating shop, muffler shop.

064	T & A Services & Supply Inc Auto Repair Shop	REC	Auto repair, refrigerator recycle, outdoor storage of barrels.
067	Former Brake Center Auto Brake Repair Shop (vacant)	De minimis	Former auto repair.
068	Medical Equipment, Break Center	De minimis	Potential auto repair.
069	Unknown	De minimis	Former motorcycle shop.
073	Both and Class auto repair	De minimis	Current auto repair.
079	Multi-tenant Office Building	REC	Former petroleum bulk facility, Spills, Leaks.
082	St. Landon Company Electrical Supply Store	De minimis	Spills, Leak, former USTs.

Hazardous liquid pipelines were identified through the project corridor and are depicted on **Figure 2**. The NPMS public online viewer (NPMS, 2019) allows viewers to access general locations of pipeline accidents and incidents dating back to 2002. No liquid pipeline accidents or incidents were identified within the project corridor. Pipeline products can be released to the environment and are commonly the result of corrosion or accidental damage to the pipe system.

The following sites were identified for environmental concerns during this Modified Phase I ESA and are depicted on **Figure 2**. Site specific details for each site are included on individual data sheets in **Attachment A**. In general, the majority of the sites identified for environmental concerns are sites with a long history of auto repair and/or fueling operations. Several of these sites have documented petroleum

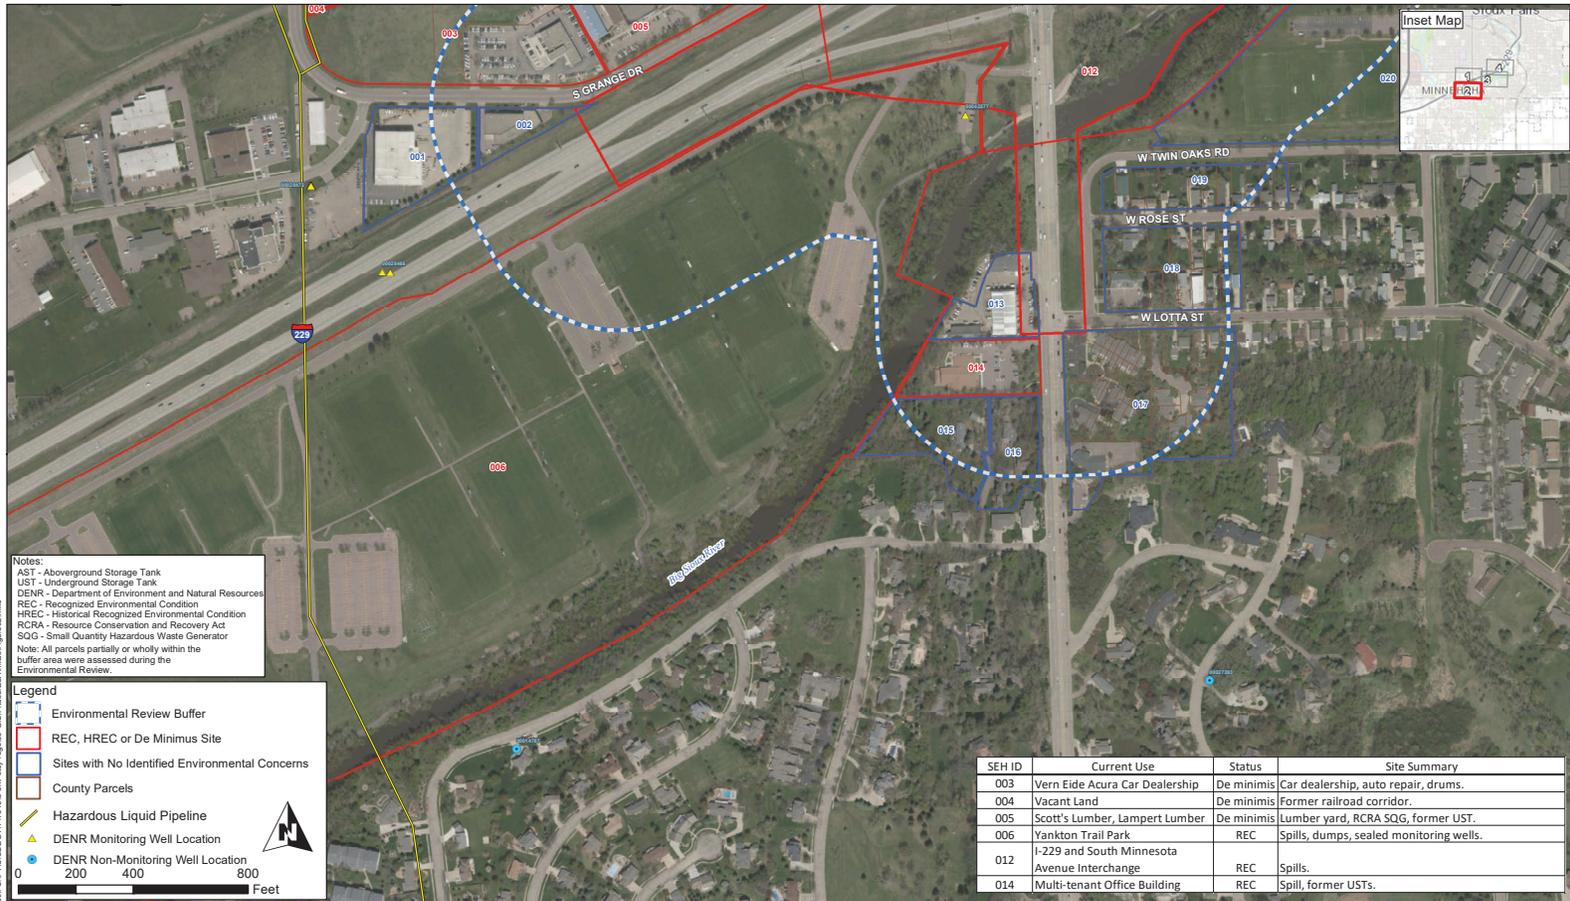
**Figure 2-2**

SEH ID	Current Use	Status	Site Summary
003	Vern Eide Acura Car Dealership	De minimis	Car dealership, auto repair, drums.
004	Vacant Land	De minimis	Former railroad corridor.
005	Scott's Lumber, Lampert Lumber	De minimis	Lumber yard, RCRA SQG, former UST.
006	Yankton Trail Park	REC	Spills, dumps, sealed monitoring wells.
012	Avenue Interchange	REC	Spills.
014	Multi-tenant Office Building	REC	Spill, former USTs.

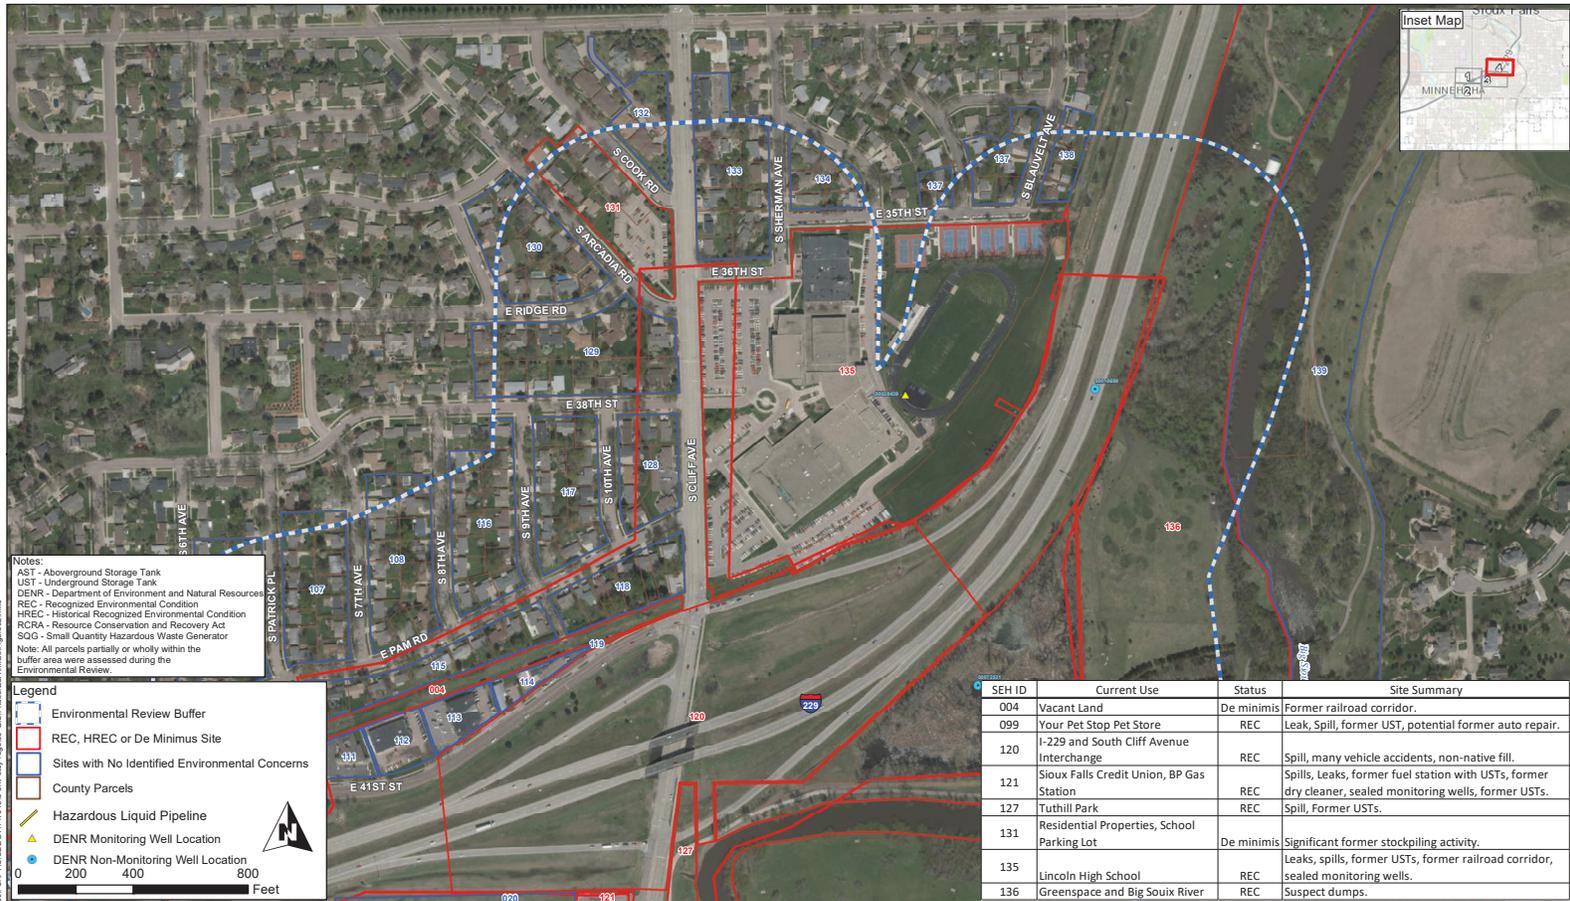
SEH ID	Current Use	Status	Site Summary
004	Vacant Land	De minimis	Former railroad corridor.
099	Your Pet Stop Pet Store	REC	Leak, Spill, former UST, potential former auto repair.
120	I-229 and South Cliff Avenue Interchange	REC	Spill, many vehicle accidents, non-native fill.
121	Sioux Falls Credit Union, BP Gas Station	REC	Spills, Leaks, former fuel station with USTs, former dry cleaner, sealed monitoring wells, former USTs.
127	Tuthill Park	REC	Spill, Former USTs.
131	Residential Properties, School Parking Lot	De minimis	Significant former stockpiling activity.
135	Lincoln High School	REC	Leaks, spills, former USTs, former railroad corridor, sealed monitoring wells.
136	Greenspace and Big Sioux River	REC	Suspect dumps.
