**REPORT FINDINGS**

PRJ # BRO 8006 (46)		PCN: 6778		Date: 6/10/14		Year Constructed: 2009							
County: Brookings				Structure Location: 06-290-177									
Assessed By: Maier/Boone				Stream Name: Medary Creek									
Structure Type			Structure Shape Comments										
	Number of Barrels X Width (ft) X Height (ft)		Inlet Type					Outlet Type*					
Box	4x12'x8'		Projecting					At Stream Grade					x
Arch			Wing wall					Cascade over Riprap					
Pipe Diameter			Headwall					Free Fall into Pool					
<sup>1</sup> Bridge			Apron					Free Fall Onto Rip Rap					
<sup>1</sup> Bridge Deck Length X Width			Riprap					Apron					
			Other:					Other:					
Rapid Visual Assessment:													
Observation												Y / N N.A.

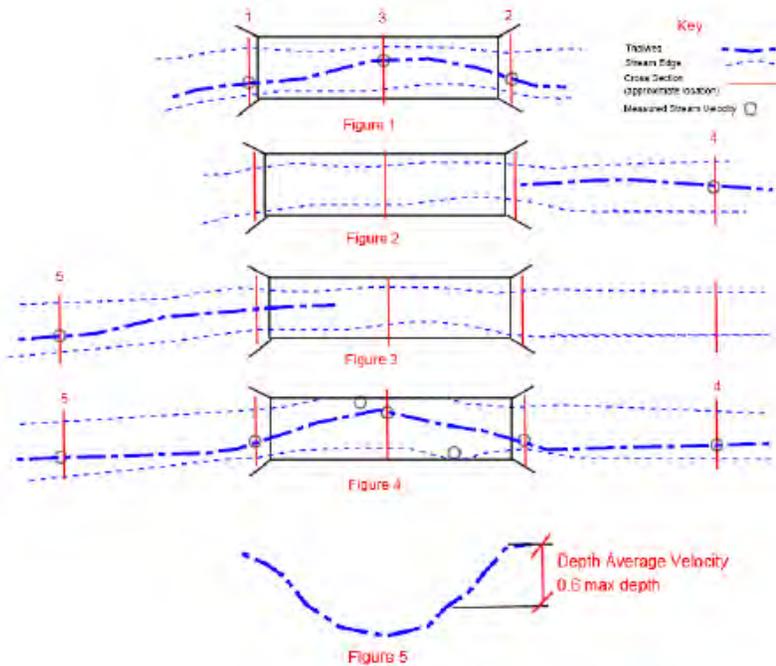
44.388572 -96.666561

Structure does not appear to affect fish passage or stream development.

Structure facing upstream

- Water was over 4ft deep, so no depth/velocity was able to be recorded													
- Vegetation is well established. No erosion apparent													
- Mud has accumulated in bottom of culvert. Box is countersunk per plans.

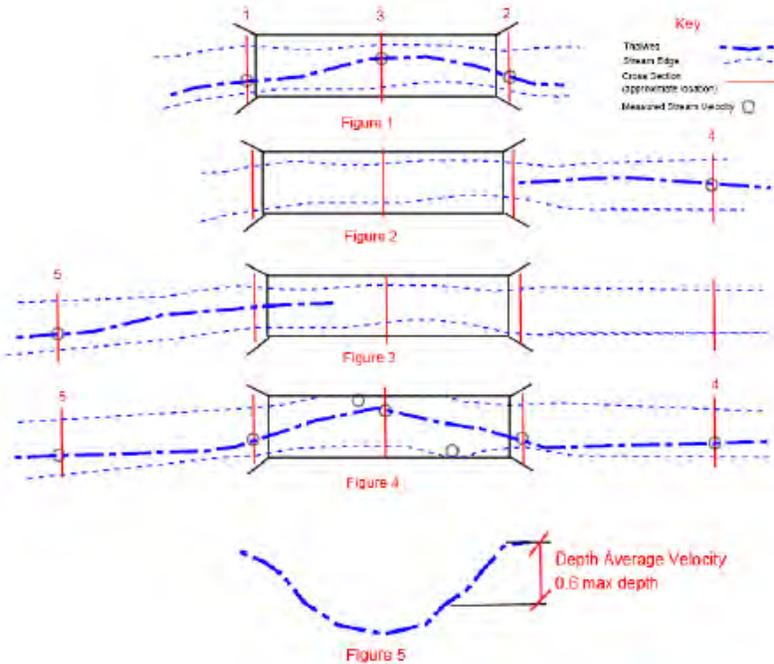
44.286196, -96.547133

2014 monitoring was for scheduled 3rd year evaluation. Water depth prohibited any measurements within the structure on 6/10/2014 and on return visit 7/29/2014. Still no change in wide channel area. Culvert is countersunk. Sediment (thick mud) is accumulating inside structure. Fish passage does not appear to be restricted by structure.

From structure facing upstream
