SOUTH DAKOTA DEPARTMENT OF TRANSPORTATION REST AREA STUDY: ALONG THE I-29 AND I-90 CORRIDORS

FINAL REPORT

South Dakota Department of Transportation

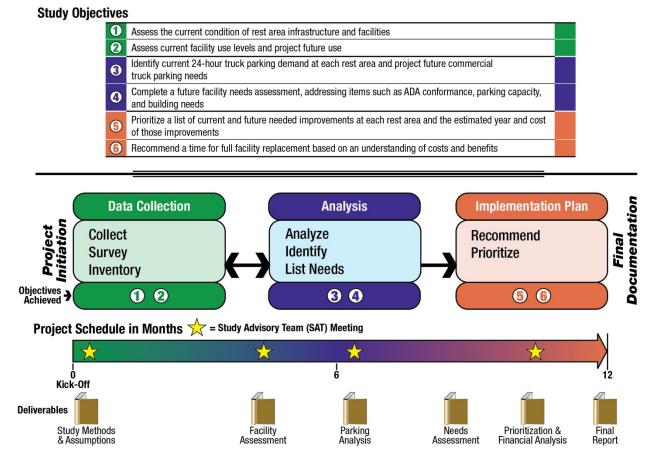
Figure 1. **Study Work Flow**

The project team designed a work flow and a schedule to meet the six study objectives, and the result is depicted on Figure 1. The project began in summer 2013 with the development of the Methods and Assumptions Document. Data collection efforts included site visits, interviews with SDDOT maintenance staff, and traffic/parking data collection at each rest area. The gathered data were used to develop an analysis of needs. Improvements were identified and prioritized in the Implementation Plan stage. Four meetings with the Study Advisory Team were used to support each step and to ensure that objectives were met.

Six project deliverables depicted on Figure 1 support the project objectives. They are described as follows:

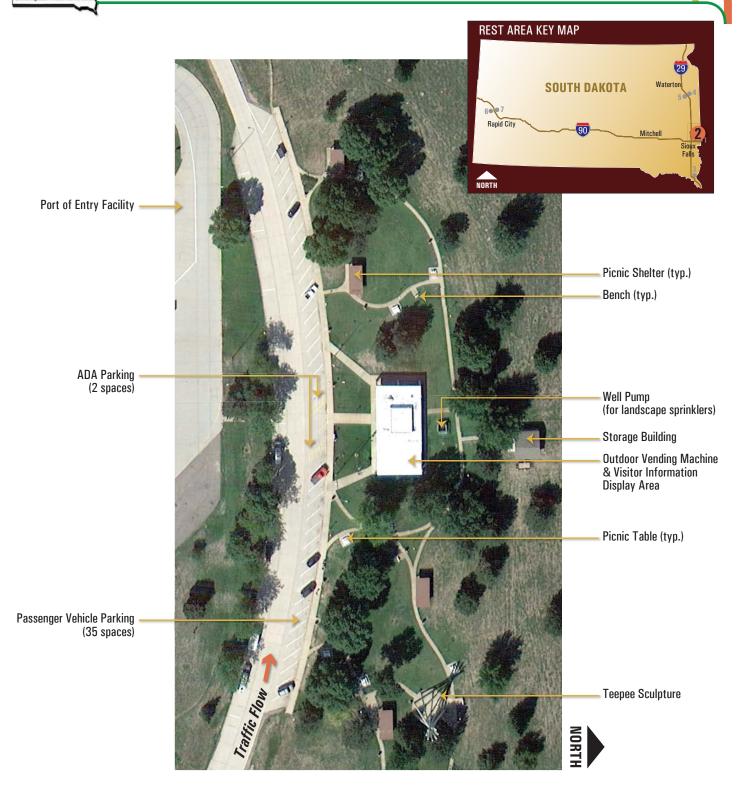
Figure 3. Valley Springs Rest Area Site Layout

Figures 3 through **9** provide aerial depictions of each rest area and identify basic rest area characteristics.

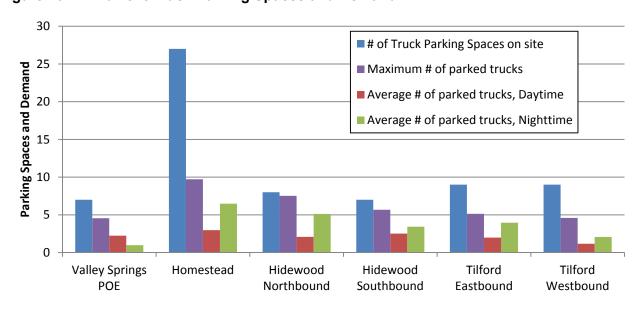
Figure 10. Current Truck Parking Spaces and Demand

Figure 10 depicts the truck parking spaces and demand. As shown, truck parking capacity meets average and maximum demand at each rest area, though the maximum number recorded at both Hidewood Rest Areas nearly reaches the capacity.

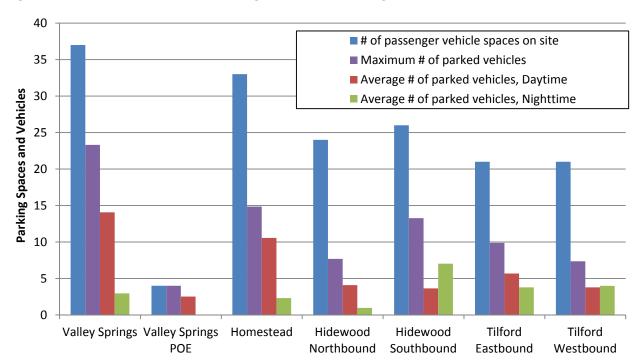
Figure 13. Forecast 2040 Passenger Vehicle Parking Spaces and Demand

Figure 13 shows the passenger vehicle parking spaces and occupancy. As shown, passenger vehicle parking capacity by 2040 continues to meet average and maximum demand at each rest area.

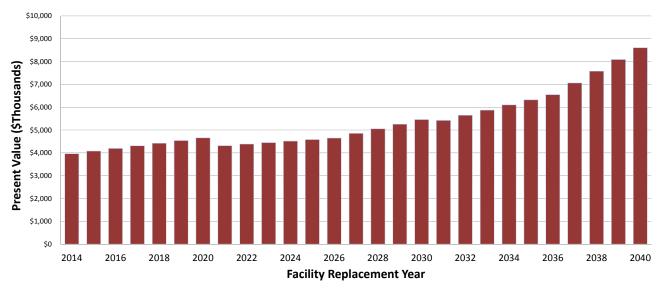
Figure 15. Present Value of Repair Plans – Hidewood North

Note: Total present value of the preservation plan through 2040 is \$6.1 million, not including the value of a new facility. Source: TSP and BBC Research & Consulting. 2014.

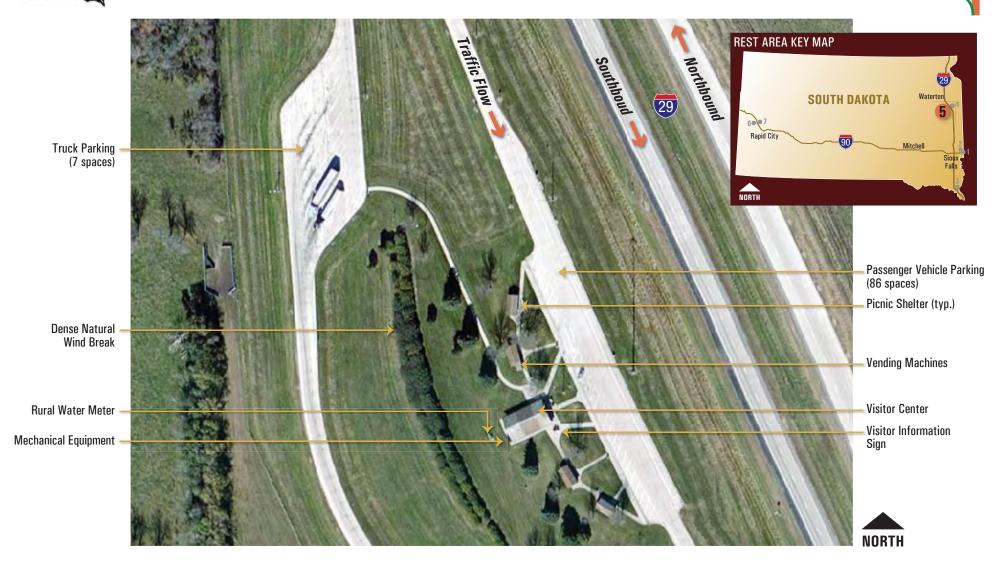
Figure 1. Hidewood Southbound Rest Area Site Layout

- The site has been well maintained, there are some age related repairs required (sidewalks, picnic shelter roofs, etc.) and replacement (lighting, and the sprinkler system).

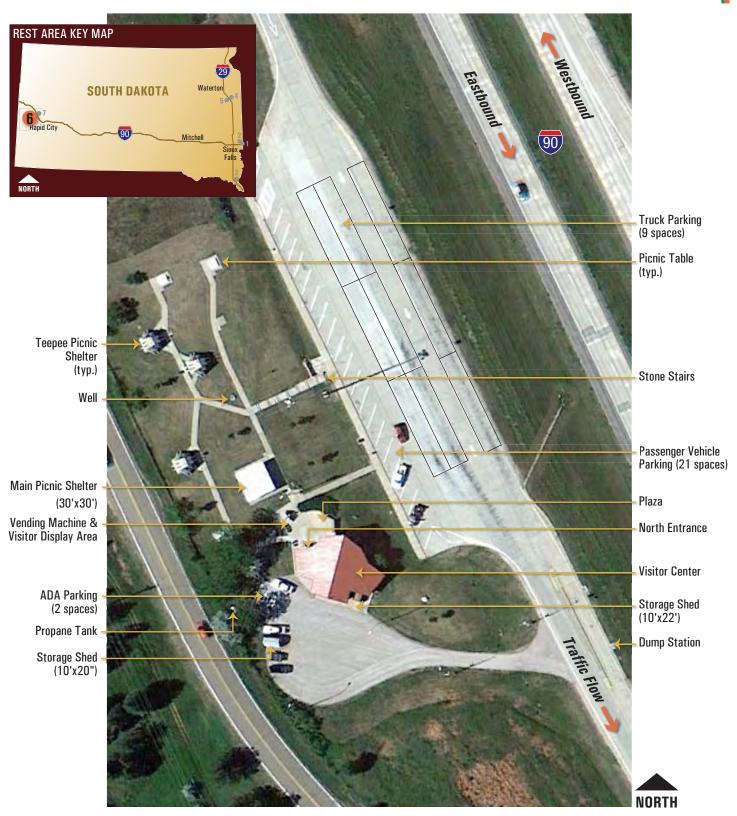
Figure 1. Tilford Eastbound Rest Area Site Layout

Figure 1 shows the layout of the Tilford Eastbound Rest Area facility including the rest area's location in relation to major roadways in the area.

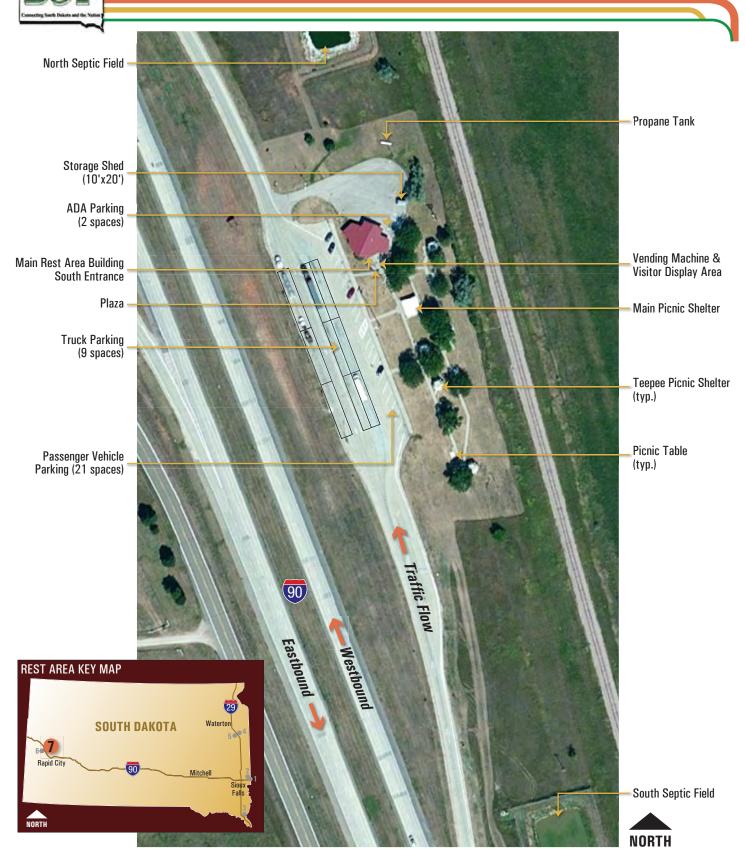
Figure 1. Tilford Westbound Rest Area Site Layout

Figure 1 shows the layout of the Tilford Westbound Rest Area facility including the rest area's location in relation to major roadways in the area.

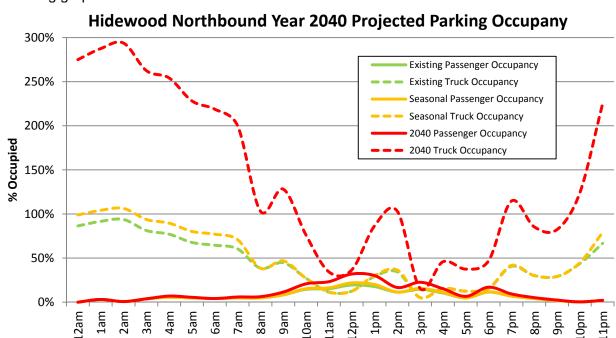
• Hidewood Northbound - The future use estimates show that the passenger vehicle parking will be adequately served by the existing allotment of parking spaces. Hourly passenger vehicle parking occupancy is projected to be less than 50% during all hours of the day. September 2013 truck parking at the rest area operates just under the existing capacity, and would operate over capacity when adjusting for seasonal peaks, To meet future year truck parking demand, the rest area would need to provide nearly 200% more truck parking spaces. A summary of the projected parking occupancy is shown on the following graph:

The long term facility use estimates were applied to the existing parking occupancy count results (summarized in **Figure 1** through **Figure 7**) to determine long term parking demand. It was assumed that hourly variation in parking use remained constant through year 2040. Parking demand at each rest area is summarized in the following bullets.

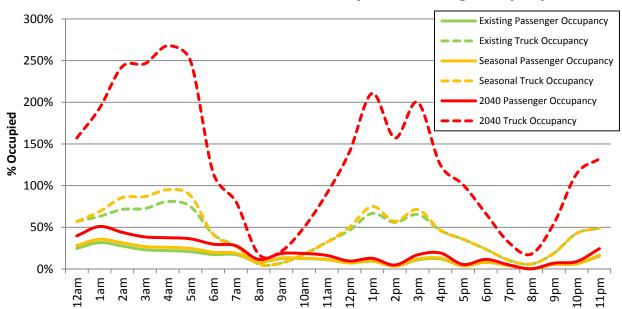
Hidewood Southbound Year 2040 Projected Parking Occupany

Hidewood Southbound - Similar to the Northbound location, passenger vehicle parking
will be adequately served by the existing allotment of parking spaces at the Southbound
Rest Area. Hourly passenger vehicle parking occupancy would operate at or below 50%
occupancy during the day. To meet future year truck parking demand, the rest area would
need to provide a 175% increase in truck parking spaces to meet both nighttime and
daytime peaks. A summary of the projected parking occupancy is shown on the following
graph:

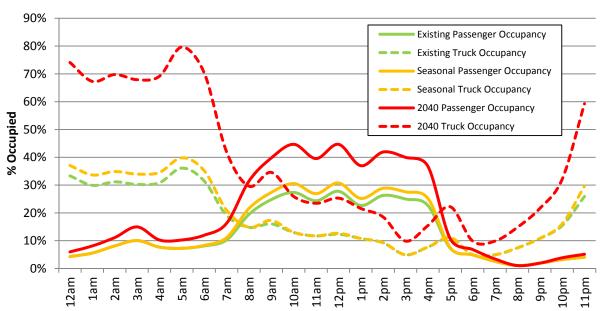
Homestead Year 2040 Projected Parking Occupany

Homestead - The existing inventory of both passenger vehicle and truck parking spaces is anticipated to meet projected year 2040 demand. The rest area currently provides the highest number of both passenger vehicle and truck parking spaces. A summary of the projected parking occupancy is shown on the following graph:

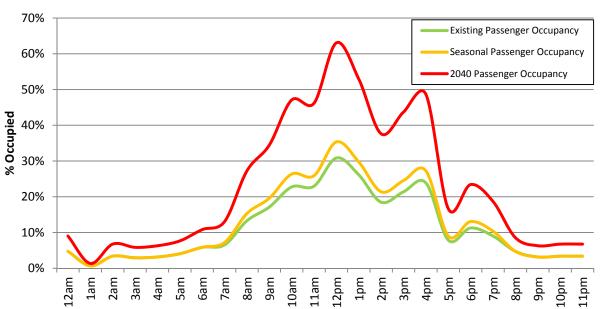
Valley Springs Year 2040 Projected Parking Occupany

• Valley Springs Westbound - As stated previously, the Valley Springs Rest Area has the highest number of visitors on a daily basis. Including both seasonal and future growth, it is anticipated that the existing parking capacity would be adequate to serve the future year 2040 demand. Parking occupancy is anticipated to operate well below the capacity threshold throughout the majority of a typical day. A summary of the projected parking occupancy is shown on the following graph:

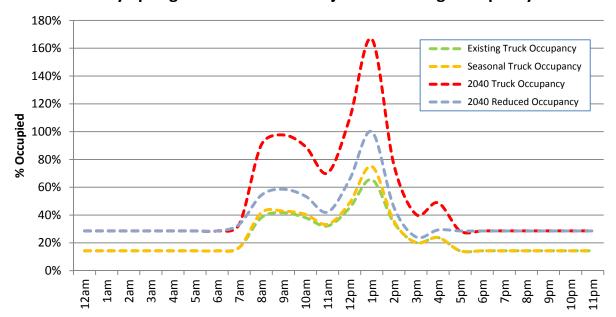
Valley Springs POE Year 2040 Projected Parking Occupancy

• Valley Springs POE - The existing passenger vehicle parking is dedicated to South Dakota Highway Patrol staff, is not anticipated to grow, and therefore will not need to be expanded in the future (not shown on graph). Between now and the year 2040, truck traffic utilizing the POE is anticipated to increase by over 200%. Both the facility and the parking dedicated to the operation will need to be expanded to meet that need. However, future demand is only anticipated to significantly increase during the daytime hours when the facility is open, as truck operators prefer not to park overnight at the facility.

Based on discussions with SDDOT, in the future POE's throughout the State may be equipped with electronic metering capabilities. Drivewyze and license plate recognition software would be installed, and its estimated that as much as 60% of all truck traffic would be able to bypass the POE's throughout the state. Therefore, a second 2040 projection was added assuming electronic metering is installed at the POE. Based on the expected 60% reduction in truck traffic requiring inspection, the existing POE would be able to handle the projected parking demand through year 2040.

A summary of the projected parking occupancy is shown on the following graph:

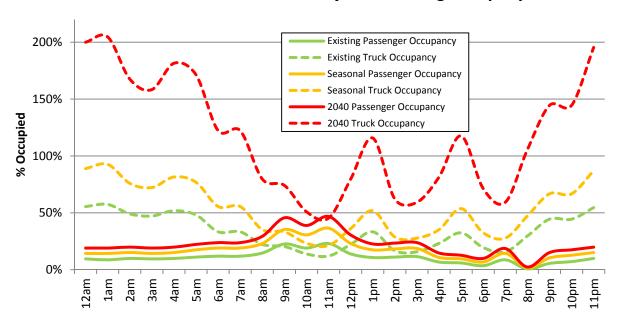
Tilford Eastbound Year 2040 Projected Parking Occupany

Tilford Eastbound - Passenger vehicle parking capacity is anticipated to meet long term
demand, as the lot is anticipated to be less than 50% occupied through year 2040. Truck
parking capacity would need to more than double current allotment to handle the future
demand. A summary of the projected parking occupancy is shown on the following graph:

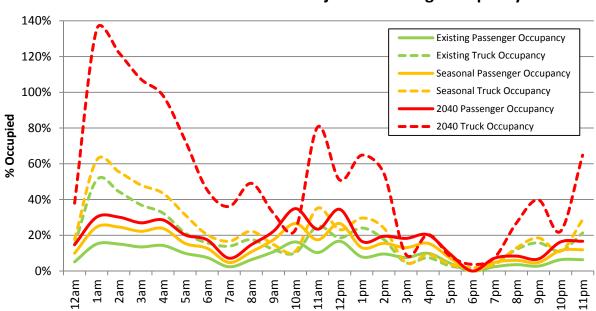
Tilford Westbound Year 2040 Projected Parking Occupancy

• **Tilford Westbound** - Similar to the Eastbound location, passenger vehicle parking will be adequately served by the existing allotment of parking spaces at the Westbound Rest Area. Also, truck parking is would need to increase almost 40% to meet future demand. A summary of the projected parking occupancy is shown on the following graph:

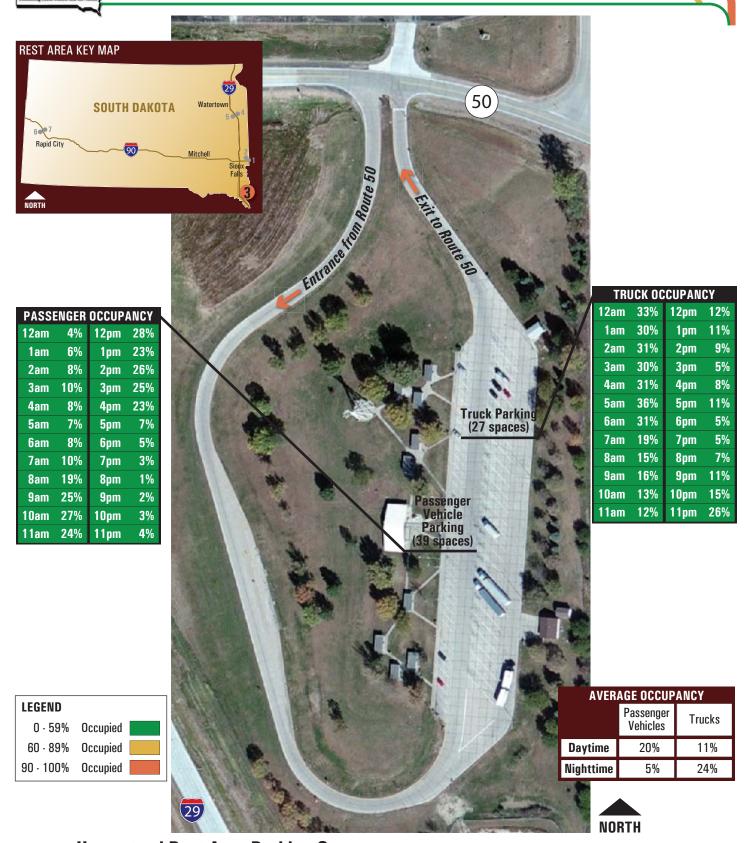
Figure 3. Homestead Rest Area Parking Occupancy

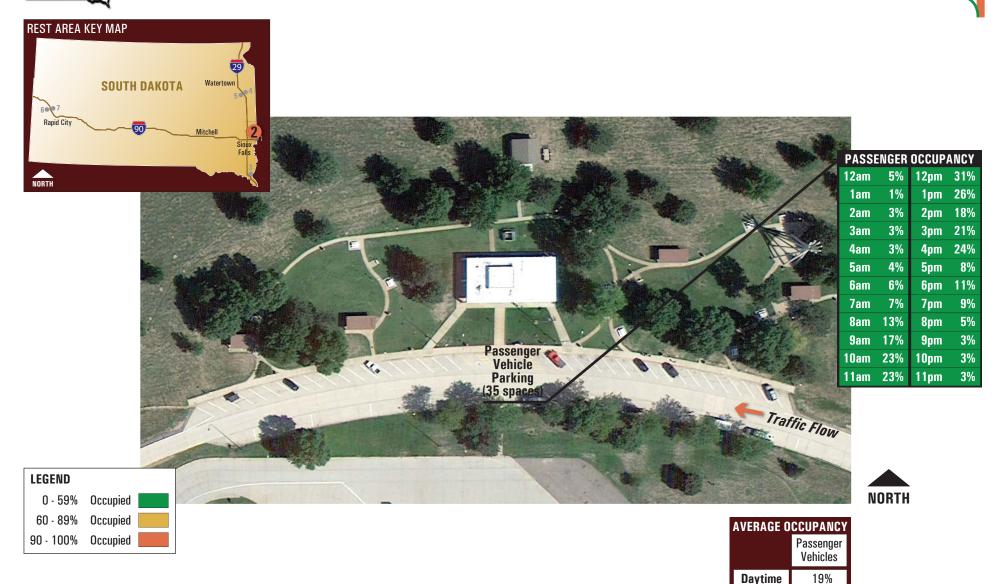
Figure 4. Valley Springs Westbound Rest Area Parking Occupancy

- Valley Springs Westbound The rest area served the most number of parked vehicles of
 the seven sites observed for this study. Since the average time vehicles were parked was
 30 minutes or less (see Table 3), parking occupancy operated well below the capacity
 threshold even with the higher volume of visitors. Occupancy also peaked mid-day, and
 significantly dropped off during the nighttime hours. Parking occupancy for the Valley
 Springs Westbound Rest Area is shown on Figure 4.

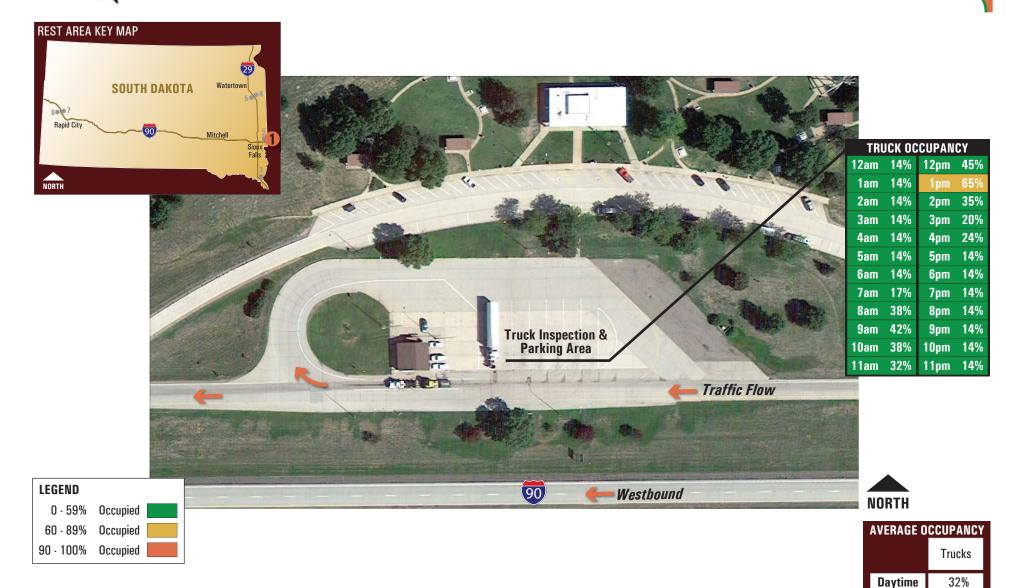
Figure 5. Valley Springs Port of Entry Site Parking Occupancy

- Valley Springs POE The facility, dedicated to the inspection of trucks and their operators, provides both passenger vehicle and truck parking. Passenger vehicle parking is dedicated to the South Dakota Highway Patrol and is fully occupied throughout the hours of operation. As opposed to a typical rest area, truck parking peaked during the daytime hours primarily due to inspections by Highway Patrol staff. Once the facility was closed, truck parking decreased with one vehicle parked throughout the entire nighttime peak. It is not anticipated that the truck was being operated at the time of the count, and remained parked either due to a violation or mechanical failure. Parking conditions at the Valley Springs POE are shown on Figure 5.

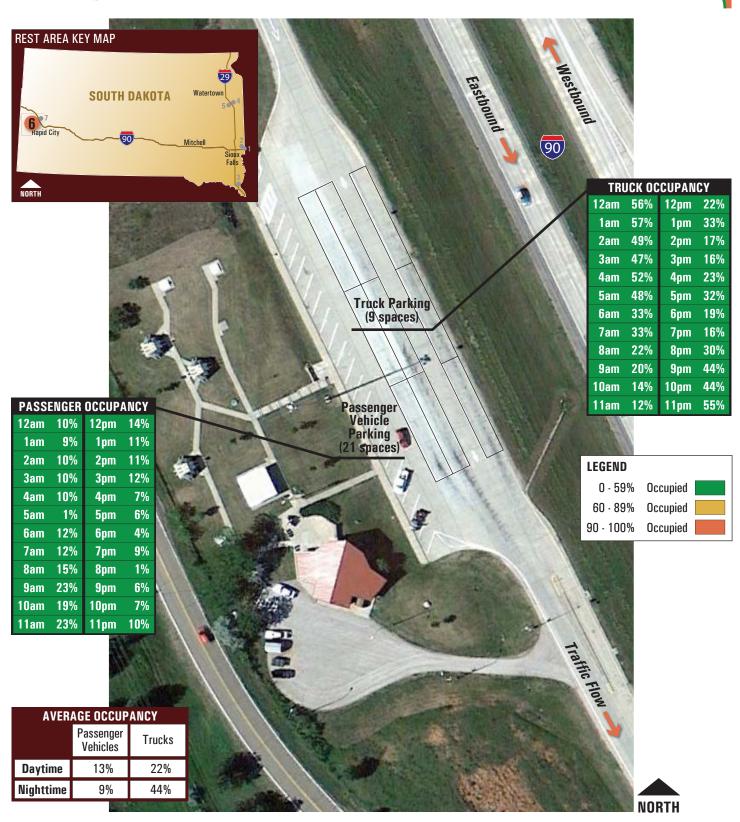
Figure 6. Tilford Eastbound Rest Area Parking Occupancy

- Tilford Eastbound Passenger vehicle parking peaked during the daytime hours (23% at 11:00AM) and operated well below the capacity threshold throughout the entire 24-hour period. Similar to other rest areas, truck parking peaked during the nighttime hours (57% at 1:00AM) and operated below the capacity threshold. As stated previously, the rest area provides nine parallel truck parking spaces, requiring trucks to complete complex turning movements to enter / exit parking spaces. Although truck parking occupancy was within capacity, the layout of the parking spaces could contribute to trucks either bypassing the site or driving through without parking due to the complex turning movements that would be required. A summary of the parking occupancy counts at the Tilford Eastbound Rest Area is shown on Figure 6.

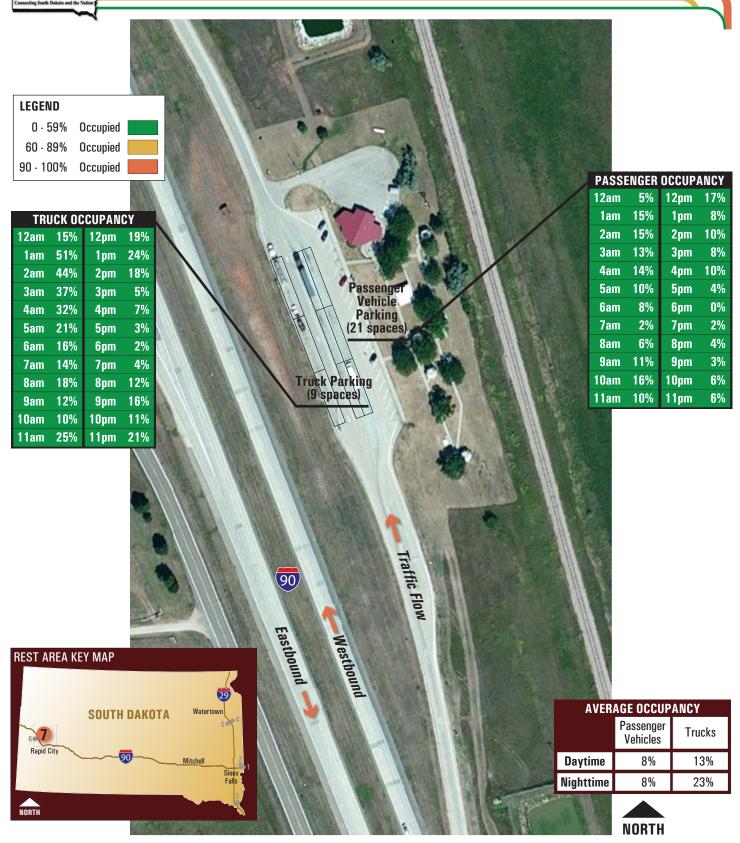
Figure 7. Tilford Westbound Rest Area Parking Occupancy

- **Tilford Westbound** Both passenger vehicle and truck parking demand remained within capacity during the study period. Truck parking peaked during the nighttime hours (51% at 1:00AM) and operated the remainder of the 24-hour period well under the capacity threshold. Of note, security video was used to supplement video data during the 3:00AM through 8:00AM time frame, which was not viewable. A summary of the parking occupancy counts at the Tilford Westbound Rest Area is shown on **Figure 7**.

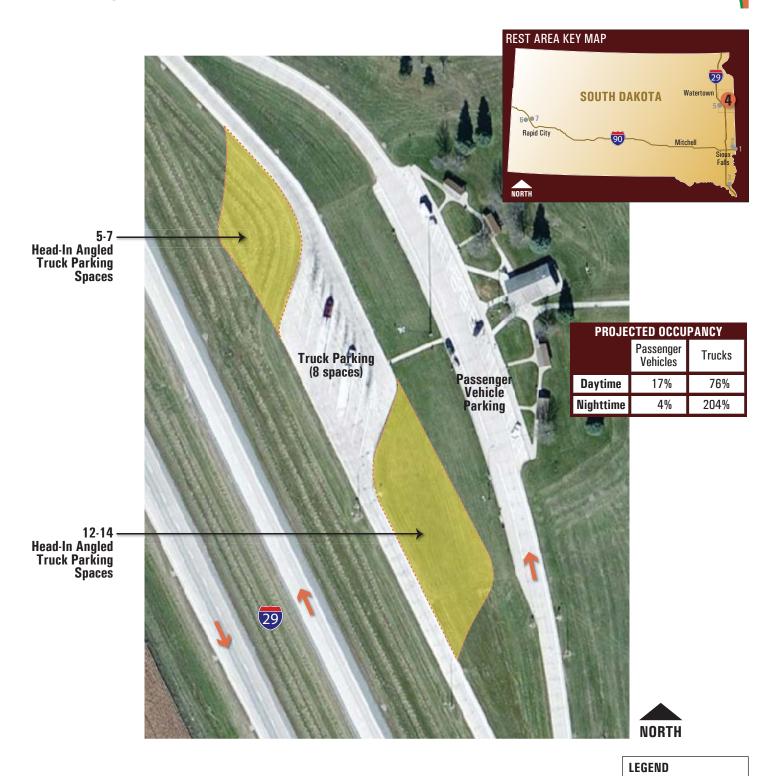
Figure 8. Hidewood Northbound Rest Area Future Expansion Potential

- Hidewood Northbound Future estimates show parking would need to increase by 16 spaces, tripling existing capacity. The parking area currently provides eight head-in angled parking spots. The area directly north and south of the existing truck parking lot provides adequate room to expand the facility. It is anticipated that 17-21 truck parking spaces could be added with minimal impact to the existing infrastructure. Figure 8 depicts the expansion potential for the facility.

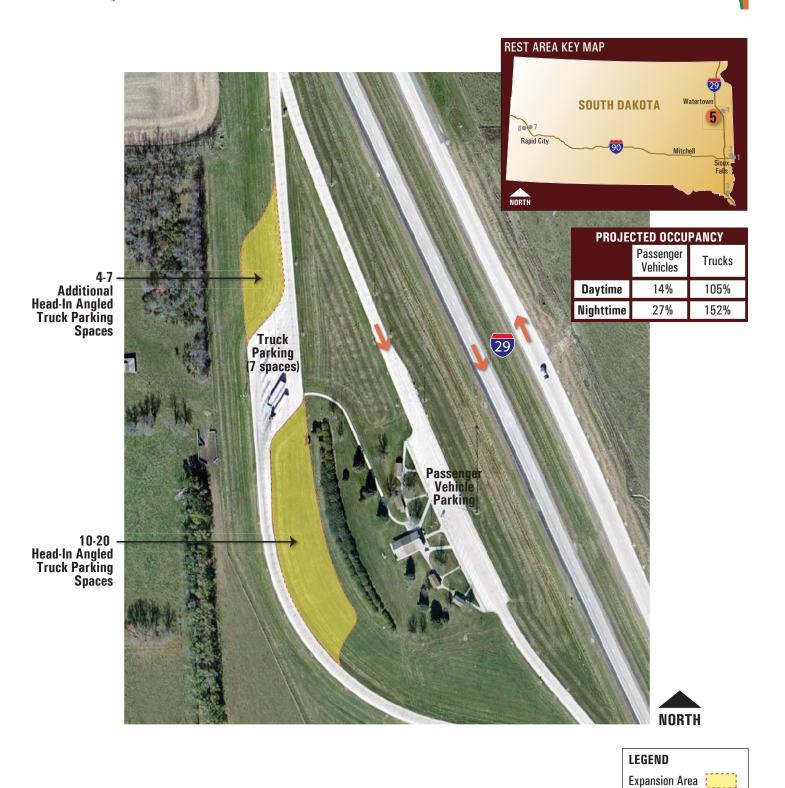
Figure 9. Hidewood Southbound Rest Area Future Expansion Potential

- Hidewood Southbound It is anticipated that the rest area would need to provide approximately 175% more truck parking spaces to meet demand. Similar to the Northbound Rest Area, the area north and south of the existing seven space parking facility could be expanded with minimal impact to the existing infrastructure. An estimated 14-27 additional parking spaces could be added, exceeding future demand. Figure 9 shows the expansion potential for the facility.

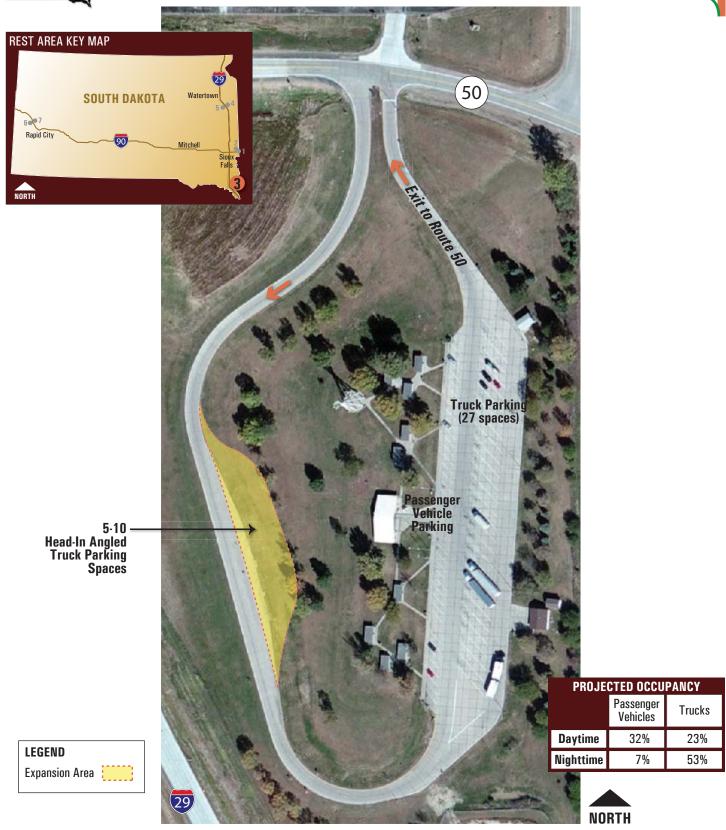
Figure 10. Homestead Rest Area Future Expansion Potential

- Homestead As stated previously, the existing passenger vehicle and truck parking
 capacity is anticipated to meet future demand at this location. However, if demand does
 exceed projections in the future, the existing facility does provide area for expansion of the
 truck parking in the future. An additional five to ten angled truck parking spaces could be
 added along the western side of the site, and would require removal of existing trees to
 accommodate the additional pavement. Figure 10 shows the expansion potential for the
 facility.

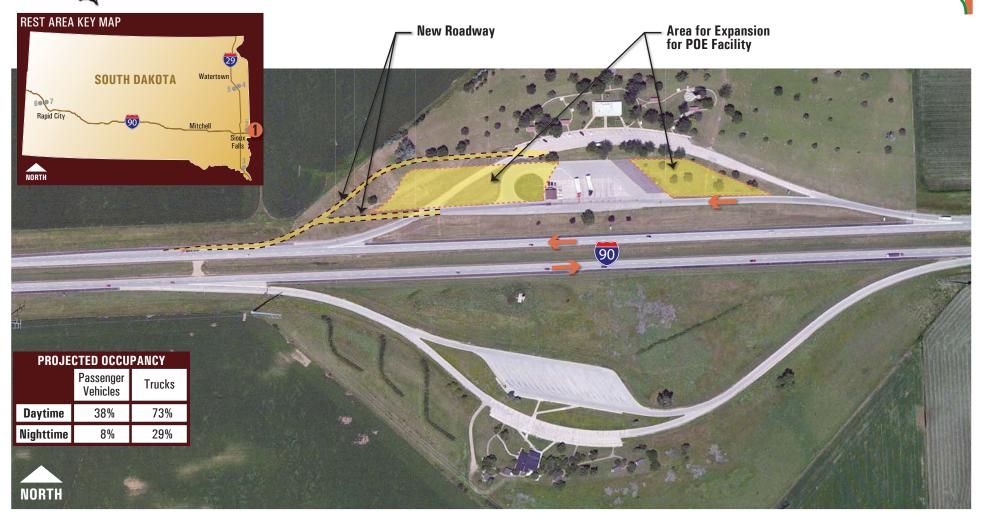
Figure 11. Valley Springs Sites Future Expansion Potential

- Valley Springs Westbound & POE It is anticipated that truck parking capacity would need to be expanded by almost 80% to meet future demand, only if electronic metering equipment is not installed. In addition, the POE facility may require expansion to fulfill its mission of inspecting trucks and their operators entering South Dakota. Compared to other POE's within South Dakota, the Valley Springs location is smaller and does not provide a covered inspection area. With improvements to the passenger vehicle and truck parking egress points onto Interstate 90, the POE facility could be expanded to include up to 100% of additional area that could be designated for either parking or vehicular inspection. Figure 11 shows the expansion potential for the facility.

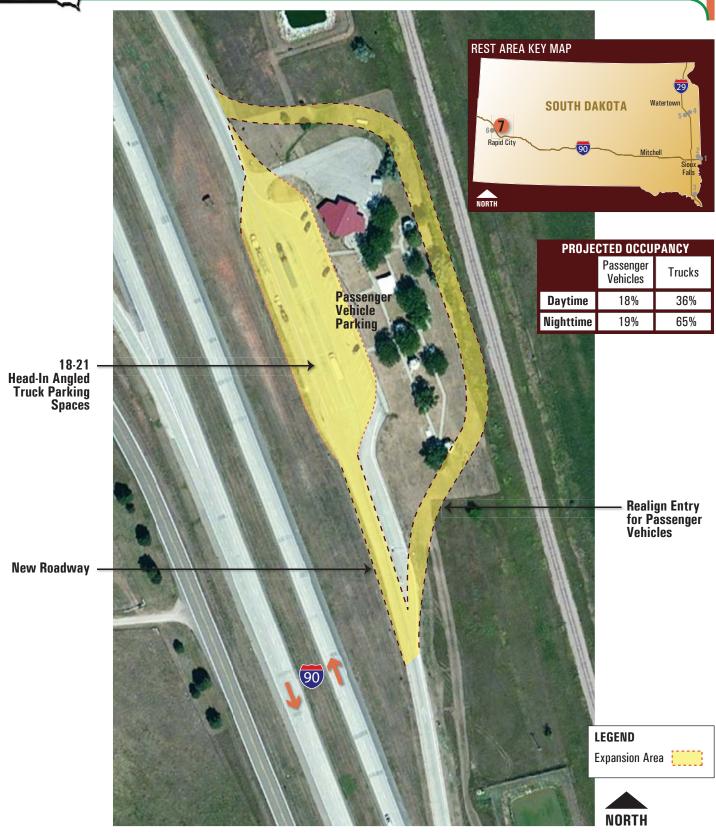
Figure 13. Tilford Westbound Rest Area Future Expansion Potential

- Tilford Westbound Truck parking would need to be expanded by more than 40% to meet future demand. Similar to the Eastbound location, the Westbound Rest Area provides limited areas for expansion. Redesigning the parking lot to provide head-in angled truck parking could provide as many as 21 truck parking spaces, a 130% increase in capacity. The proximity of the expanded parking lot to the Interstate 90 corridor would require installation of barrier to meet clear zone criteria. Figure 13 shows the expansion potential for the facility.

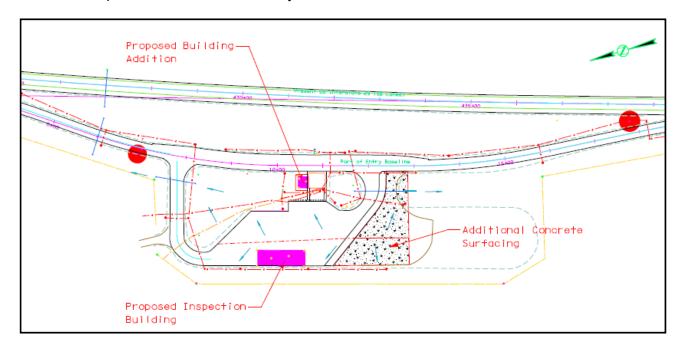
Below is a depiction of the Sisseton facility:

The project team reviewed the footprint of the Sisseton POE and found that it would require an approximate 200' wide x 550' long area to accommodate the layout. That 200' wide distance is from the north shoulder/ edge of the access road. On this basis, the existing Valley Springs area could accommodate an upgraded facility by routing the rest area access roadway slightly farther to the north and expanding west from the current POE facilities. A preliminary assessment of site grading to the west indicates that some fill might be required to sufficiently level the area.

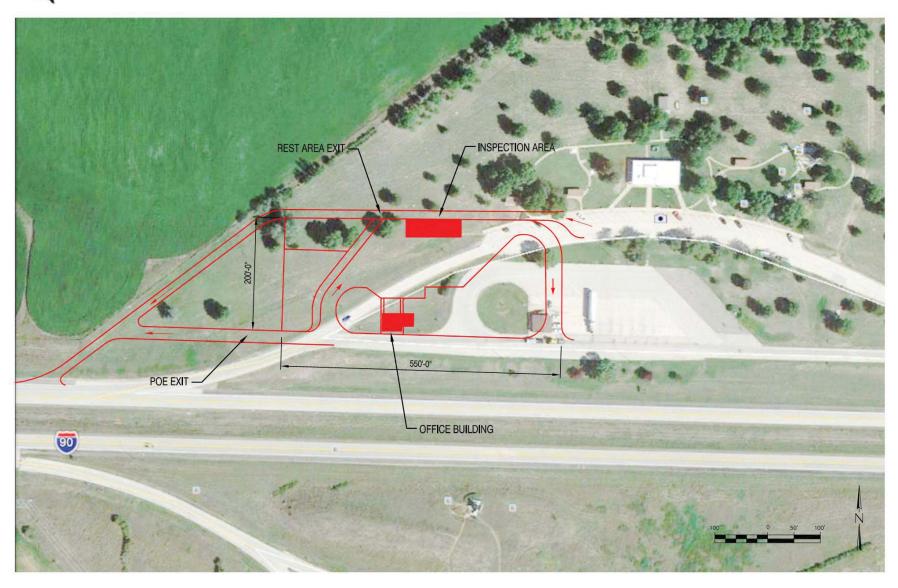
Figure 1. Valley Springs POE - Site Upgrade Layout

Figure 1 depicts a potential layout for the updated/upgraded POE. The presence of the truck access roadway and inspection building would remove approximately 12 passenger car parking spaces from the Valley Springs Westbound rest area, but parking analyses indicate that the remaining spaces could accommodate projected Year 2040 demand, though peak parking lot occupancy could reach as high as 96 percent. The seven truck parking spaces within the existing POE area would remain and would be adequate to accommodate demand, assuming WIM technology is fully adopted at the site. It is recommended that the updated site continue to provide truck parking spaces, as particular situations such as weather emergencies can sometimes require that trucks stay parked at the POE for extended periods of time. The Sisseton POE staff noted in an informal telephone conversation that their newly expanded site has limited ability to accommodate such demand.

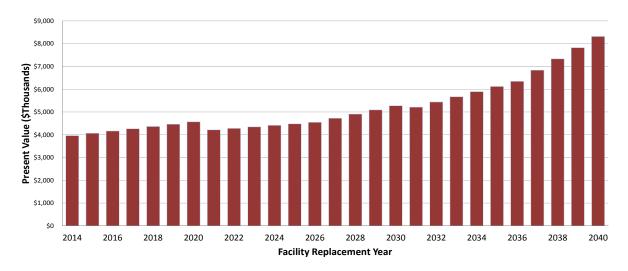
Note: Total present value of the preservation plan through 2040 is \$5.7 million, not including the value of a new facility. Source: TSP and BBC Research & Consulting. 2014

The rest area at Hidewood Southbound is in similar condition to the Hidewood Northbound facility. While it is preferable to replace the facility as soon as possible, it is possible to preserve the facility until 2030 without incurring prohibitive costs; however after 2030 it becomes financially inefficient to continue making the necessary repairs. Between 2014 and 2030, SDDOT should consider reconstructing the Hidewood Southbound facility. The values of different repair plans are shown below in **Figure E-2**.

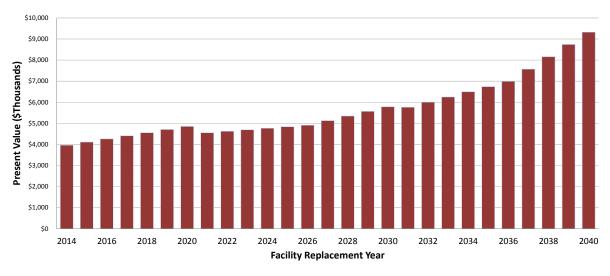
Figure E-3. Present Value of Repair Plans- Homestead

Note: Total present value of the preservation plan through 2040 is \$6.8 million, not including the value of a new facility. Source: TSP and BBC Research & Consulting. 2014

Costs for the Homestead rest area repair plans are shown in **Figure E-3**. Preserving this rest area is slightly more expensive than either Hidewood rest area.

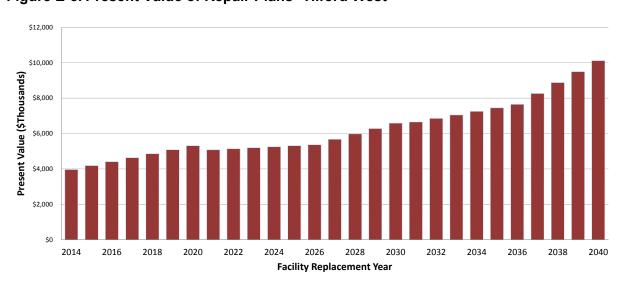
Figure E-5. Present Value of Repair Plans- Tilford West

Note: Total present value of the preservation plan through 2040 is \$7.7 million, not including the value of a new facility. Source: TSP and BBC Research & Consulting. 2014

Costs for the Tilford West rest area repair plans are shown in **Figure E-5**.

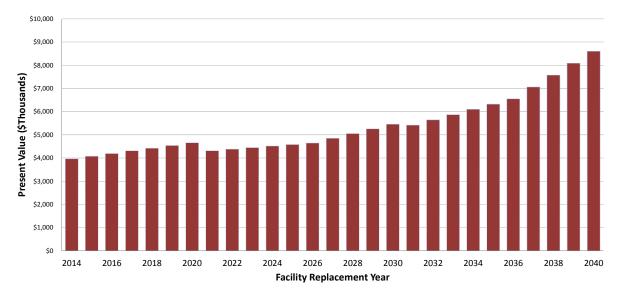
Figure E-7. Present Value of Repair Plans- Valley Springs Point of Entry

Note: New facility cost for the Valley Springs POE is approximately \$2.7 million
Total present value of the preservation plan through 2040 is \$6.8 million, not including the value of a new facility.

The present value cost analysis for the Valley Springs point of entry facility is shown in **Figure E-7**. FHU estimates that it will cost approximately \$2.7 million to build a new POE facility.
